Preliminary Report

Fort Worth, TX

HWY21FH005

HIGHWAY

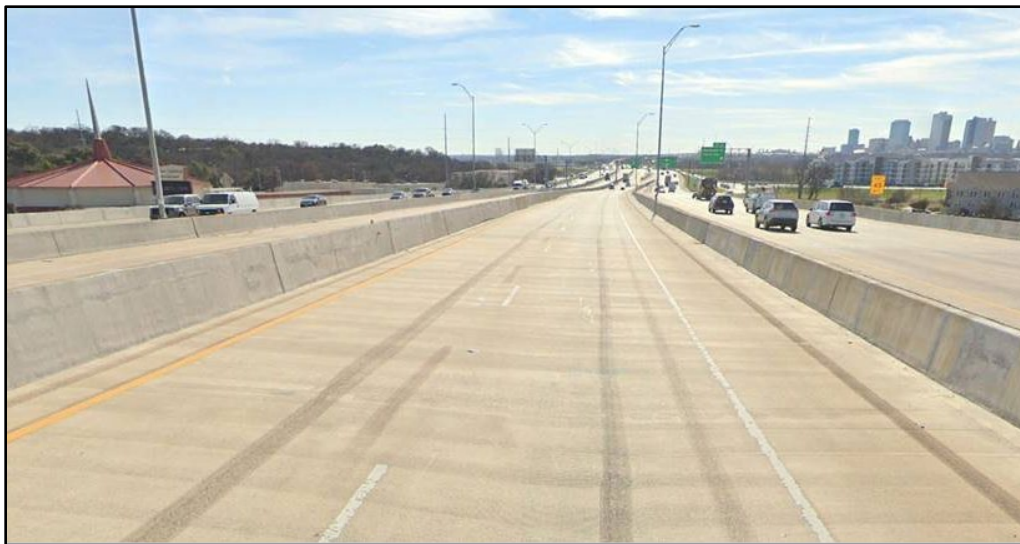
Figure 1. Approximate location of crash, looking south. (Source: Google Earth image from January 2020)

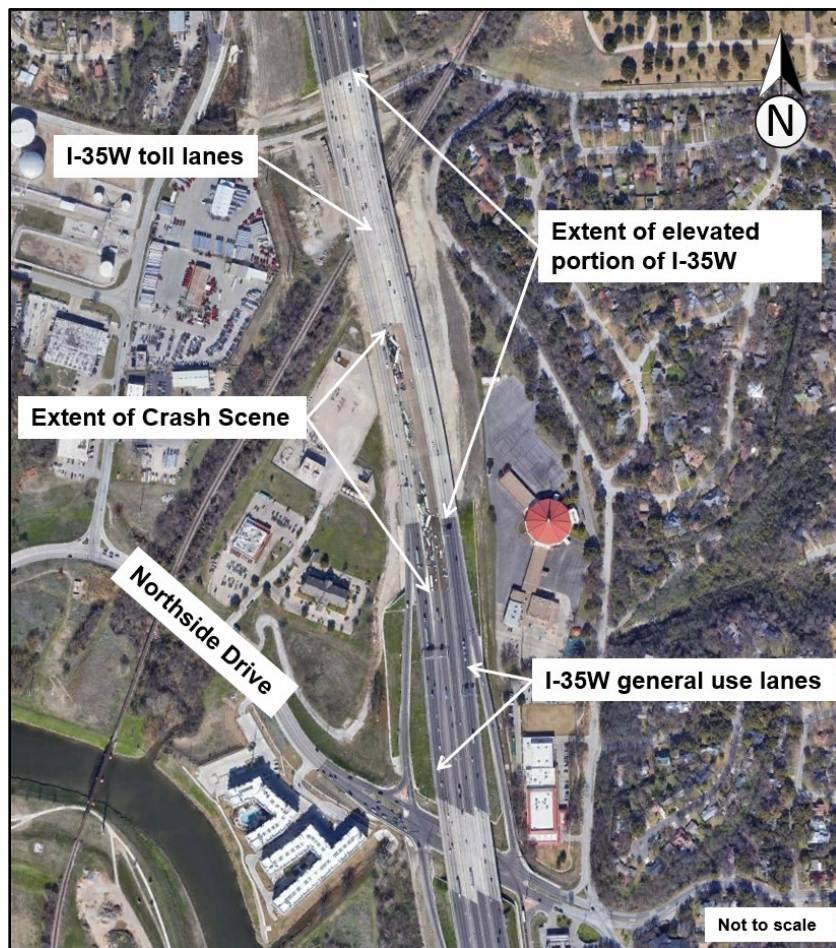
The crash involved a combination of commercial and passenger vehicles and covered a segment of roadway approximately 1,100 feet long (figure 2). As a result of the crash, 6 people were fatally injured. Two of the fatally injured people were pedestrians who exited their vehicles and were struck on the road. The other fatally injured people had remained inside their vehicles. Thirty-six vehicle occupants were transported to area hospitals for treatment of their injuries.

Figure 2. Crash scene (Source: Adapted from Google Earth).
