*METALLURGICAL INVESTIGATION OF A
FRACTURED SECTION OF THE 20" O.D.
PIPELINE AT MILEPOST 314.77 IN THE
CONWAY TO CORSICANA SEGMENT OF
THE PEGASUS CRUDE OIL PIPELINE*

REPORT NO. 64961, REV. 1

Prepared for
ExxonMobil Pipeline Company and the
Pipeline and Hazardous Materials Safety Administration
pursuant to Corrective Action Order CPF 4-2013-5006H

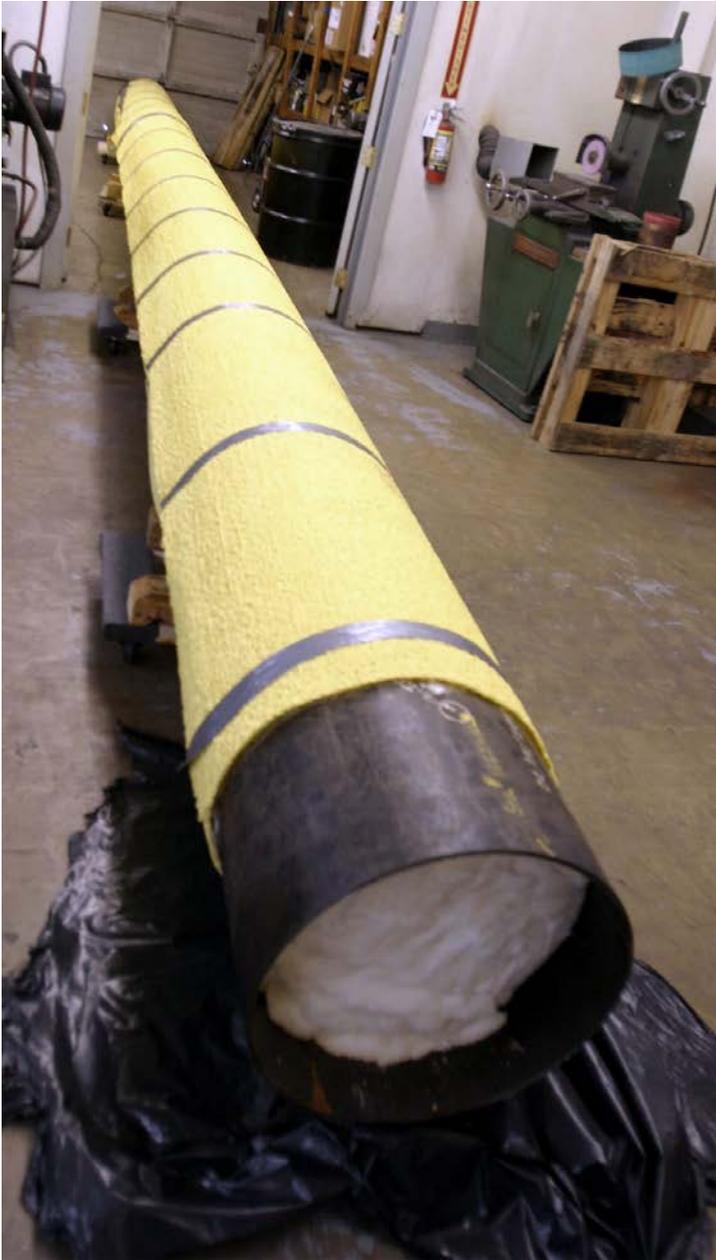
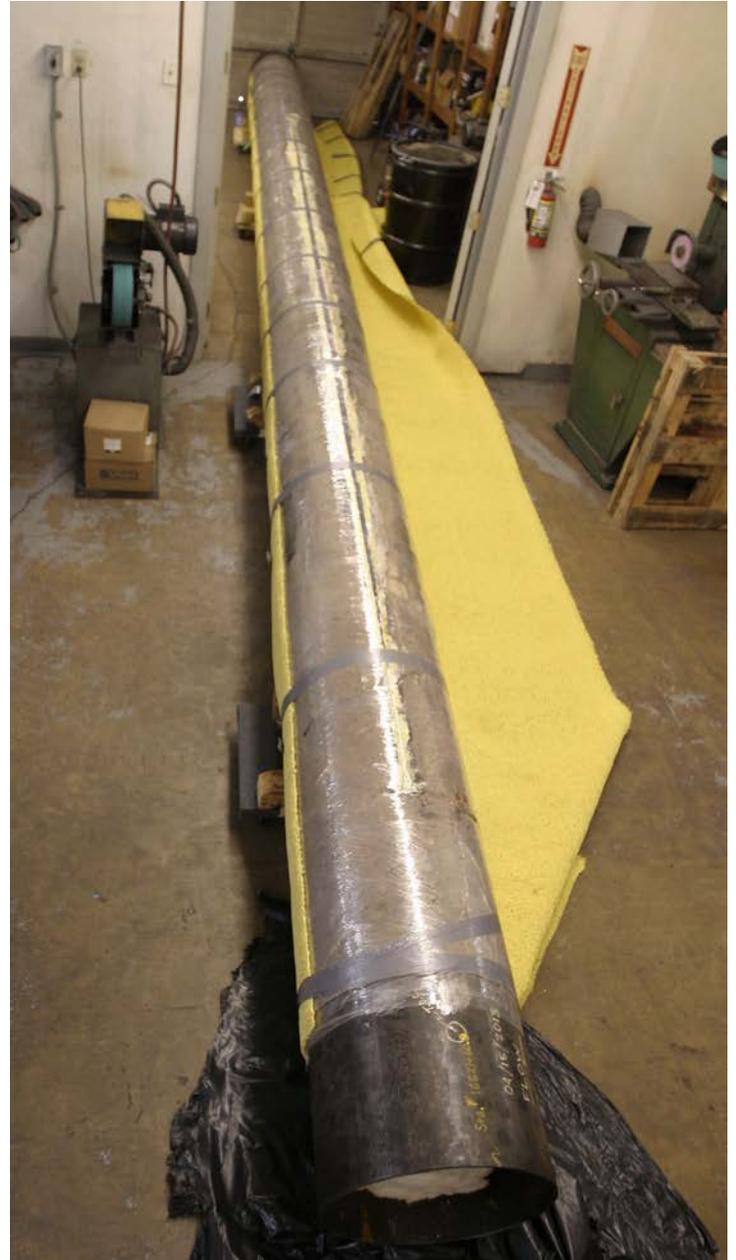
Photograph No. 4

The photographs display the fractured section of the pipe in the as-received condition and following removal of the outer protective wrapping material.

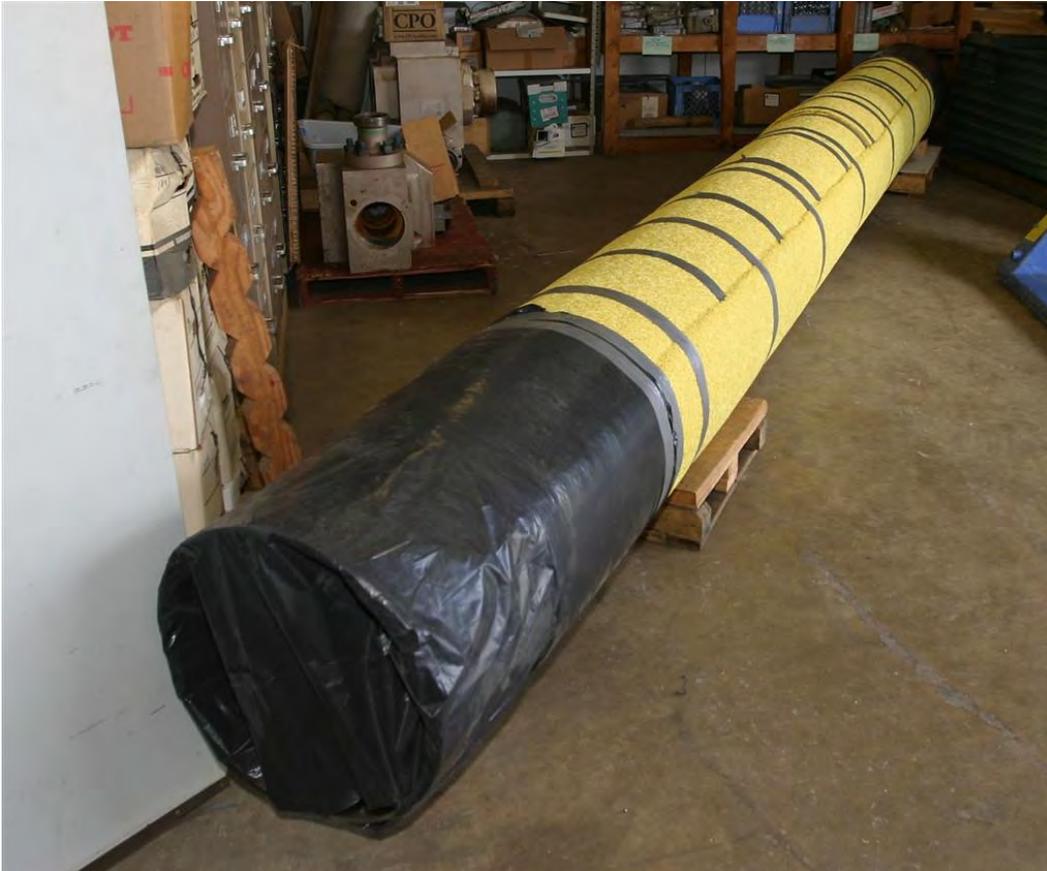
Photograph No. 6

The photograph displays the intact section of the pipe in the as-received condition with the outer protective wrapping material.

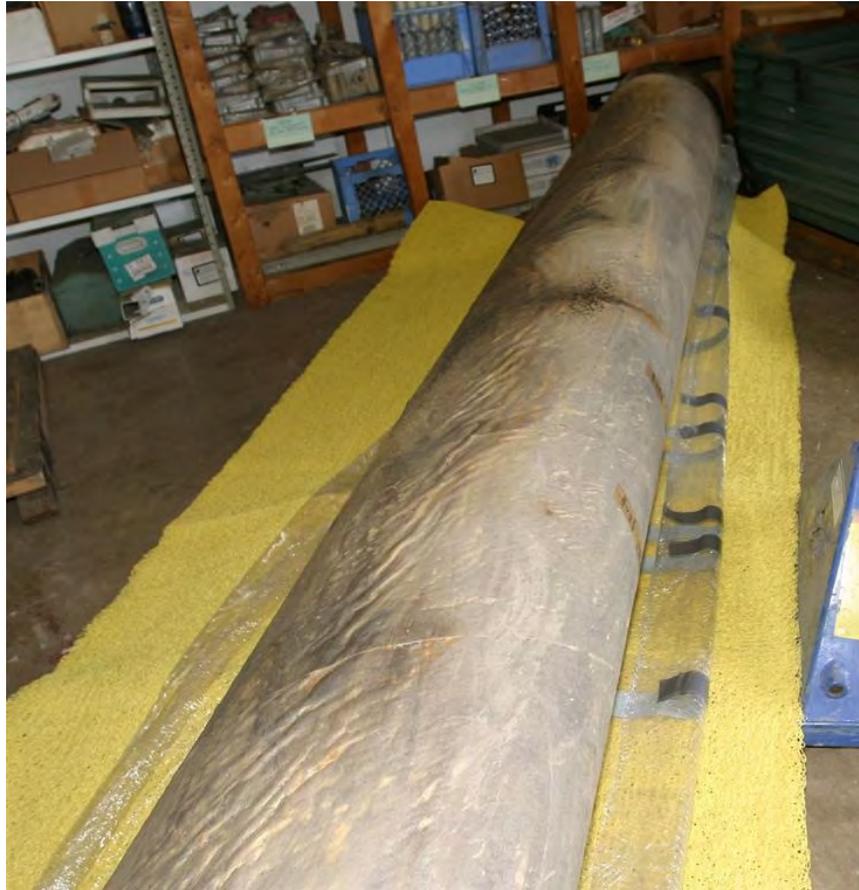
Photograph No. 7

The photograph displays the intact section of the pipe following removal of the 2nd protective wrapping material.

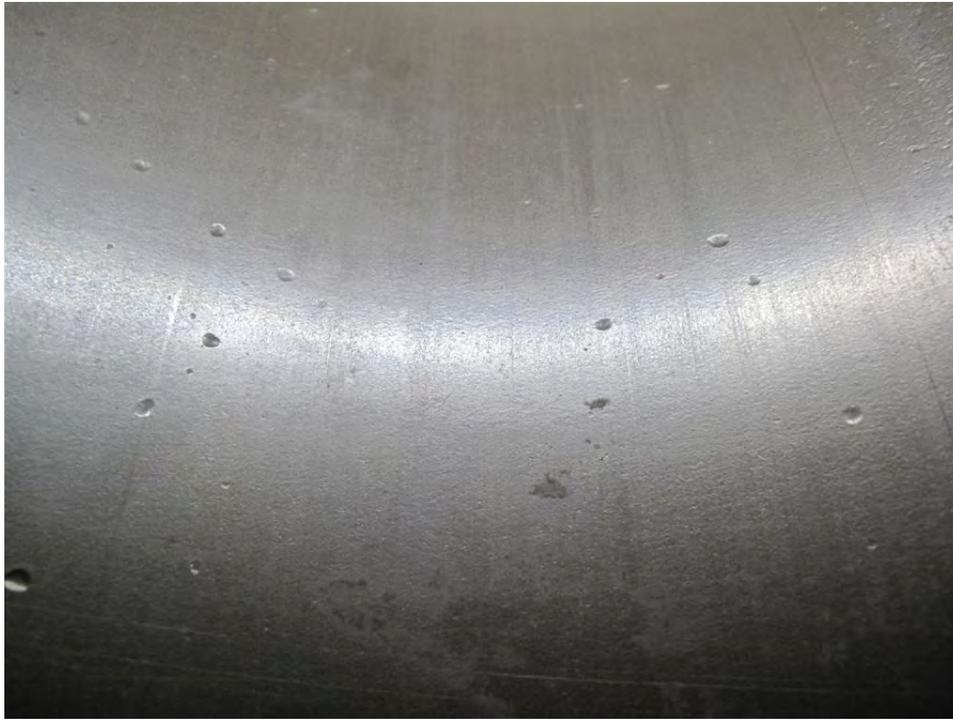
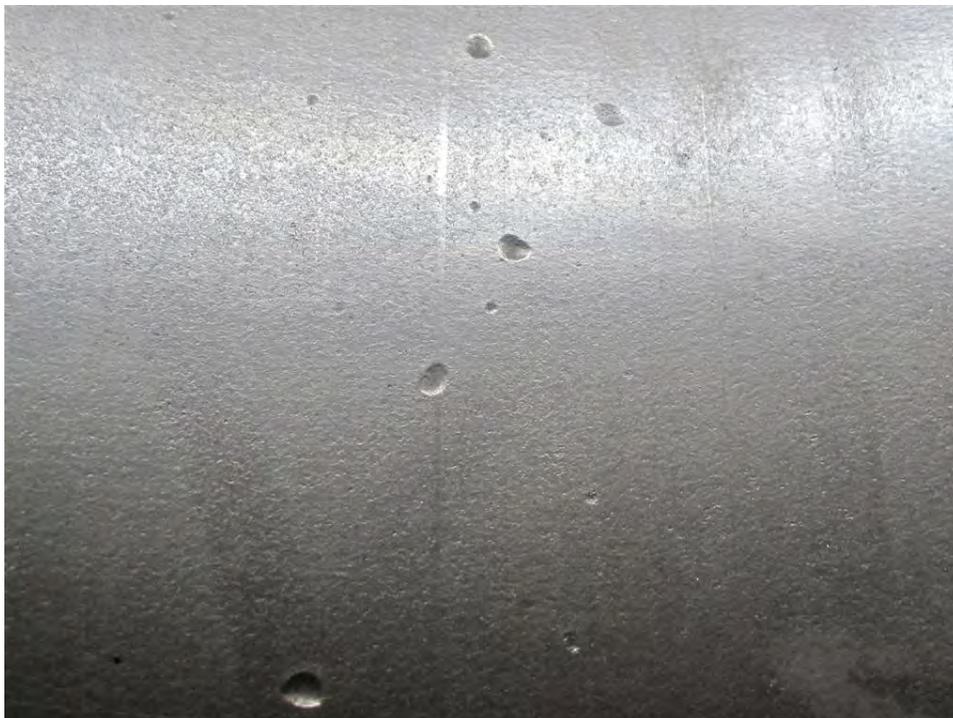
Following sectioning of the 33' 11-1/2" long and the 19' 10" long pipe lengths, the I.D. surfaces at several areas were more closely examined. Multiple shallow depressions, including those noted above, were visible around the entire circumference of the I.D. surface. The depressions were very smooth in appearance and contained no visible corrosion products, suggestive of mechanical deformation as opposed to corrosion pitting. No evidence of any significant corrosion pits was visible on the I.D. surface. Photographs No. 83 and No. 84 show representative areas of the I.D. surface.

The photographs display representative areas of the I.D. surface at an intact area of the pipe, showing the smooth, shallow impressions that resulted from mechanical damage, most likely during the hot-rolling of the steel or manufacturing of the pipe. No evidence of corrosion pitting was observed on the I.D. surface.

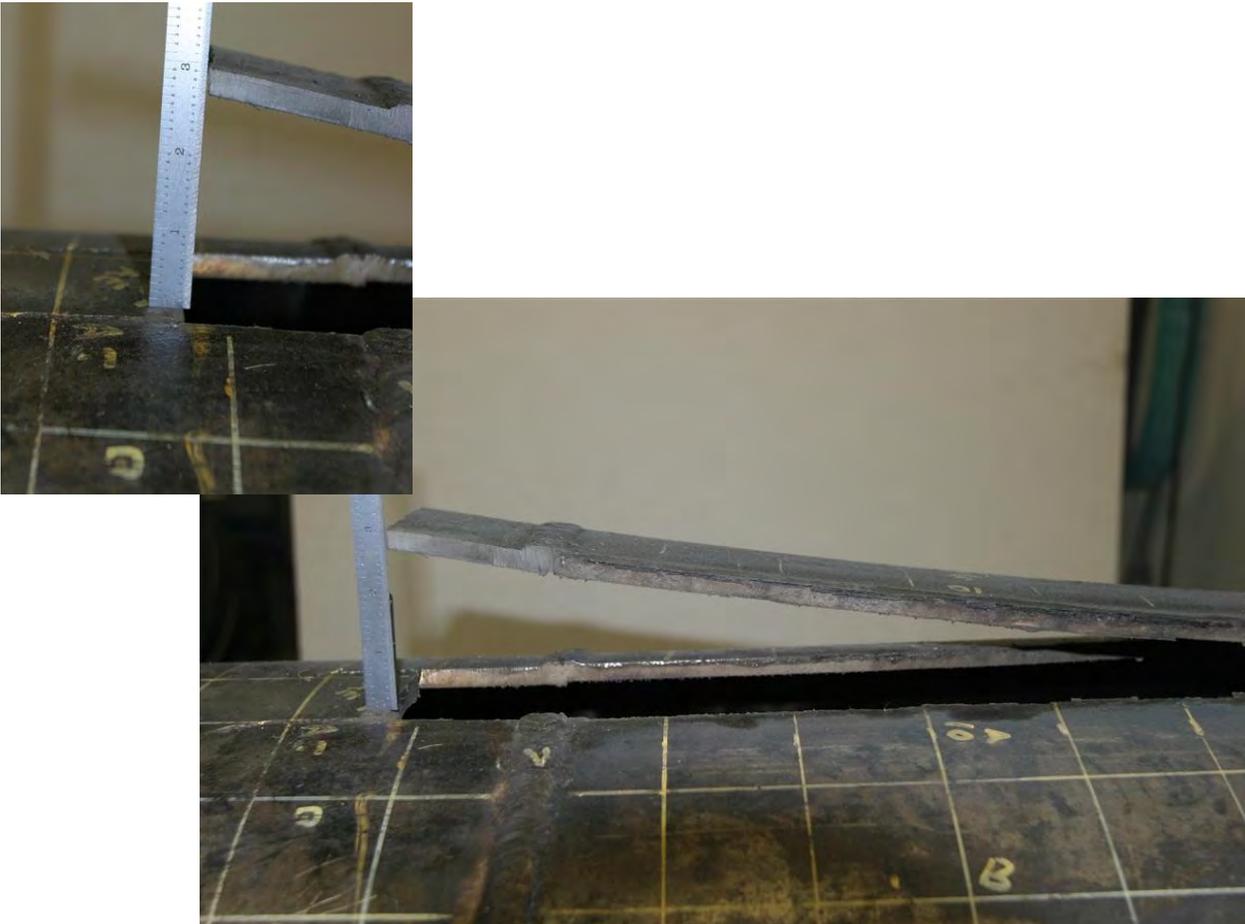
Photograph No. 85

The photograph shows the displacement of the pipe by approximately 2-31/32" following sectioning through the intact portion of the adjoining pipe, indicative of the presence of significant residual stress.

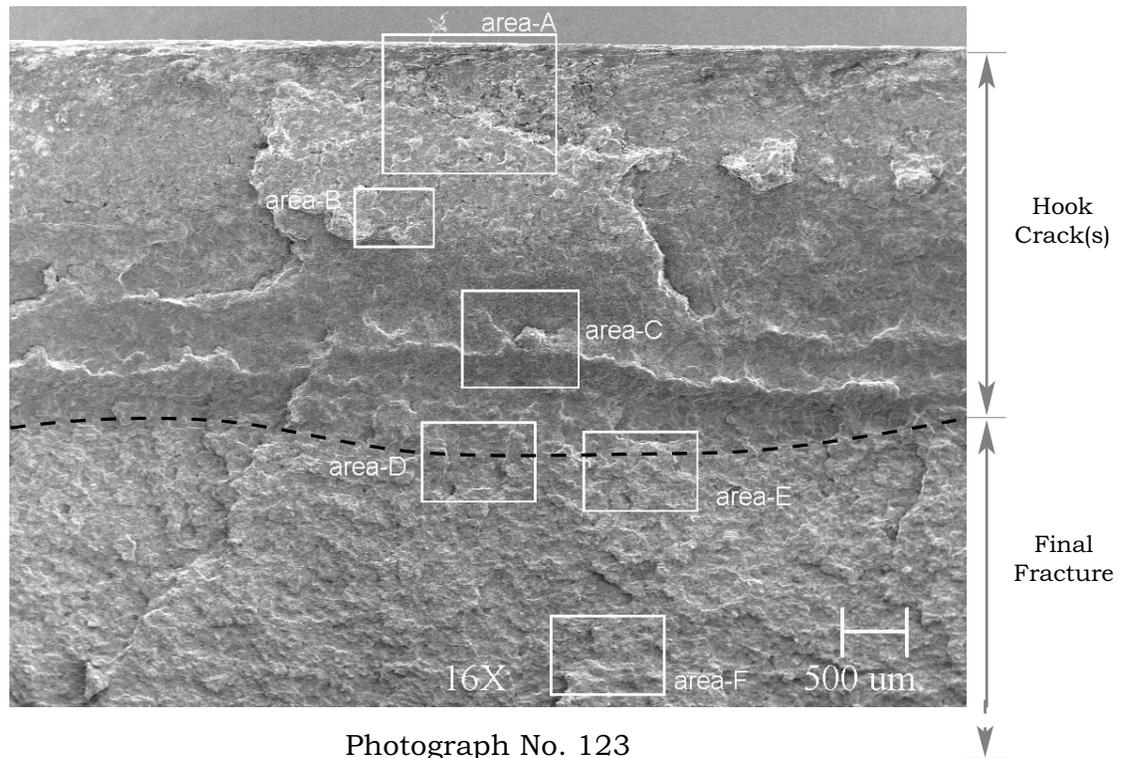
Photograph No. 123

The SEM fractograph taken of one of the final fracture origin sites at a distance of 20' 5-5/16" from the north girth weld shows an hook crack and the final fracture zone. The fracture locations within the rectangles were examined at high magnifications to further characterize the fracture morphologies. The dotted line denotes the transition zone between the hook cracks and the final fracture.

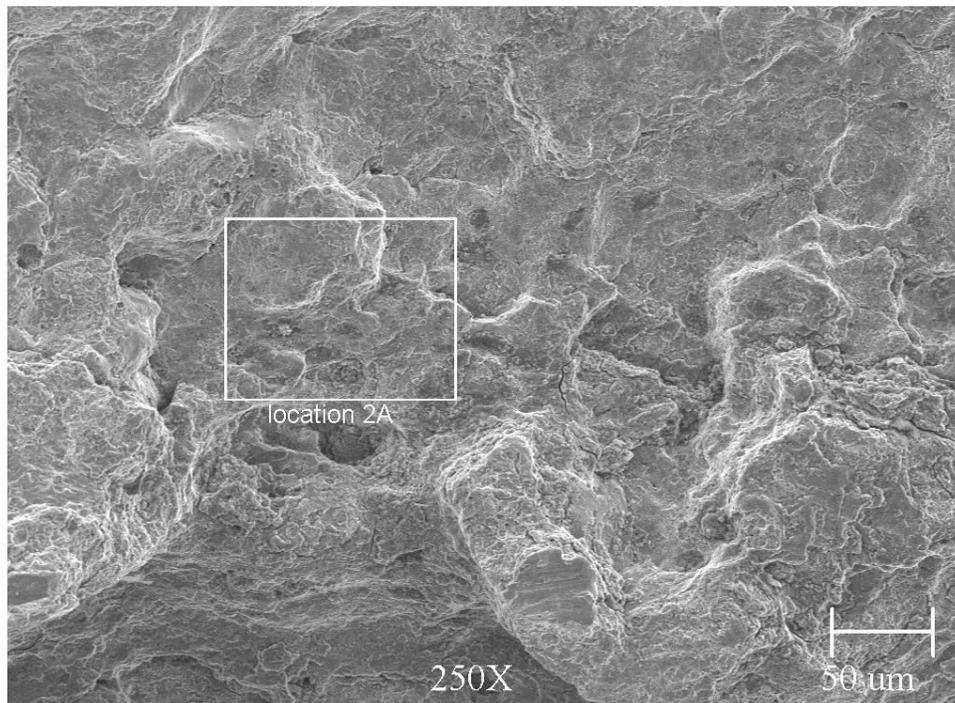
Area-B
Photograph No. 127

The SEM fractograph taken of the Area-B of the hook crack zone, as displayed in Photograph No. 123, reveals a nondescript, featureless fracture surface. The fracture location labeled as Location-2A was examined at higher magnification to further characterize the fracture morphology.

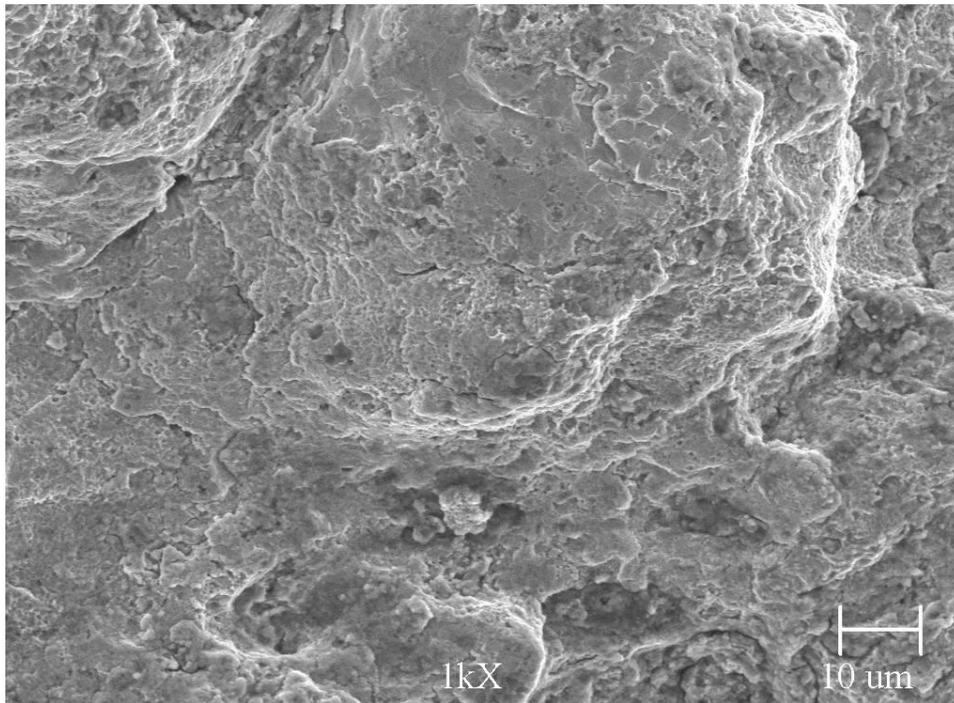
Area-B, Location-2A
Photograph No. 128

The SEM fractograph taken of the Area-B at Location-2A of the hook crack zone, as displayed in Photograph No. 127, reveals tightly adhered oxidation product on the fracture surface.

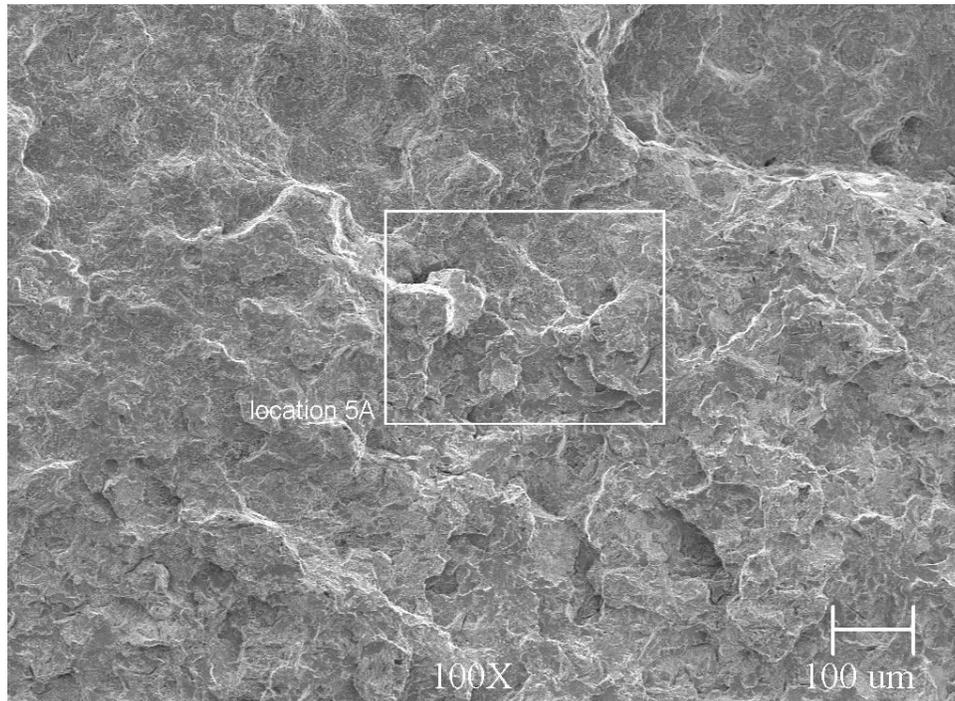
Area-E
Photograph No. 136

The SEM fractograph taken of the Area-E in the transition zone between the hook crack and the final fracture zones, as displayed in Photograph No. 123, reveals a nondescript, featureless fracture surface. The fracture location labeled as Location-5A was examined at higher magnification to characterize the fracture morphology.

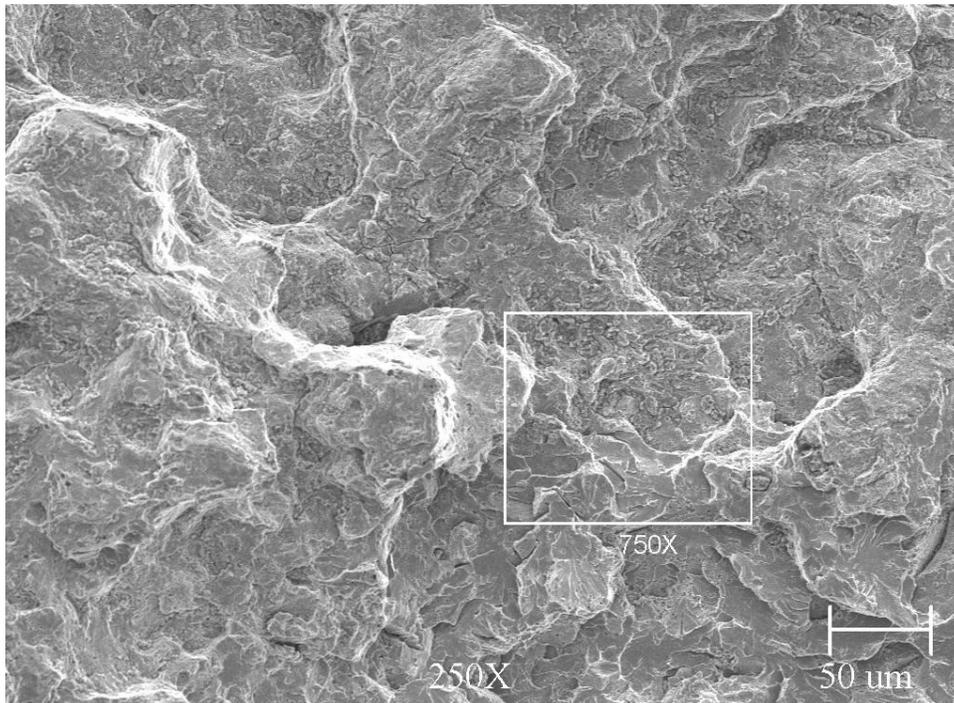
Area-E, Location-5A
Photograph No. 137

The SEM fractograph taken of the Area-E at Location-5A displays some evidence of oxidation product in the hook crack and evidence of quasi-cleavage separation in the final fracture zone, indicative of pre-existing crack and final brittle fracture, respectively.

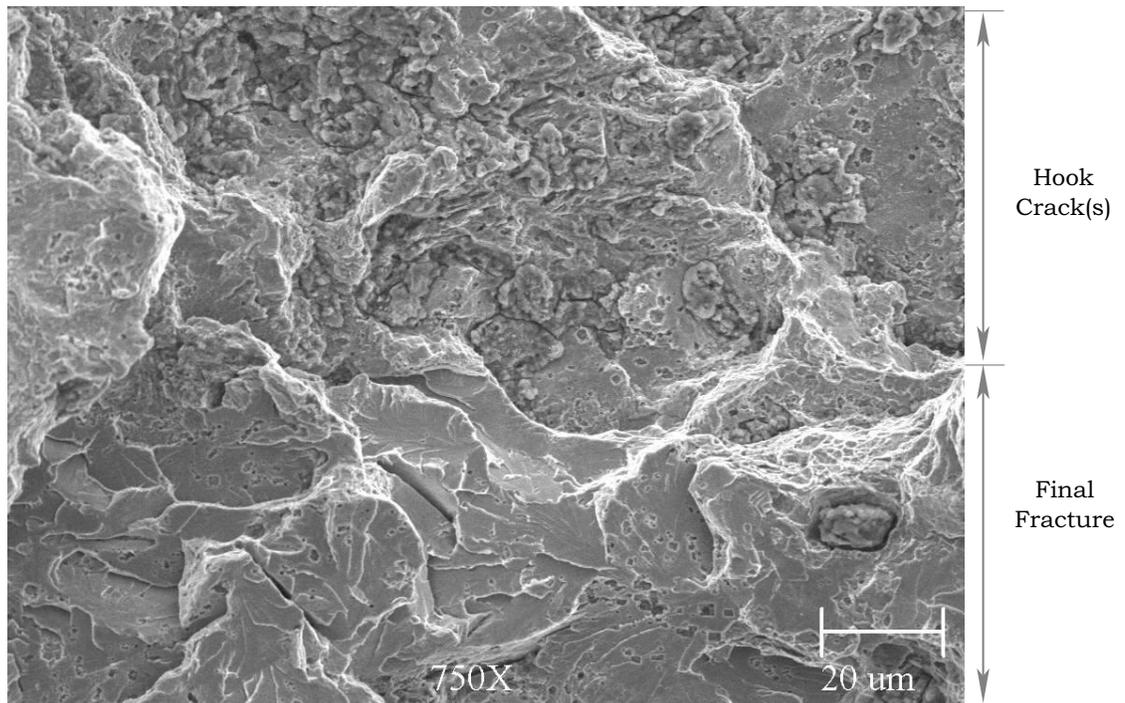
Area-E, Location-5A, Location within rectangle
Photograph No. 138

The SEM fractograph taken of the Area-E at Location-5A, as displayed in Photograph No. 137, confirms the oxidation on the hook cracks and the final fracture in the brittle manner.

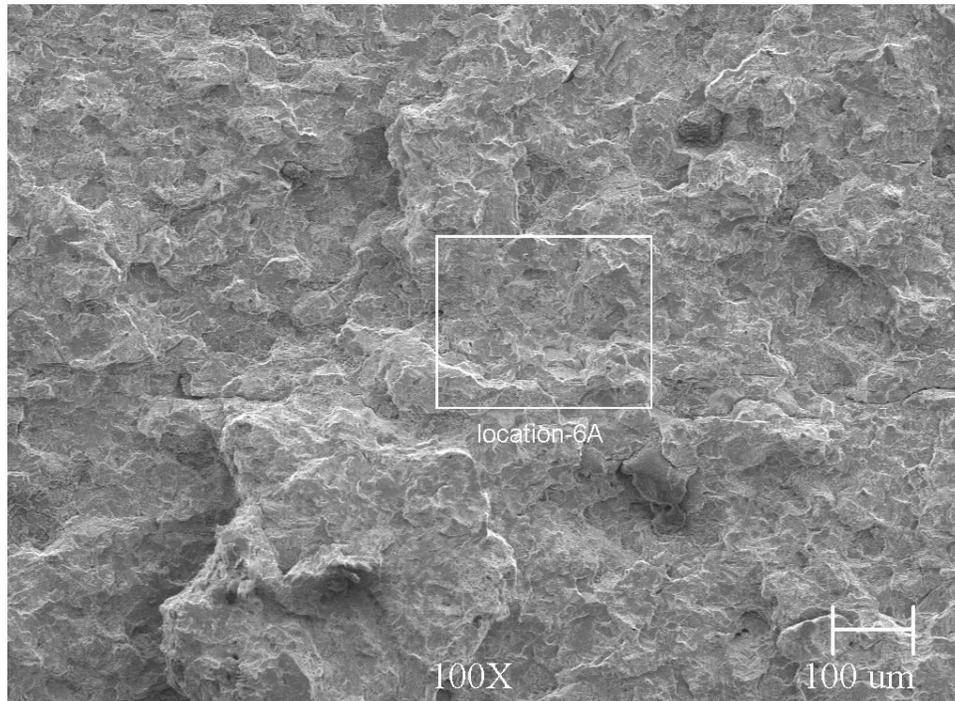
Area-F
Photograph No. 139

The SEM fractograph taken of the Area-F of the final fracture zone, as shown in Photograph No. 123, displays unresolved cleavage separation fracture features and faint evidence of ductile microvoid coalescence.

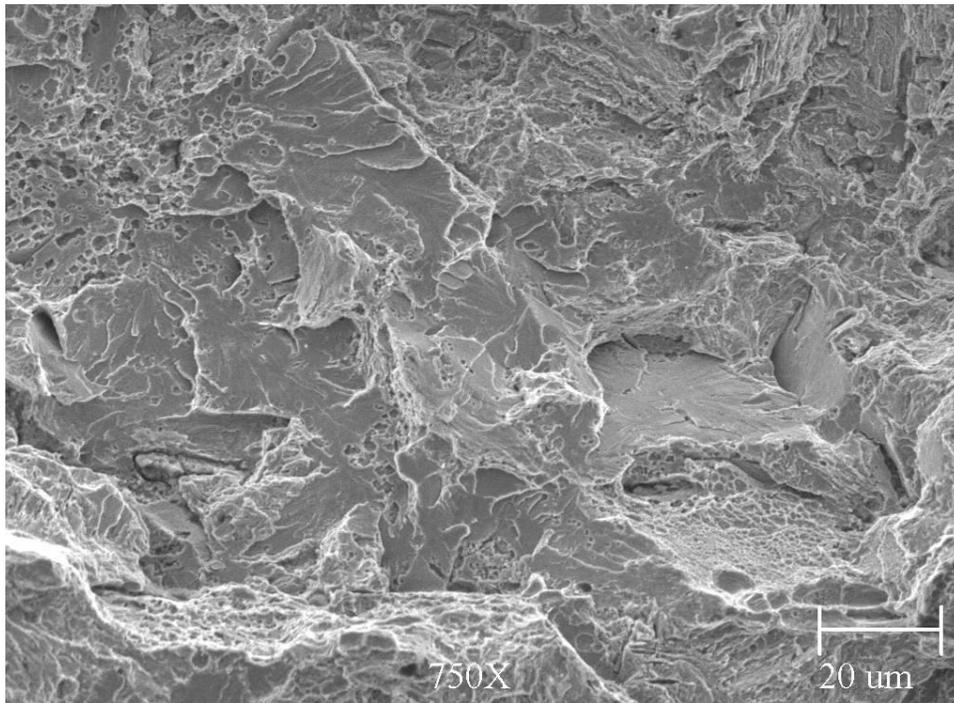
Area-F, Location-6A
Photograph No. 140

The SEM fractograph taken of the Area-F at Location-6A of the final fracture zone confirm the presence of predominantly brittle failure with some isolated areas of ductile failure, as indicated by the presence of cleavage separation and patches of microvoid coalescence, respectively.

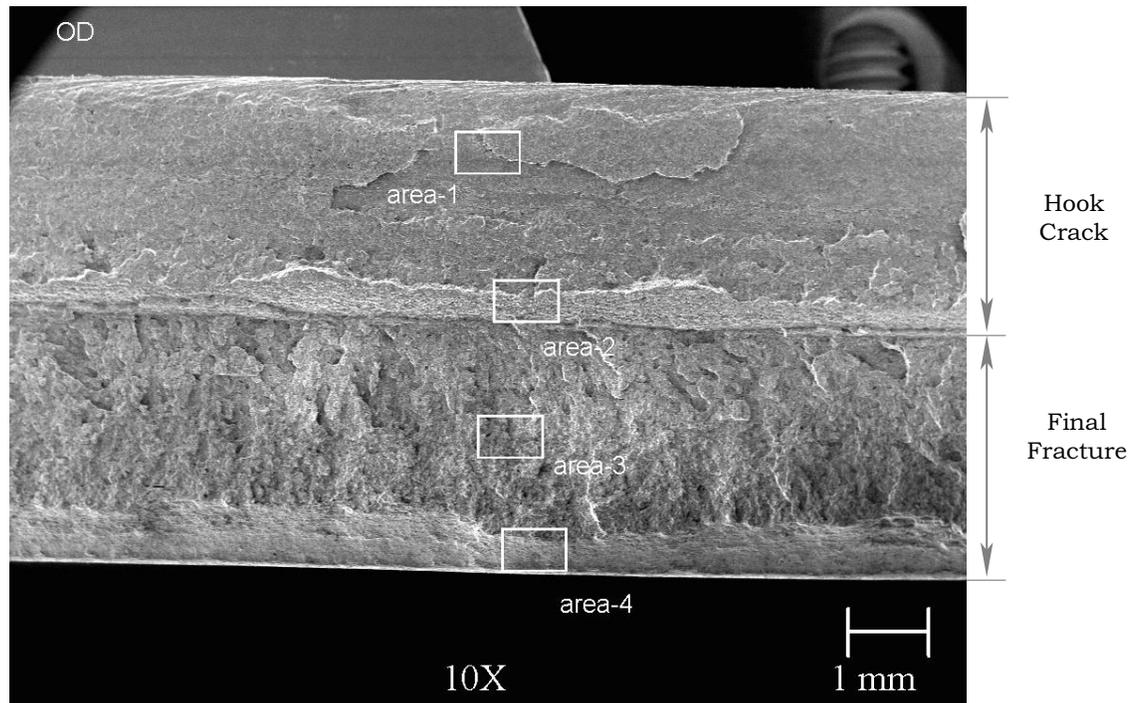
Photograph No. 141

The SEM fractograph taken of the several fracture origin sites at a distance of 20' 6-3/4" from the north girth weld shows an hook crack and the final fracture zone. The fracture areas within the rectangles were examined at higher magnifications to further characterize the fracture morphologies.

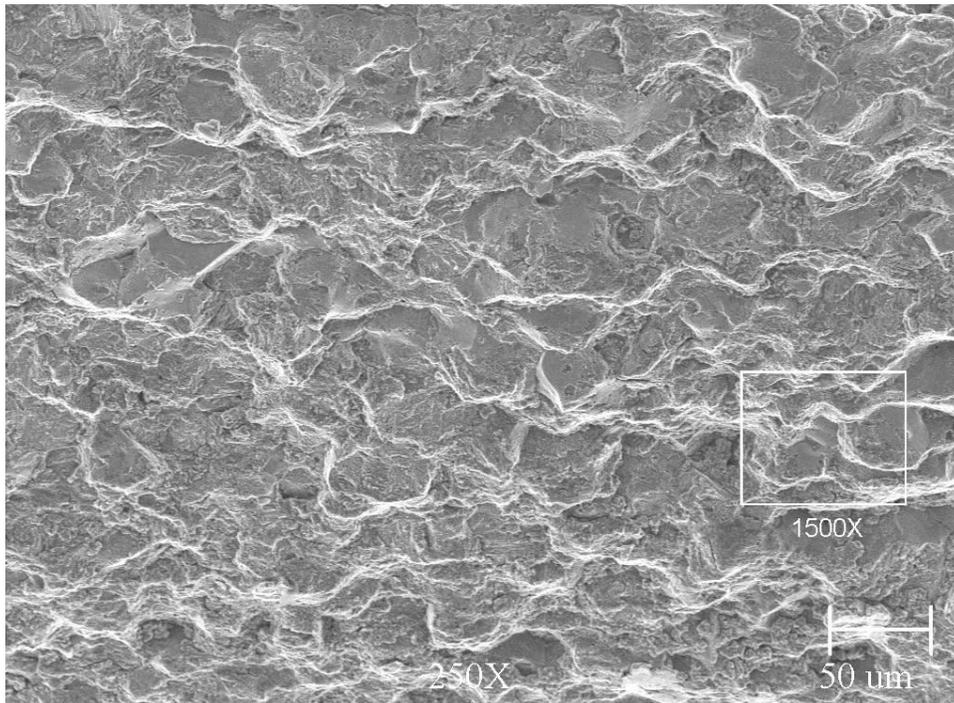
Area-2
Photograph No. 145

The SEM fractograph taken of the Area-2 of the hook crack, as displayed in Photograph No. 141, reveals the tightly adhered oxidation product. The area within the rectangle was examined at higher magnification to further characterize the fracture morphology.

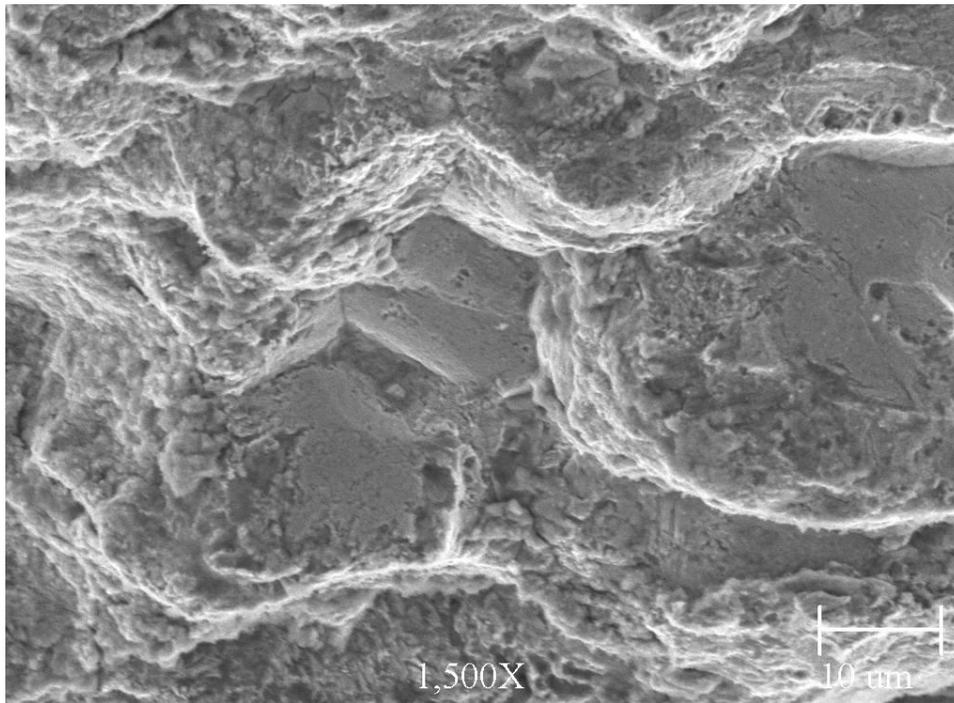
Area-2, within the rectangle
Photograph No. 146

The SEM fractograph taken of the Area-2 within the rectangle in the hook crack, as displayed in Photograph No. 145, reveals a nondescript, featureless fracture surface covered with tightly adhered oxidation product.

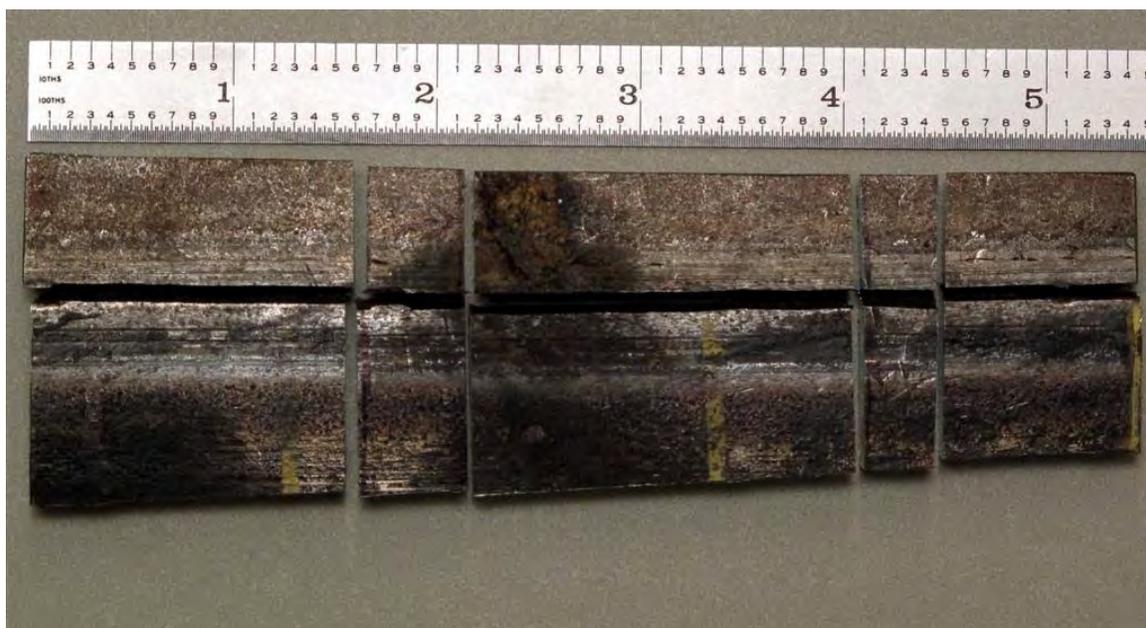
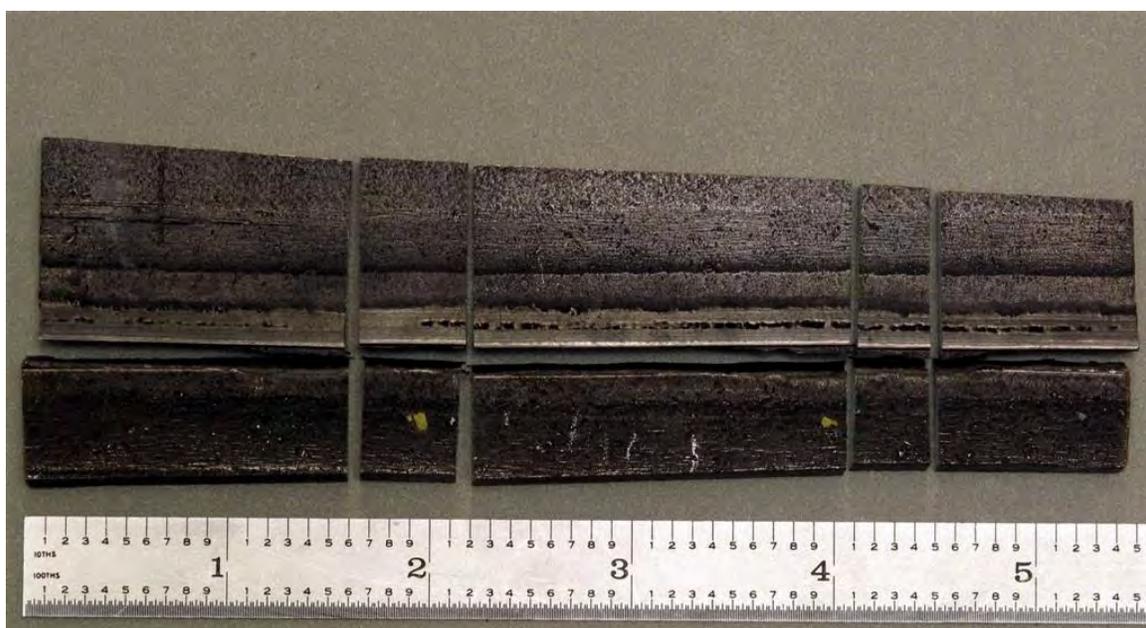
The photographs display the O.D. and I.D. surface, respectively, at the locations where the cross-sections were removed through the fractured area of the ERW seam and metallographically prepared for microstructural evaluation.
