*METALLURGICAL INVESTIGATION OF A
FRACTURED SECTION OF THE 20" O.D.
PIPELINE AT MILEPOST 314.77 IN THE
CONWAY TO CORSICANA SEGMENT OF
THE PEGASUS CRUDE OIL PIPELINE*

REPORT NO. 64961, REV. 1

Prepared for
ExxonMobil Pipeline Company and the
Pipeline and Hazardous Materials Safety Administration
pursuant to Corrective Action Order CPF 4-2013-5006H

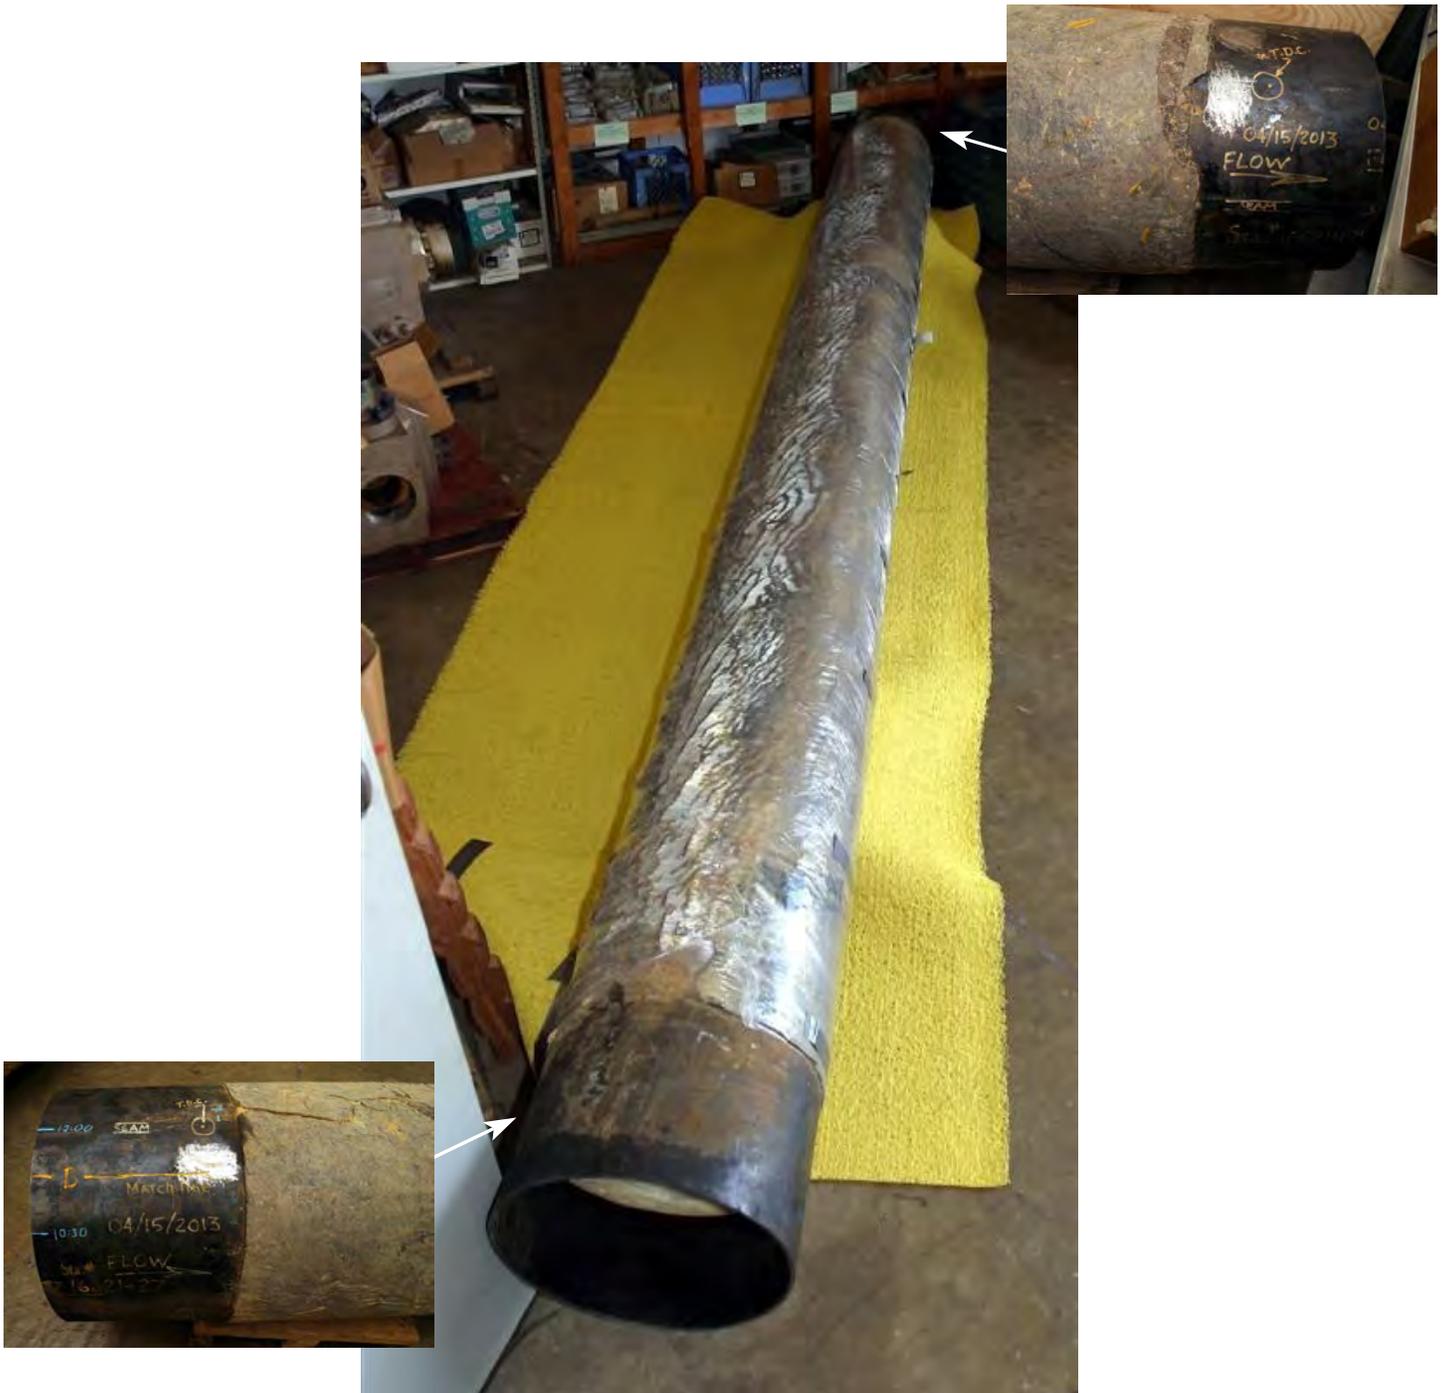
Photograph No. 9

The photograph displays the intact section of the pipe following removal of the 1st protective wrapping material.

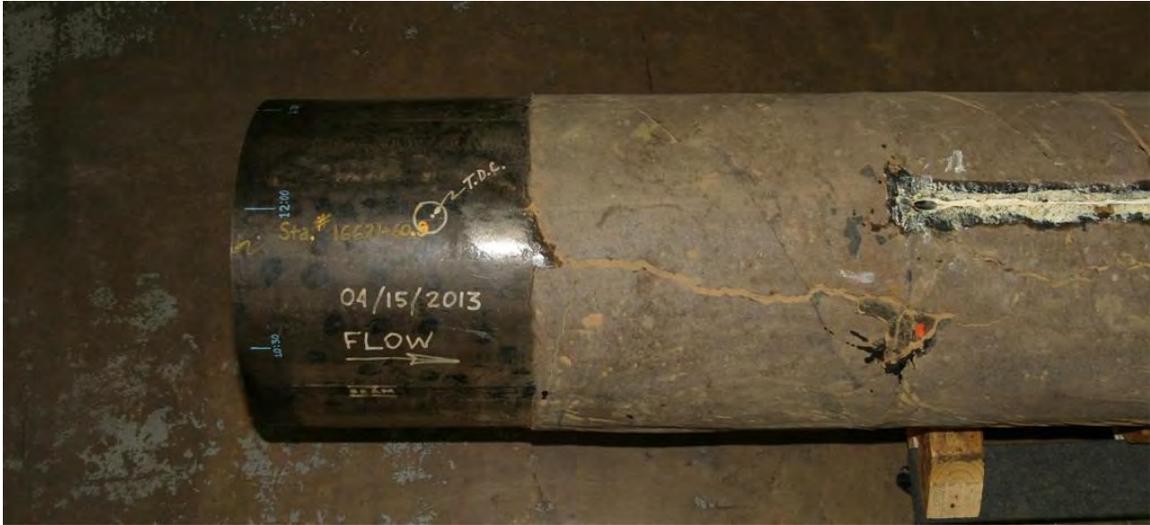
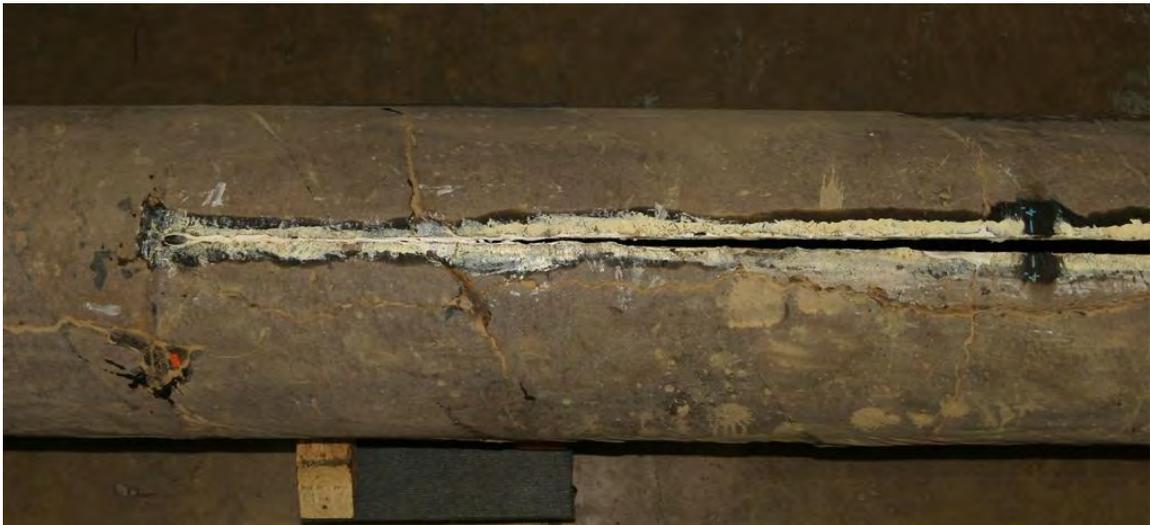
As-received Condition of the Coating			
Circumferential Location	Distance from North Girth Weld	Split Width Maximum	Split Depth Maximum
10:30 o'clock to 1:30 o'clock	-3' to 0'	1"	-
	0' to 4'	2"	0.10"

The photographs display overall top views of the pipe adjacent to the fractured pipe from approximately 3' north of the north girth weld (-3') to the center of the north girth weld (0'), and the fractured pipe from the center of the girth weld to 4' south of the north girth weld, respectively, in the as-received condition prior to removing the coating. The fracture in the pipe along the ERW seam terminated at the north girth weld. The fracture was extremely tight at the girth weld but was measured to be approximately 13/16" in width approximately 4' south of the north girth weld. Relatively narrow longitudinal and transverse splits were present in the coating. The coating had been removed from the adjacent intact pipe prior to sectioning approximately 3' north of the north girth weld.

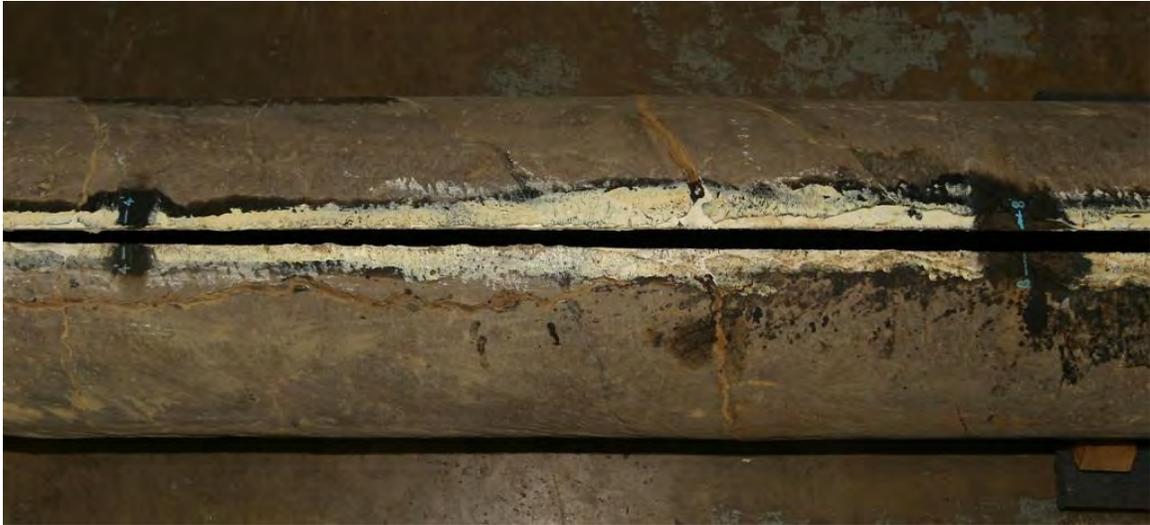
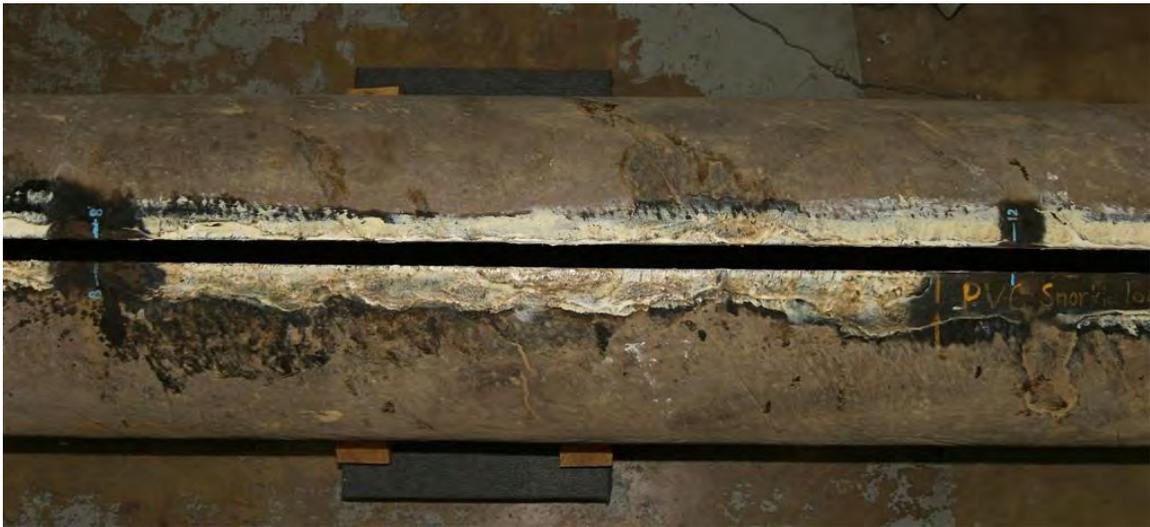
As-received Condition of the Coating			
Circumferential Location	Distance from North Girth Weld	Split Width Maximum	Split Depth Maximum
10:30 o'clock to 1:30 o'clock	4' to 8'	0.5"	0.14"
	8' to 12'	0.5"	-

The photographs display overall top views of the fractured pipe from 4' south to 8' south of the north girth weld, and from 8' south to 12' south of the north girth weld, respectively, in the as-received condition prior to removing the coating. Longitudinal and transverse splitting is present in the coating, and some of the coating is missing on either side of the fracture.

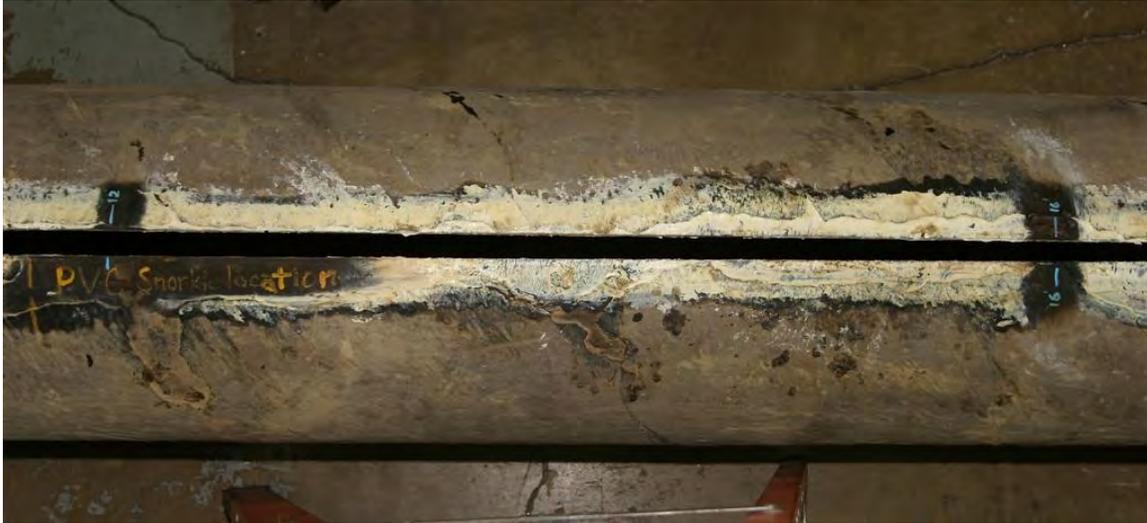
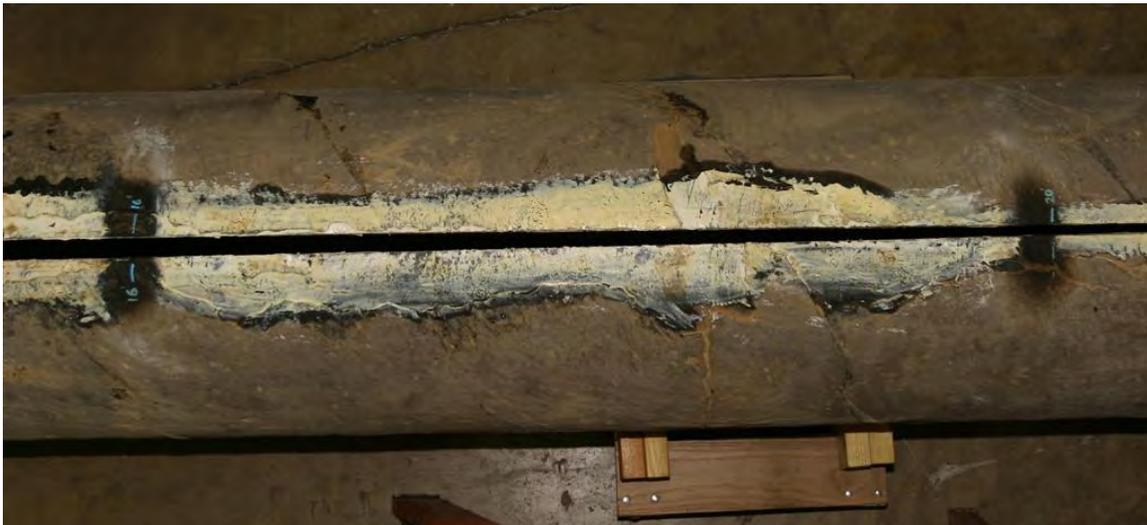
As-received Condition of the Coating			
Circumferential Location	Distance from North Girth Weld	Split Width Maximum	Split Depth Maximum
10:30 o'clock to 1:30 o'clock	12' to 16'	-	0.07"
	16' to 20'	0.25"	0.09"

The photographs display overall top views of the fractured pipe from 12' south to 16' south of the north girth weld, and from 16' south to 20' south of the north girth weld, respectively, in the as-received condition prior to removing the coating. Longitudinal and transverse splitting is present in the coating, and some of the coating is missing on either side of the fracture.

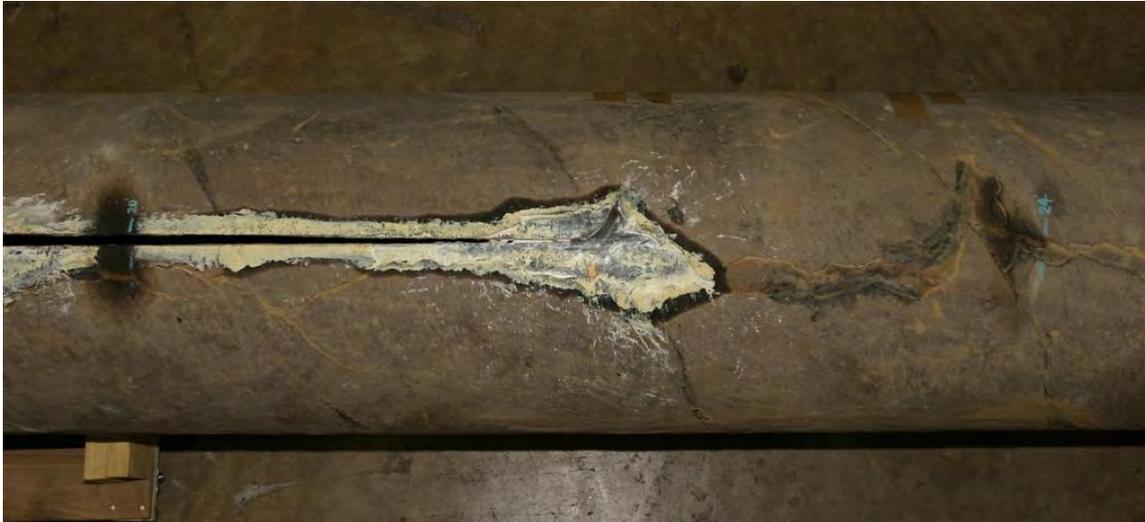
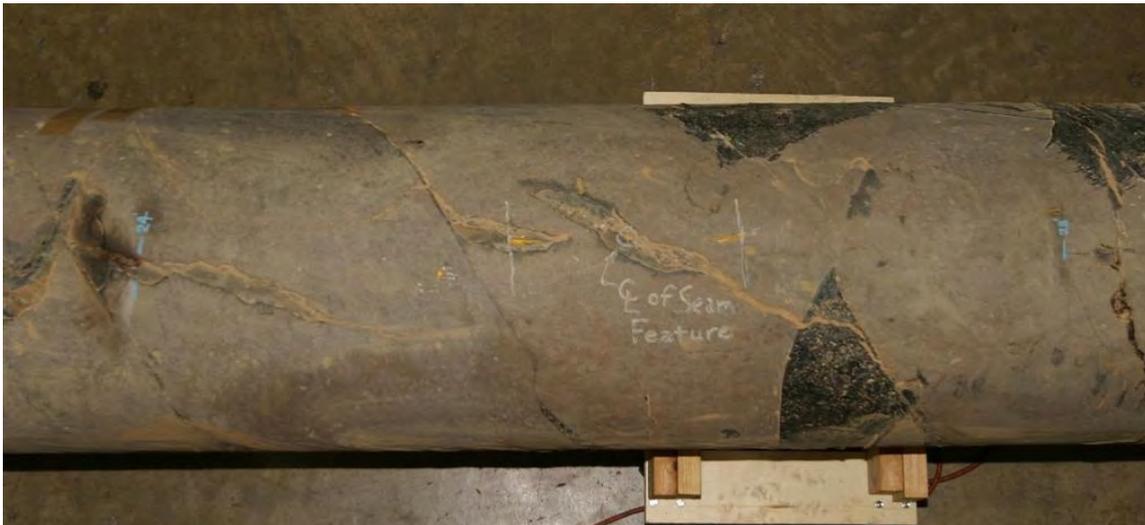
As-received Condition of the Coating			
Circumferential Location	Distance from North Girth Weld	Split Width Maximum	Split Depth Maximum
10:30 o'clock to 1:30 o'clock	20' to 24'	0.5"	0.10"
	24' to 28'	1.5"	0.10"

The photographs display overall top views of the fractured pipe from 20' south to 24' south of the north girth weld, and from 24' south to 28' south of the north girth weld, respectively, in the as-received condition prior to removing the coating. At approximately 22' south of the girth weld, the fracture in the ERW seam turned into the pipe material, progressing several inches prior to terminating. The damaged area of coating near the pipe fracture extended longitudinally past the fracture tip several feet.

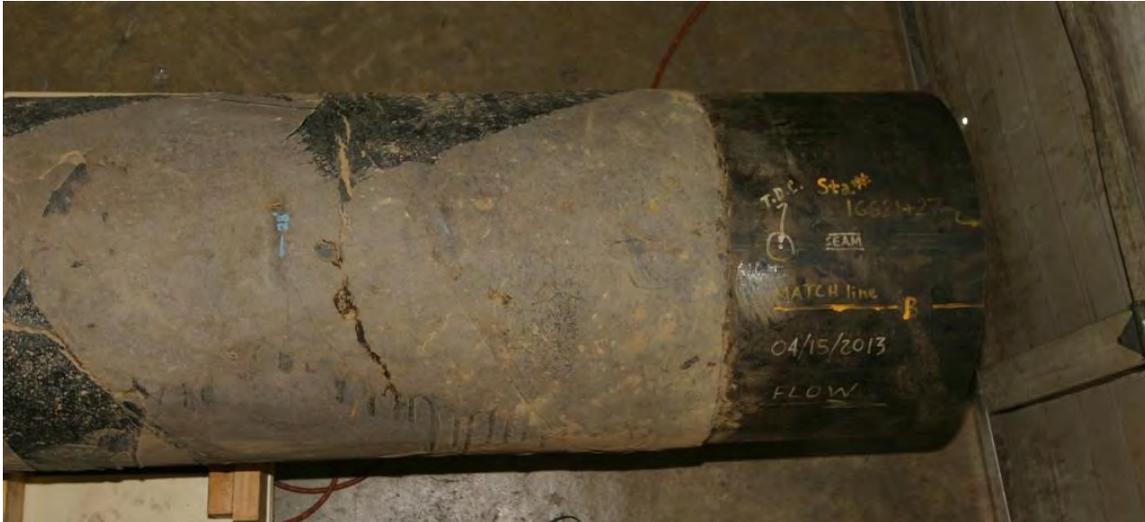
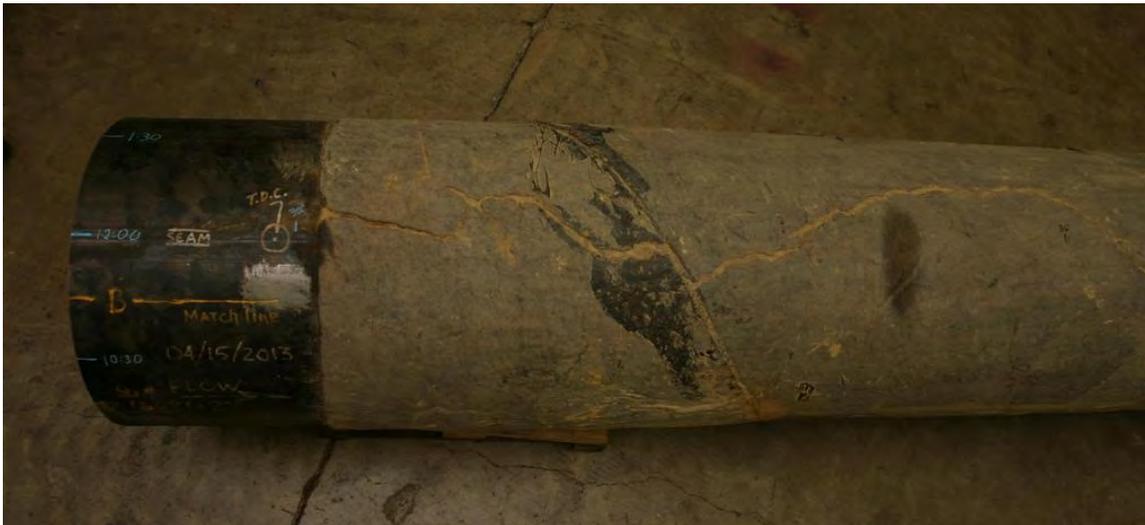
As-received Condition of the Coating			
Circumferential Location	Distance from North Girth Weld	Split Width Maximum	Split Depth Maximum
10:30 o'clock to 1:30 o'clock	28' to 31'	1"	0.05"
	31' to 35'	1"	0.15"

The photographs display overall top views of the fractured pipe from 28' south to 31' south of the north girth weld, and from 31' south to 35' south of the north girth weld, respectively, in the as-received condition prior to removing the coating. The approximately 49' 9-1/2" long pipe was sectioned in the field transversely approximately 31' south of the north girth weld. The coating was removed in the field approximately 13" in either direction from the transverse cut prior to sectioning.

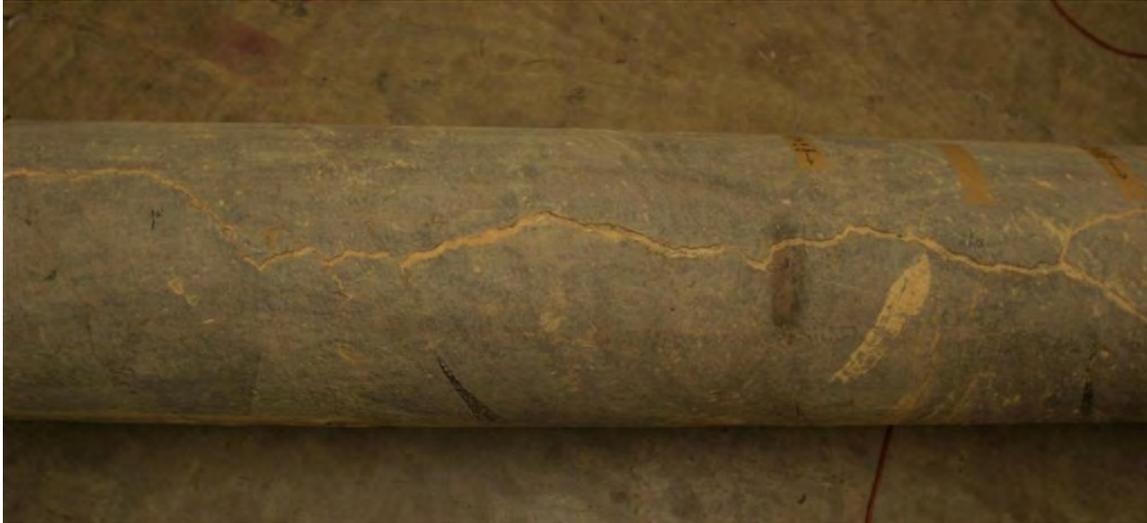
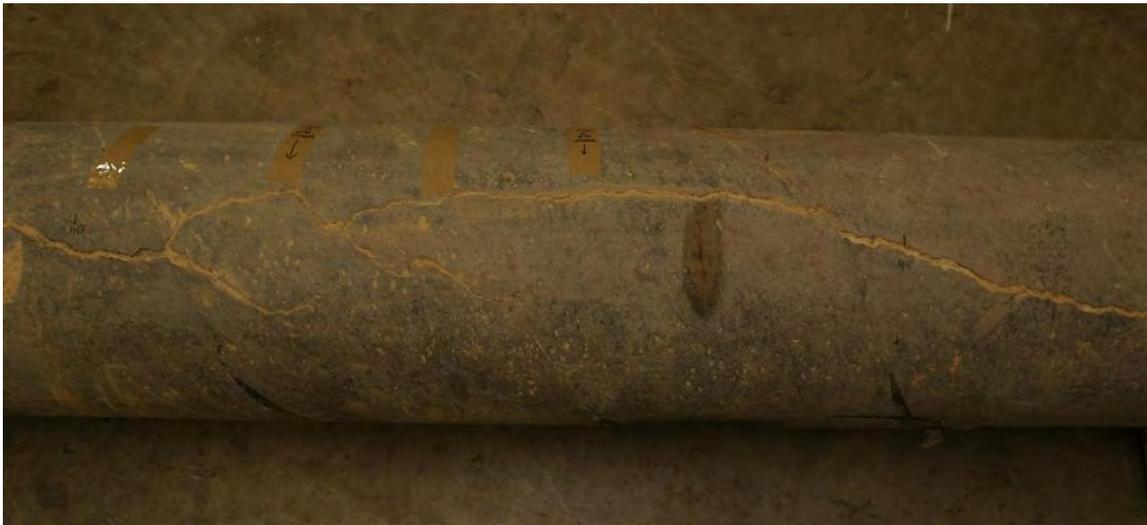
As-received Condition of the Coating			
Circumferential Location	Distance from North Girth Weld	Split Width Maximum	Split Depth Maximum
10:30 o'clock to 1:30 o'clock	35' to 39'	1"	0.10"
	39' to 43'	0.75"	0.11"

The photographs display overall top views of the fractured pipe from 35' south to 39' south of the north girth weld, and from 39' south to 43' south of the north girth weld, respectively, in the as-received condition prior to removing the coating. Longitudinal splitting is visible on the surface of the coating.

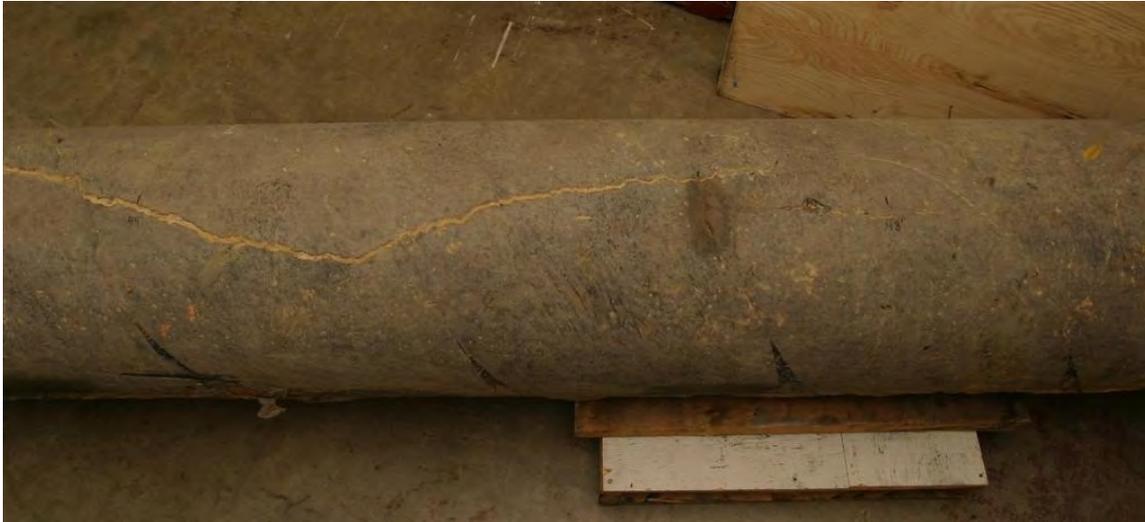
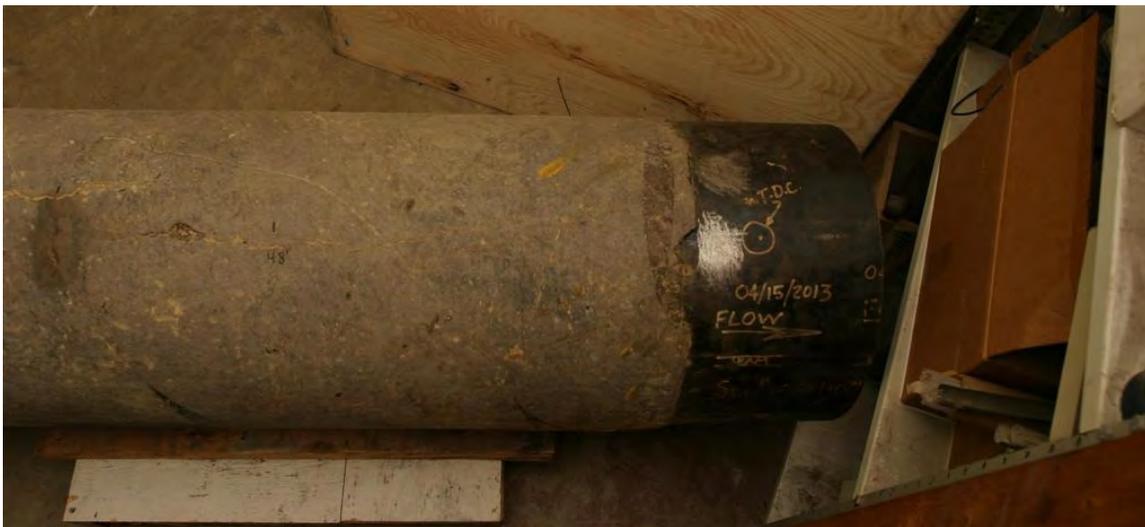
As-received Condition of the Coating			
Circumferential Location	Distance from North Girth Weld	Split Width Maximum	Split Depth Maximum
10:30 o'clock to 1:30 o'clock	43' to 47'	0.5"	0.11"
	47' to 51'	1"	-

The photographs display overall top views of the fractured pipe from 43' south to 47' south of the north girth weld, and from 47' south to 51' south of the north girth weld, respectively, in the as-received condition prior to removing the coating. Longitudinal splitting is visible on the surface of the coating. Some of the coating had been removed from the adjacent area pipe prior to sectioning.

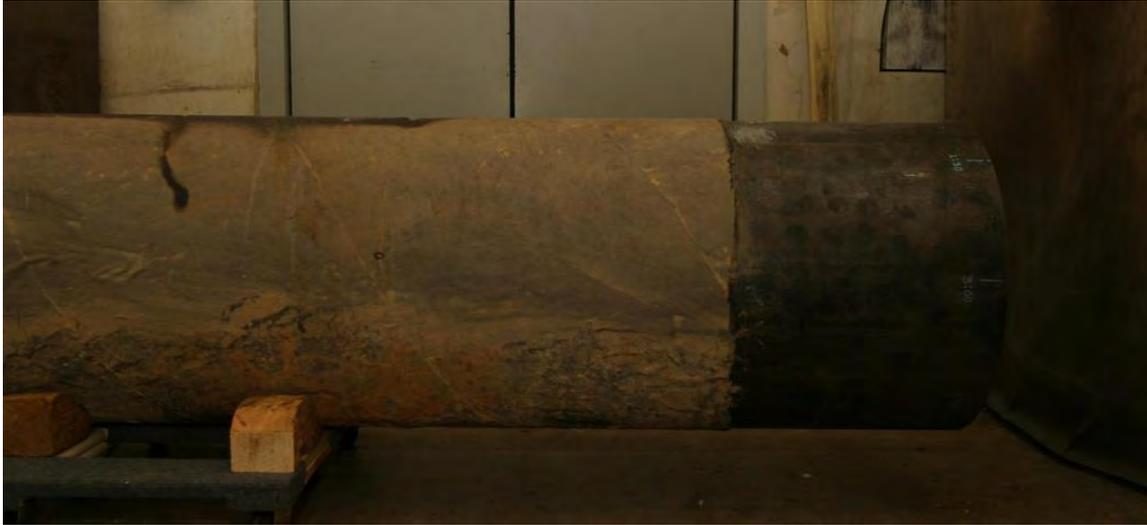
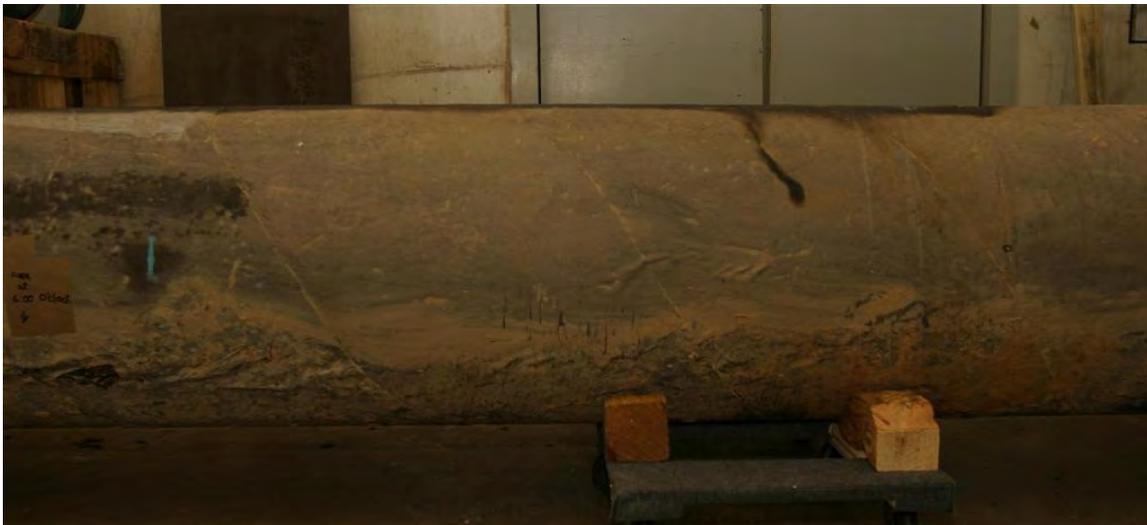
The photographs display overall views of the west side of the pipe from 7:30 to 10:30 o'clock, adjacent to the fractured pipe from approximately 3' north of the girth weld (-3') to the center of the north girth weld (0'), and the fractured pipe from the center of the girth weld to 4' south of the north girth weld (+4'), respectively, in the as-received condition prior to removing the coating. The lower half of the pipe contains disbonded and wrinkled coating.

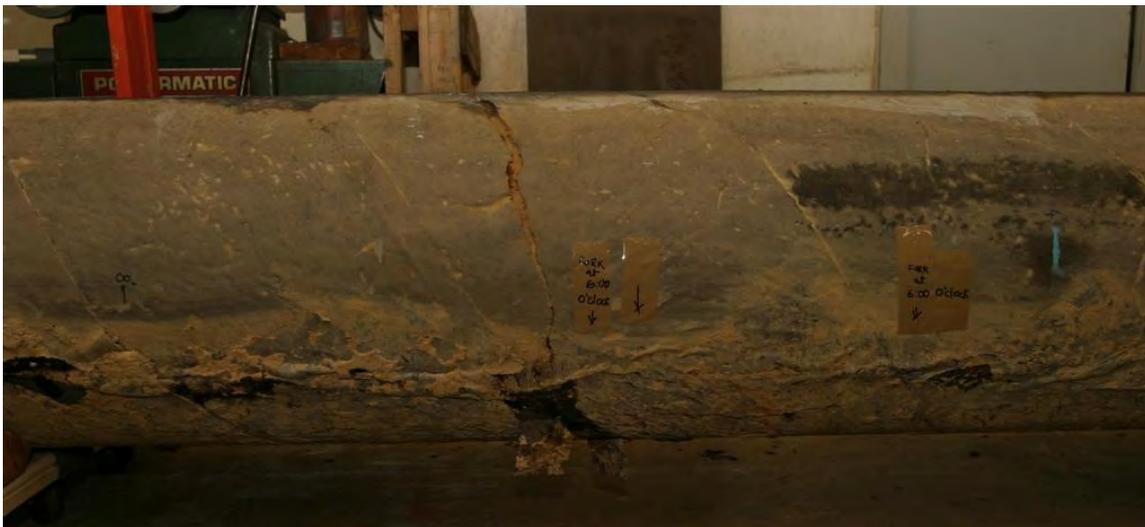
Photograph No. 26

The photograph displays an overall view of the west side from 7:30 to 10:30 of the fractured pipe from 4' south to 8' south of the north girth weld in the as-received condition prior to removing the coating. The lower half of the pipe contains disbonded and wrinkled coating, and some openings in the coating are present where the coating had begun to sag.

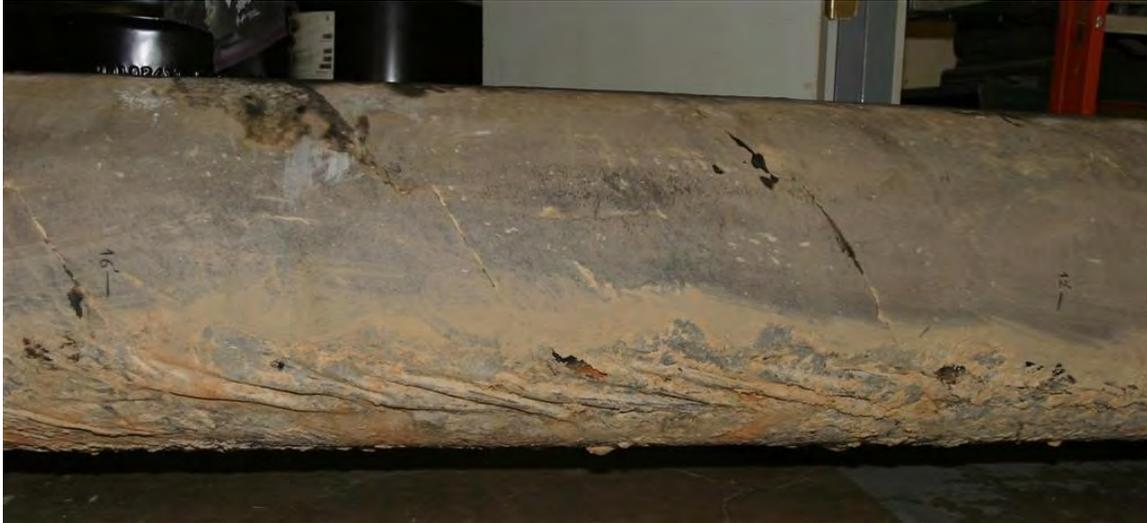
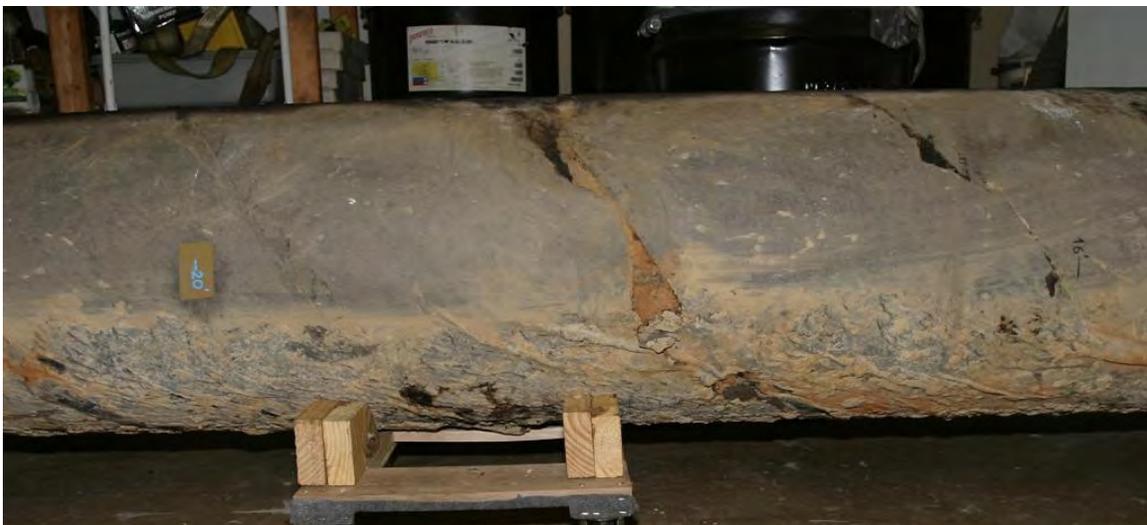
The photographs display overall views of the west side between 7:30 and 10:30 of the fractured pipe from 12' south to 16' south of the north girth weld, and from 16' south to 20' south of the north girth weld, respectively, in the as-received condition prior to removing the coating. The lower half of the pipe contains disbonded and wrinkled coating, along with some openings in the coating.

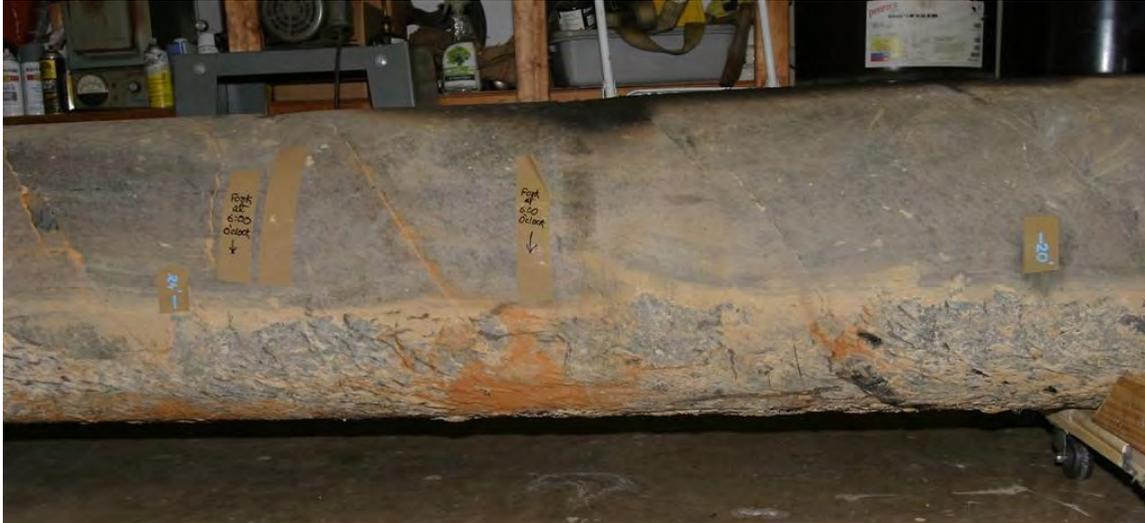
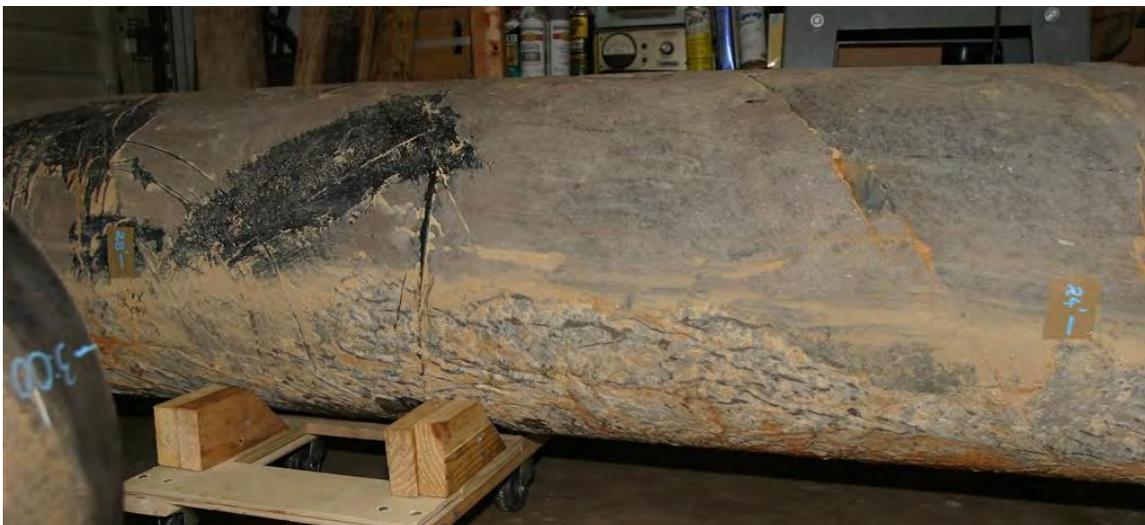
The photographs display overall views of the west side from 7:30 to 10:30 of the fractured pipe from 20' south to 24' south of the north girth weld, and from 24' south to 28' south of the north girth weld, respectively, in the as-received condition prior to removing the coating. The lower half of the pipe contains disbonded and wrinkled coating.

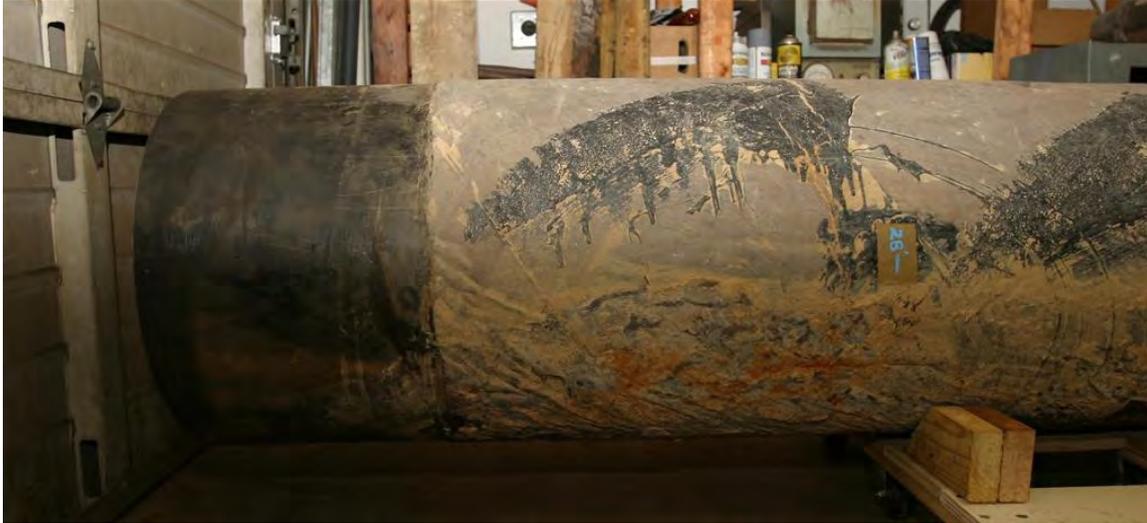
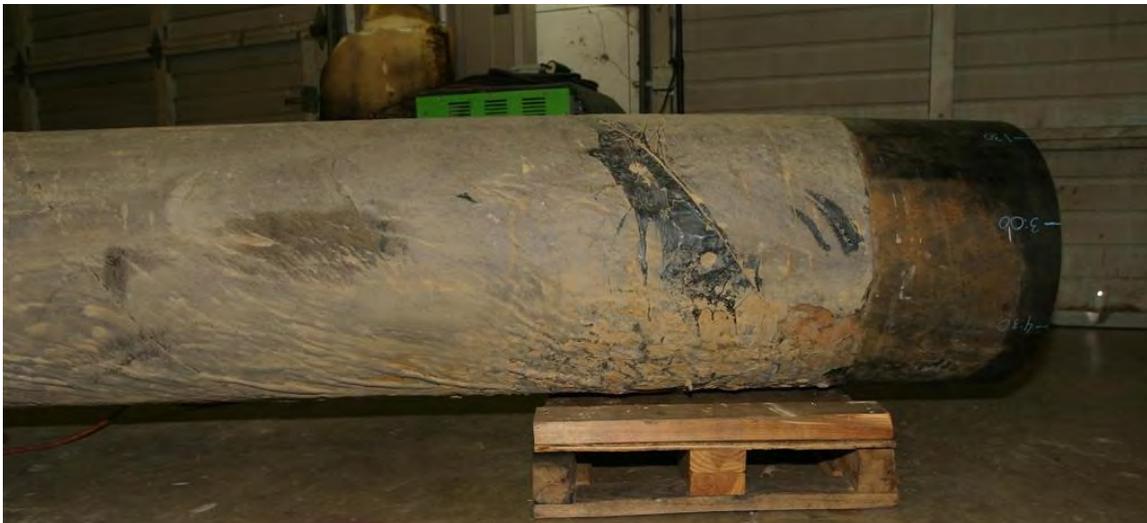
The photographs display overall views of the west side from 7:30 to 10:30 of the fractured pipe from 28' south to 31' south of the north girth weld, and from 31' south to 35' south of the north girth weld, respectively, in the as-received condition prior to removing the coating. The pipe had been sectioned transversely approximately 31' south of the north girth weld. The lower half of the pipe contains disbonded and wrinkled coating.

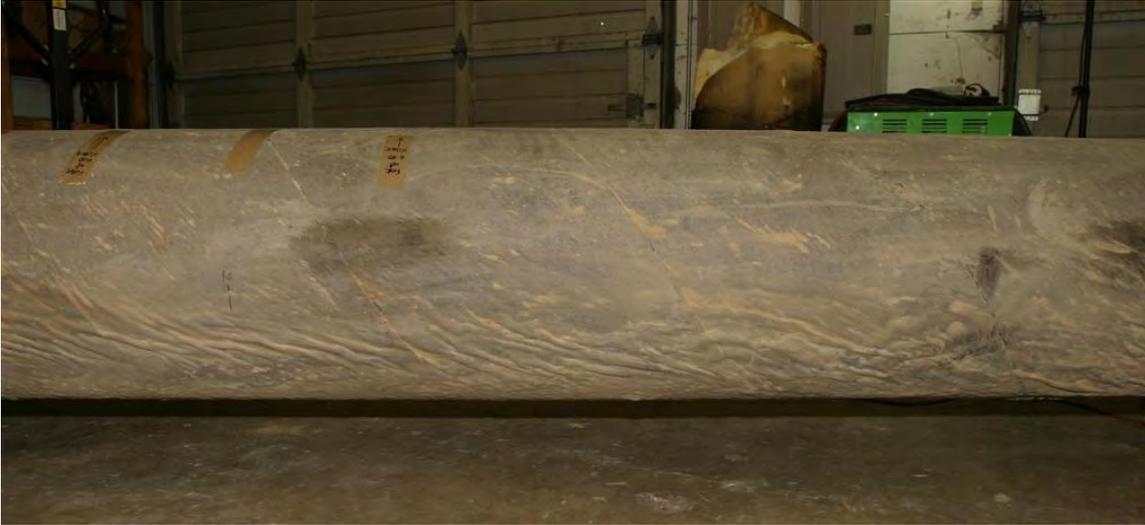
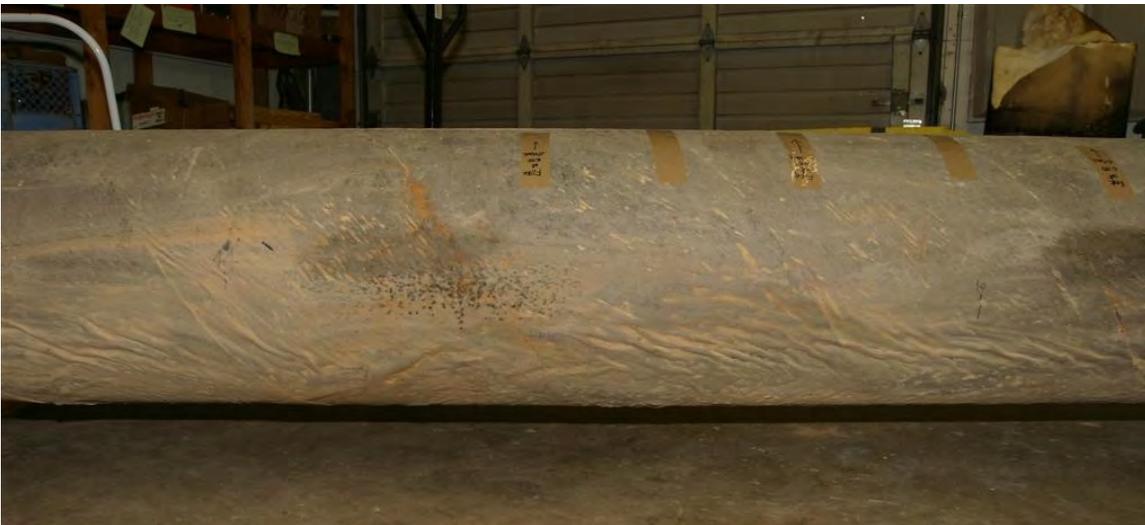
The photographs display overall views of the west side between 7:30 and 10:30 of the fractured pipe from 35' south to 39' south of the north girth weld, and from 39' south to 43' south of the north girth weld, respectively, in the as-received condition prior to removing the coating. The lower half of the pipe contains disbonded and wrinkled coating.

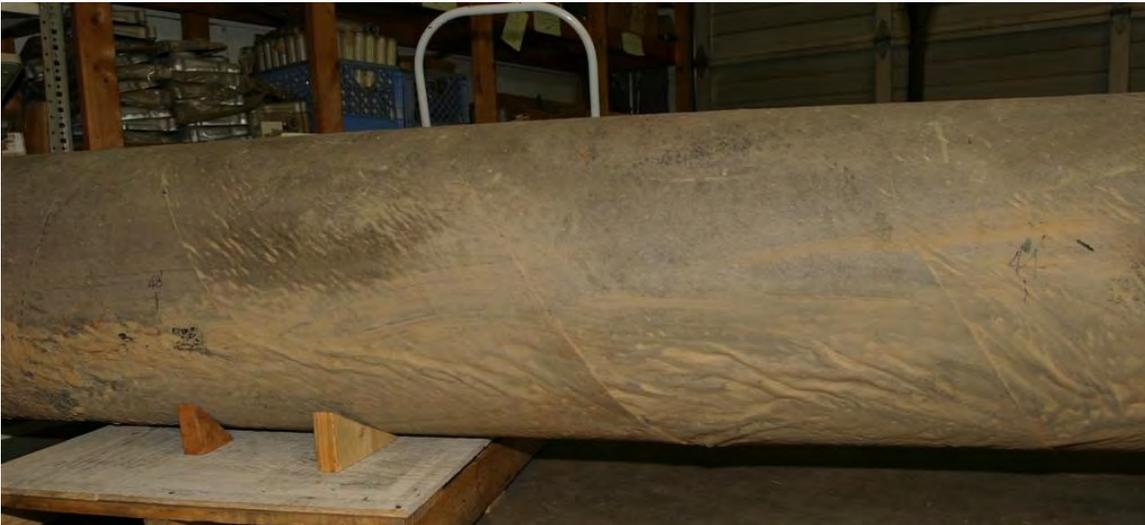
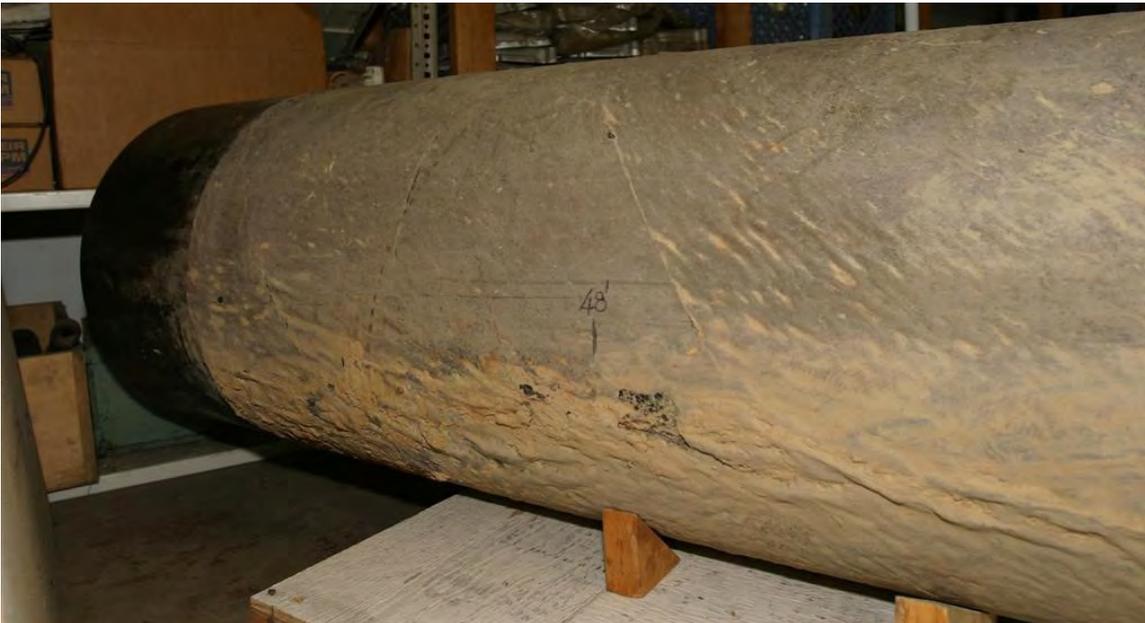
The photographs display overall views of the west side from 7:30 to 10:30 of the fractured pipe and adjacent intact pipe from 43' south to 47' south of the north girth weld, and from 47' south to 51' south of the north girth weld, respectively, in the as-received condition prior to removing the coating. The coating had been removed from the adjacent intact pipe prior to allow for sectioning. The lower half of the pipe contains disbonded and wrinkled coating.

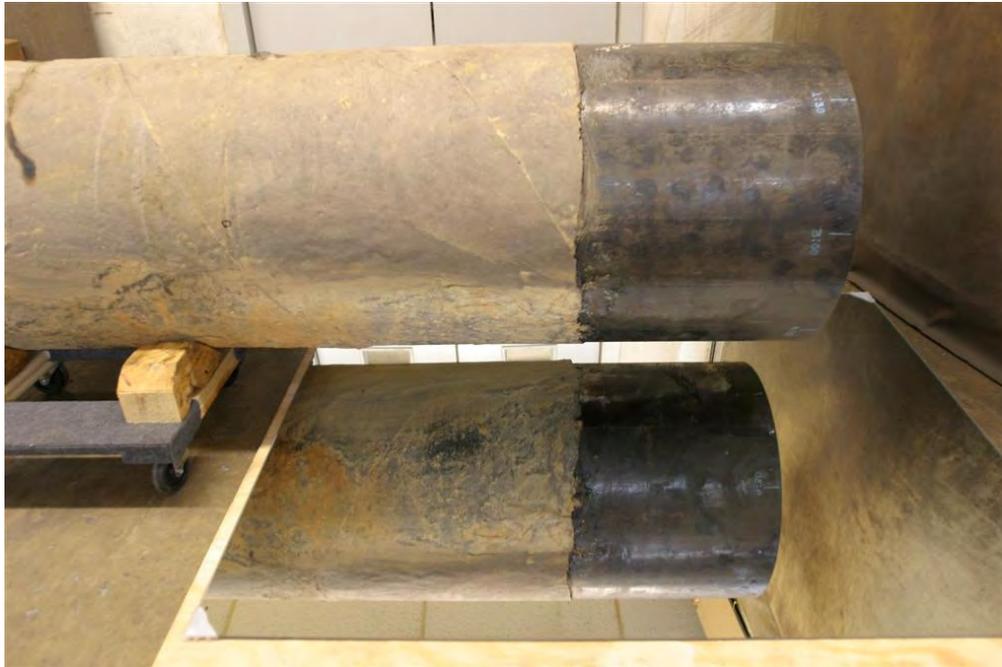
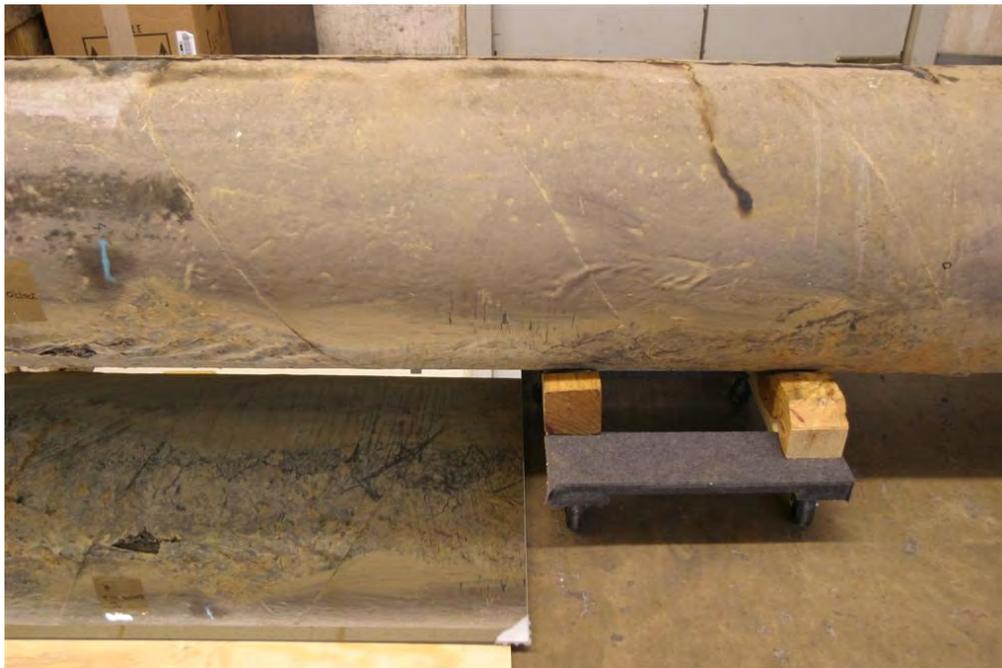
The photographs display overall bottom views of the pipe from 4:30 to 7:30 o'clock adjacent to the fractured pipe from approximately 3' north of the north girth weld (-3') to the center of the north girth weld (0'), and the fractured pipe from the center of the north girth weld to 4' south of the north girth weld (+4'), respectively, in the as-received condition prior to removing the coating. The coating had been removed from the adjacent intact pipe prior to sectioning in the field. The coating on the lower half of the pipe is sagging and contains wrinkles.
