*METALLURGICAL INVESTIGATION OF A
FRACTURED SECTION OF THE 20" O.D.
PIPELINE AT MILEPOST 314.77 IN THE
CONWAY TO CORSICANA SEGMENT OF
THE PEGASUS CRUDE OIL PIPELINE*

REPORT NO. 64961, REV. 1

Prepared for
ExxonMobil Pipeline Company and the
Pipeline and Hazardous Materials Safety Administration
pursuant to Corrective Action Order CPF 4-2013-5006H

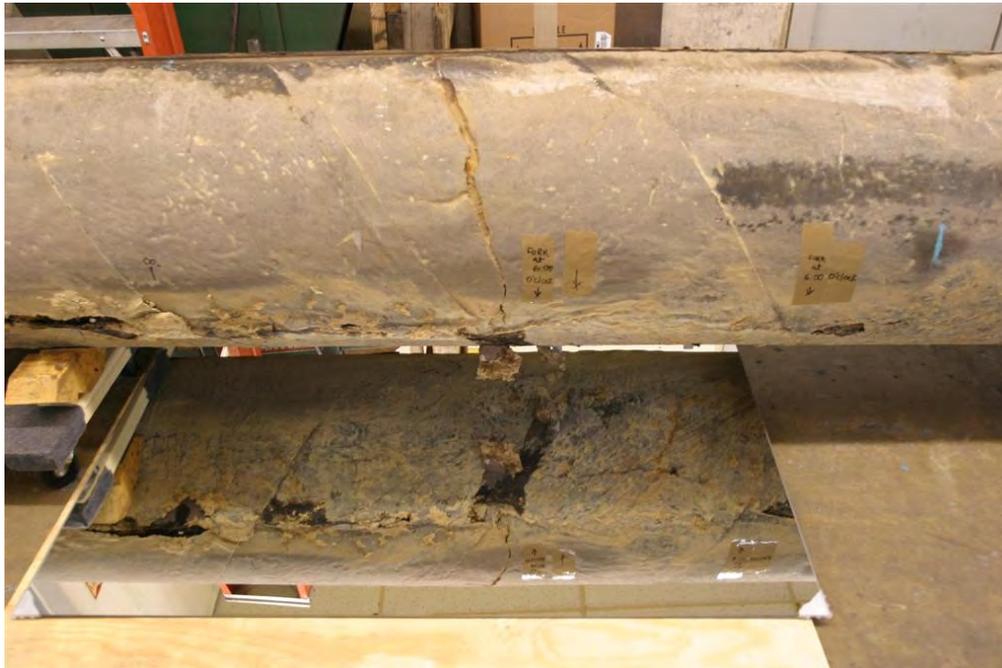
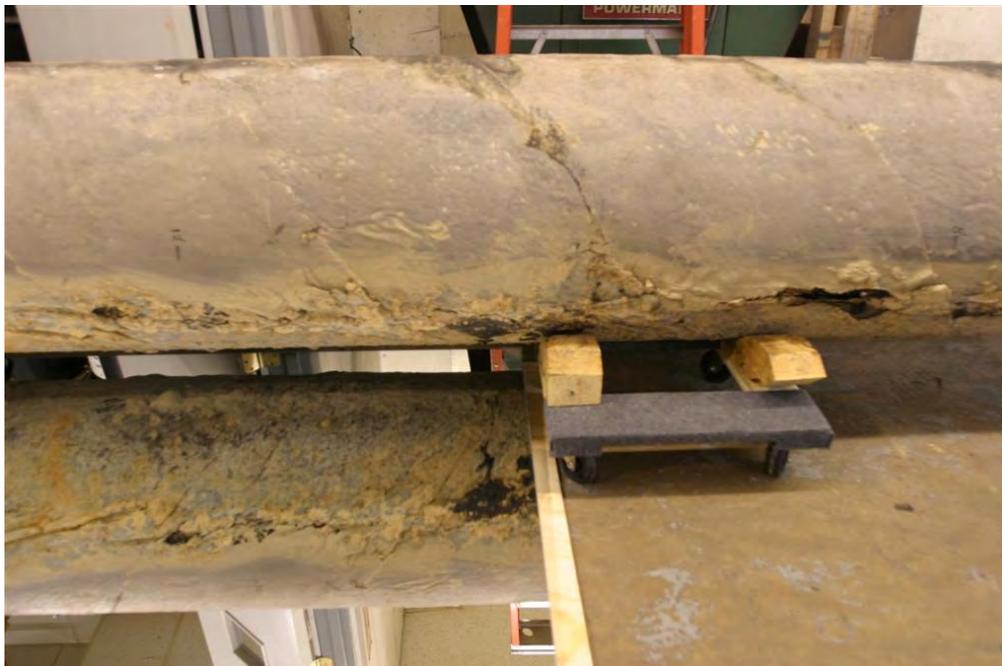
The photographs display overall bottom views of the fractured pipe from 4:30 to 7:30 from 4' south to 8' south of the north girth weld, and from 8' south to 12' south of the north girth weld, respectively, in the as-received condition prior to removing the coating. The coating on the lower half of the pipe is sagging and contains wrinkles.

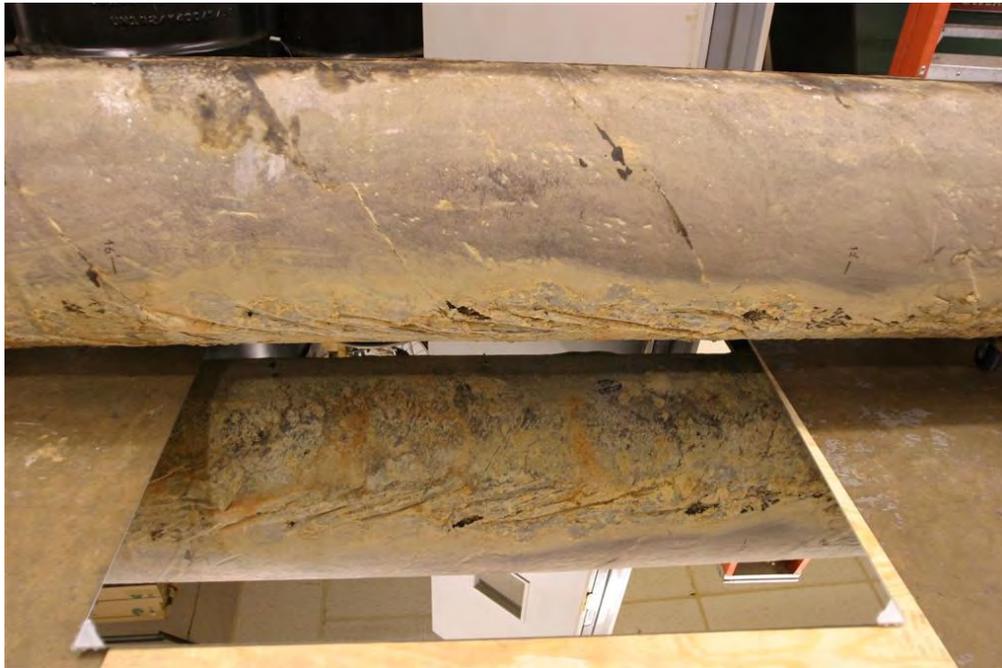
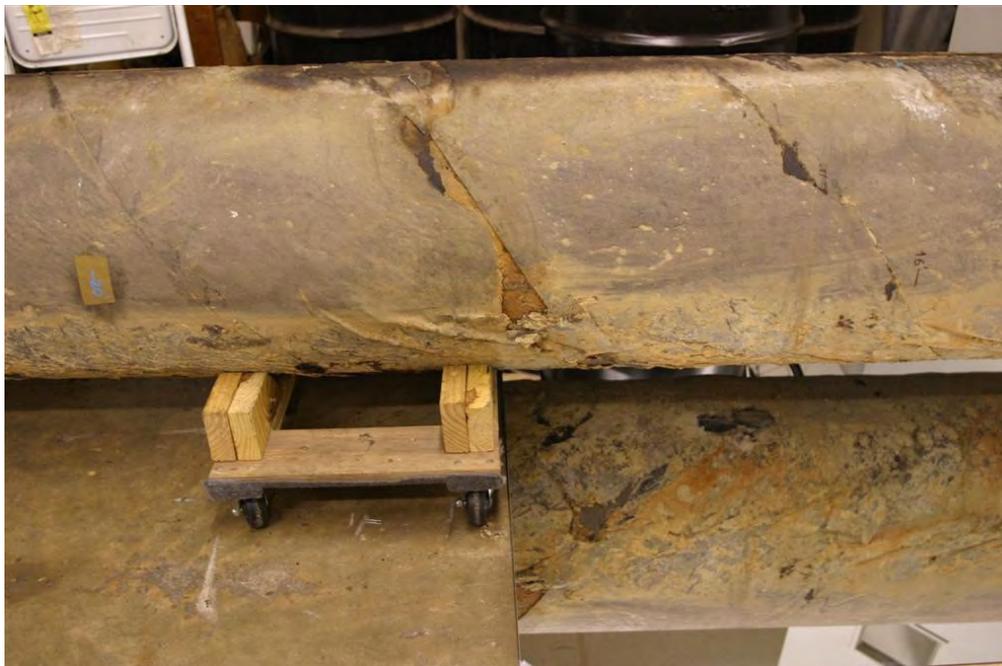
The photographs display overall bottom views of the fractured pipe from 4:30 to 7:30 from 12' south to 16' south of the north girth weld, and from 16' south to 20' south of the north girth weld, respectively, in the as-received condition prior to removing the coating. The coating on the lower half of the pipe contains wrinkles and has sagged.

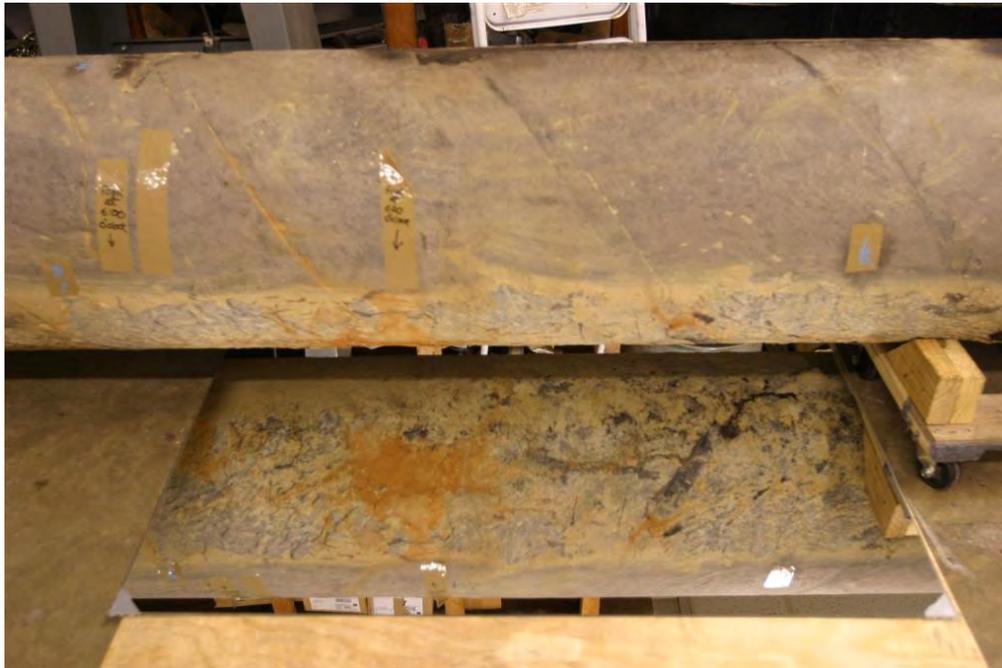
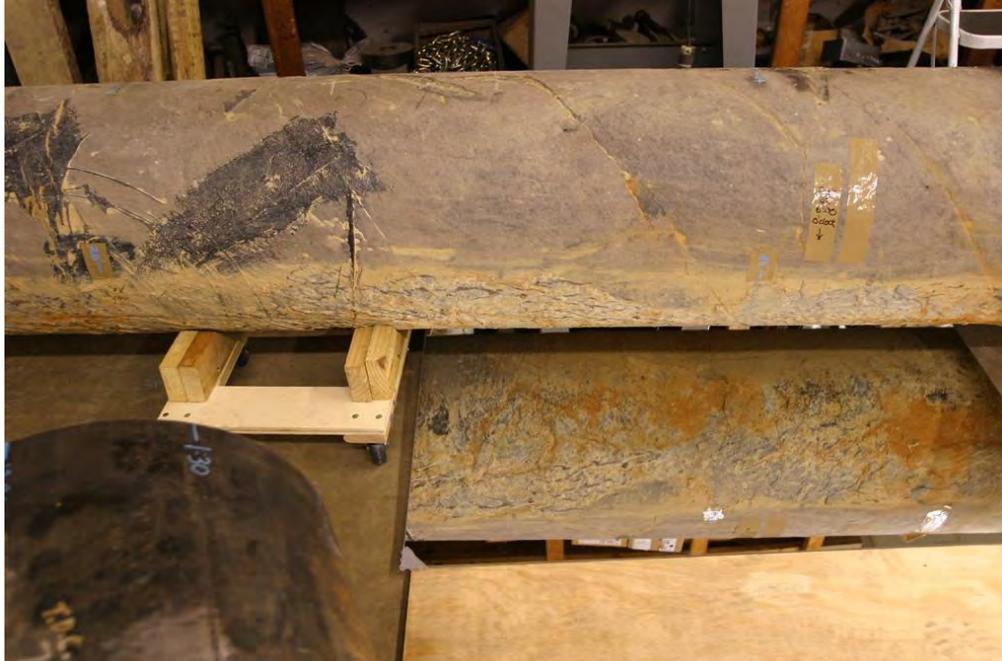
The photographs display overall bottom views of the fractured pipe from 4:30 to 7:30 from 20' south to 24' south of the north girth weld, and from 24' to 28' south of the north girth weld, respectively, in the as-received condition prior to removing the coating. The coating on the lower half of the pipe contains a significant amount of wrinkles and has sagged quite a bit.

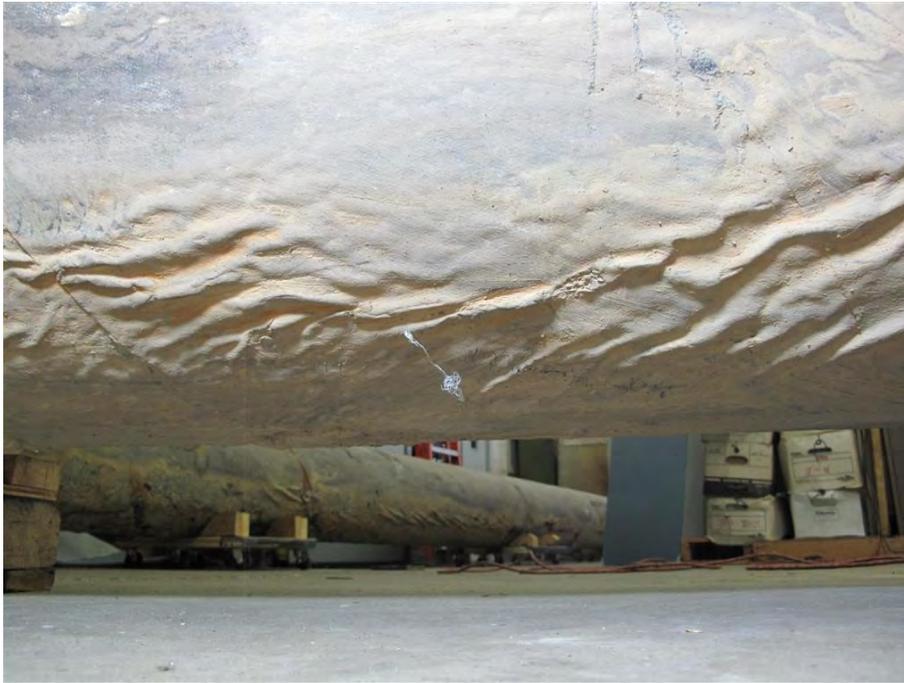
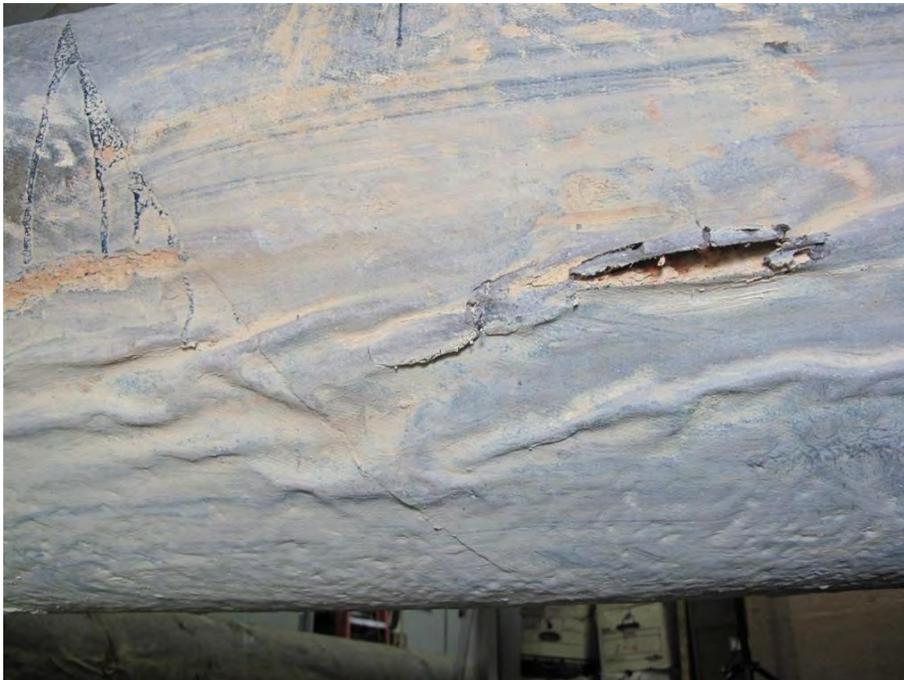
The photographs display overall bottom views of the fractured pipe from 4:30 to 7:30 from 28' south to 31' south of the north girth weld, and from 31' south to 35' south of the north girth weld, respectively, in the as-received condition prior to removing the coating. The fractured pipe was sectioned transversely approximately 31' south of the north girth weld into two sections.

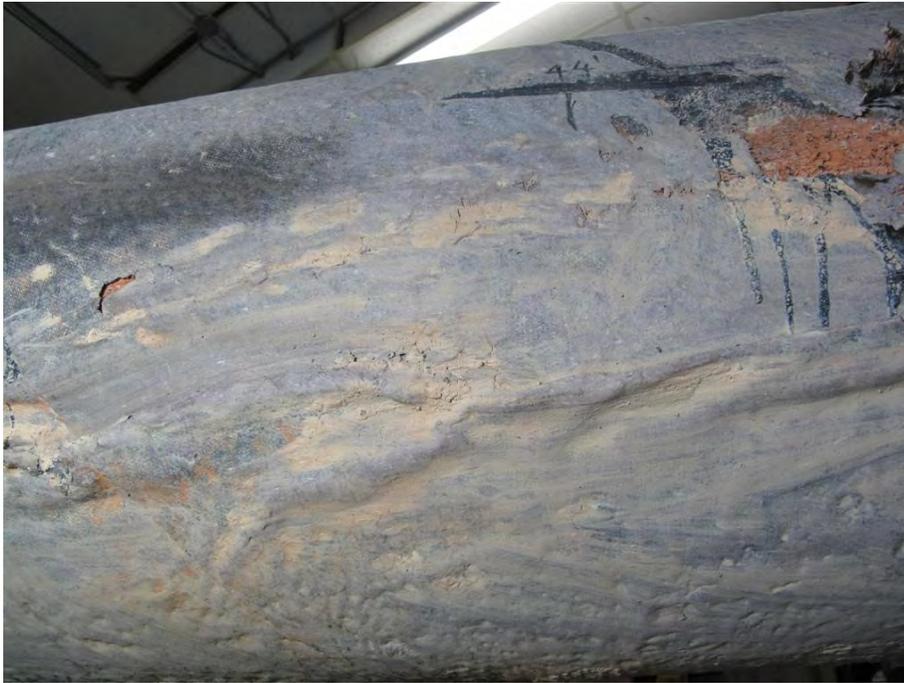
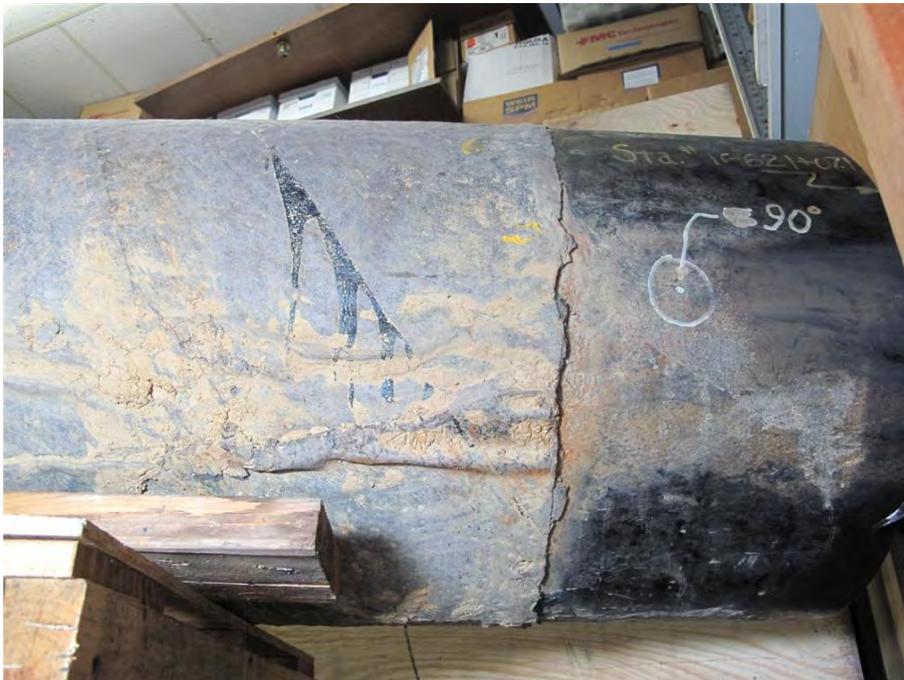
The photographs display overall bottom views of the fractured pipe from 4:30 to 7:30 from 35' south to 39' south of the north girth weld, and from 39' south to 43' south of the north girth weld, respectively, in the as-received condition prior to removing the coating. The coating on the lower half of the pipe had sagged quite a bit and contains a significant amount of wrinkles.

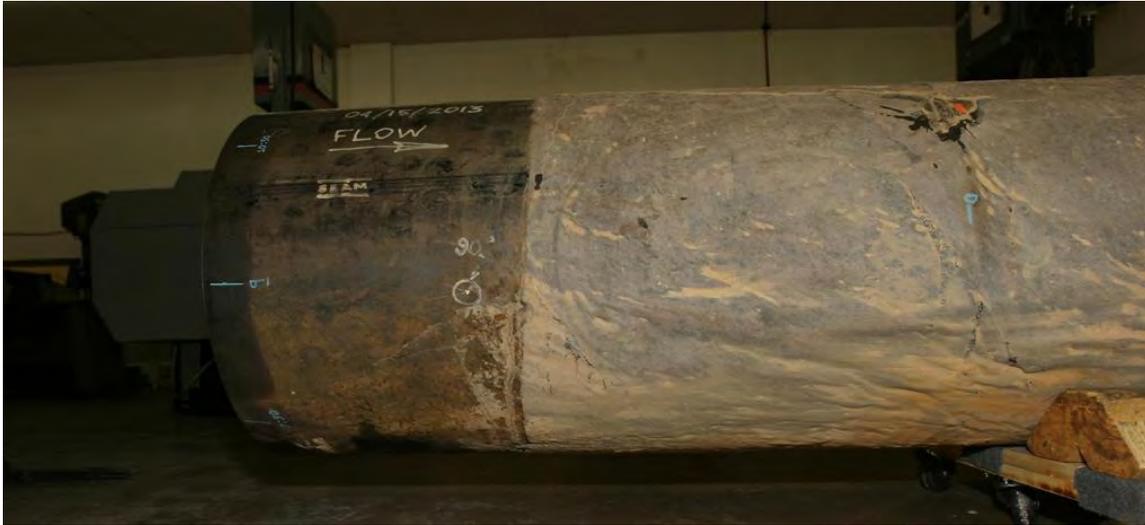
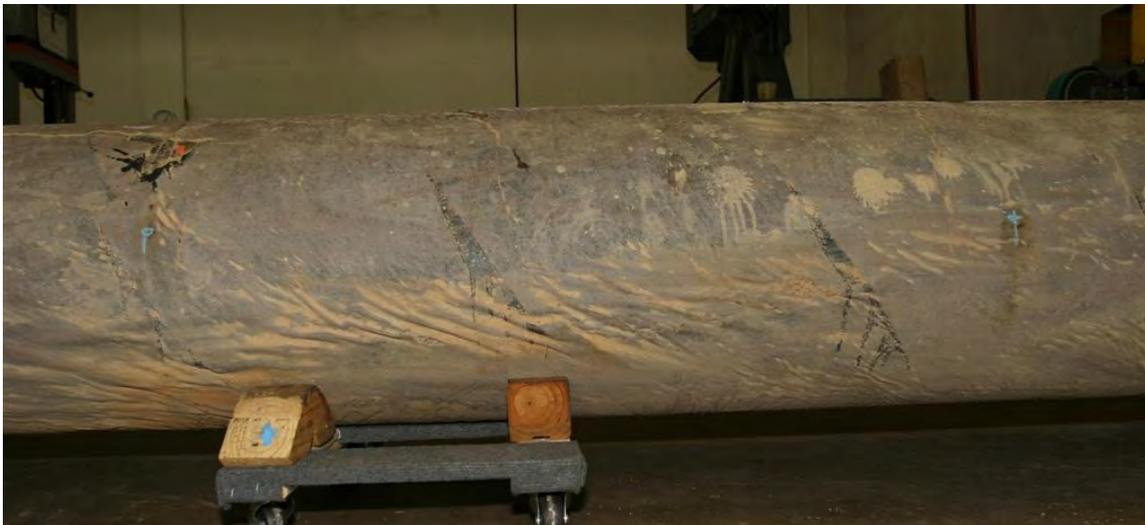
The photographs display overall bottom views of the fractured pipe from 4:30 to 7:30 and the adjacent intact pipe from 43' south to 47' south of the north girth weld, and from 47' south to 51' south of the north girth weld, respectively, in the as-received condition prior to removing the coating. The coating on the lower half of the pipe contains a significant amount of wrinkles. The coating on the lower half of the pipe contains wrinkles.

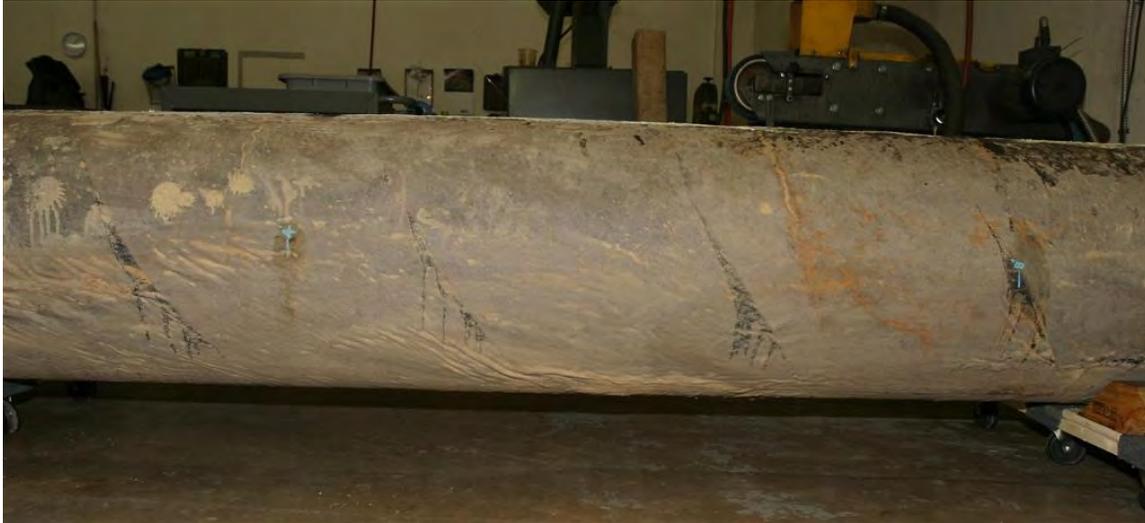
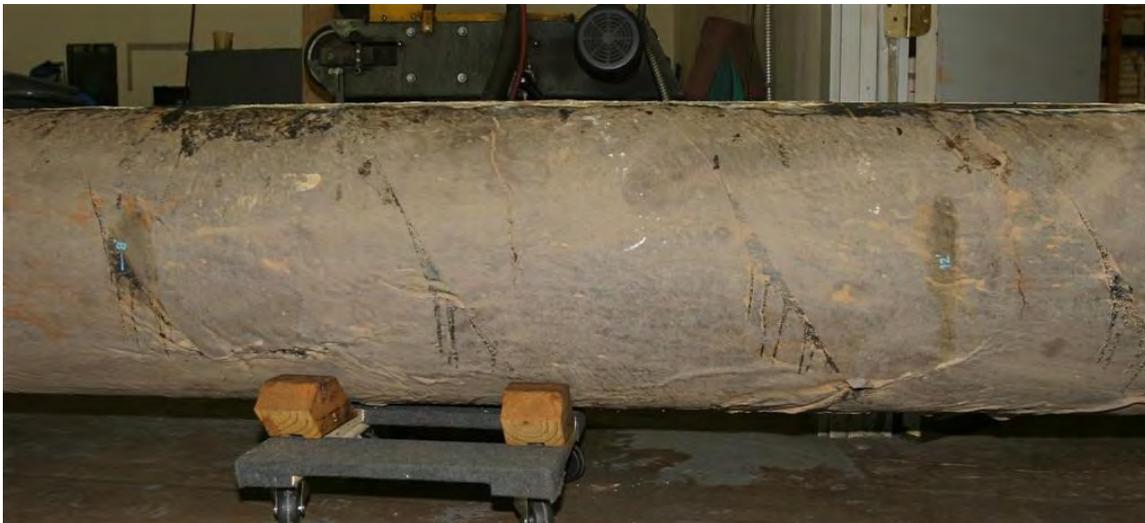
The photographs display overall views of the east side of a pipe from 1:30 to 4:30 adjacent to the fractured pipe from approximately 3' north of the north girth weld (-3') to the center of the north girth weld (0'), and the fractured pipe from the center of the north girth weld to 4' south of the north girth weld (+4'), respectively, in the as-received condition prior to removing the coating. The lower half of the pipe contains wrinkled coating.

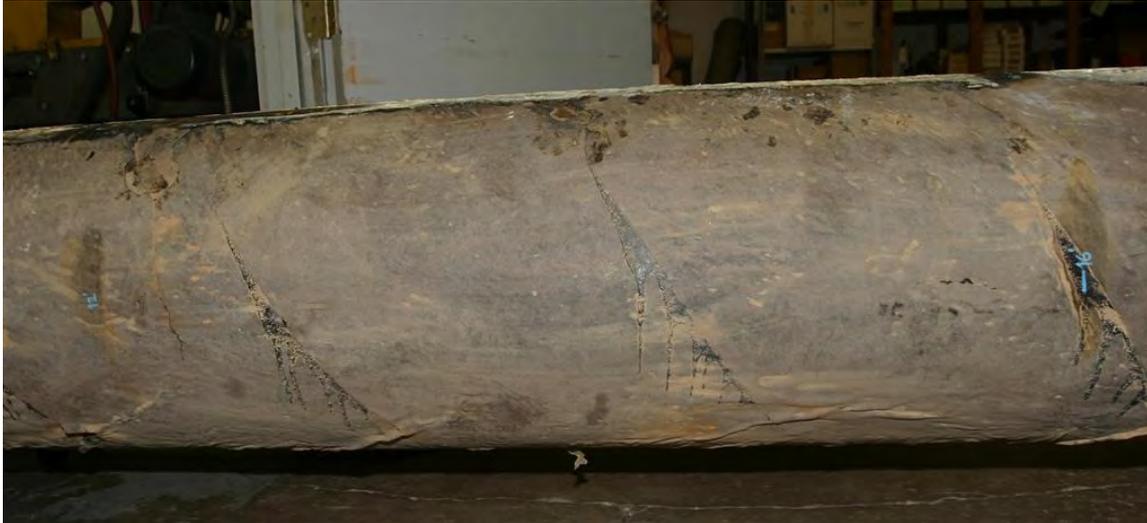
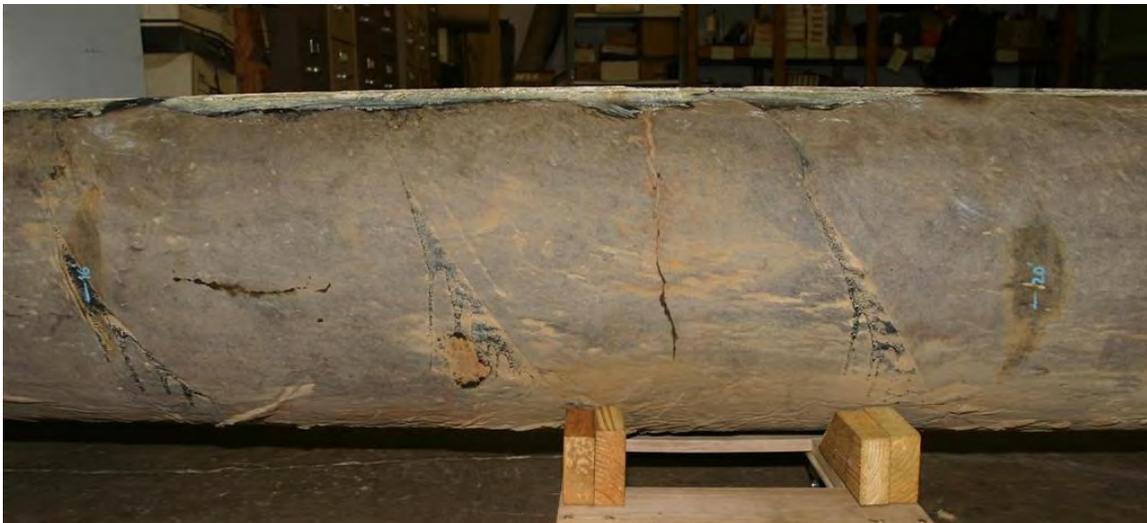
The photographs display overall views of the east side of the fractured pipe from 1:30 to 4:30 from 4' south to 8' south of the north girth weld, and from 8' south to 12' south of the north girth weld, respectively, in the as-received condition prior to removing the coating. The lower half of the pipe contains sagging and wrinkled coating.

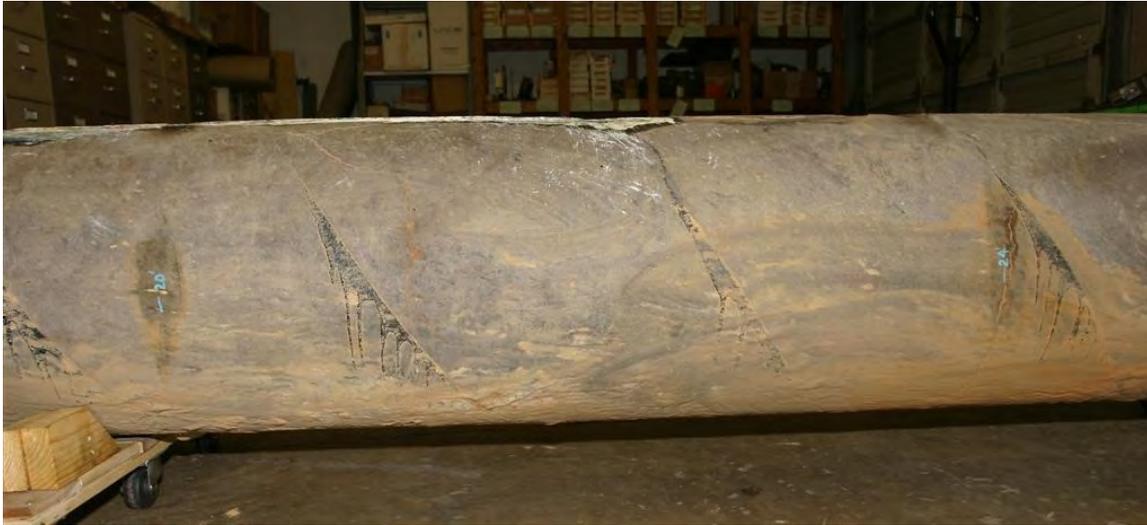
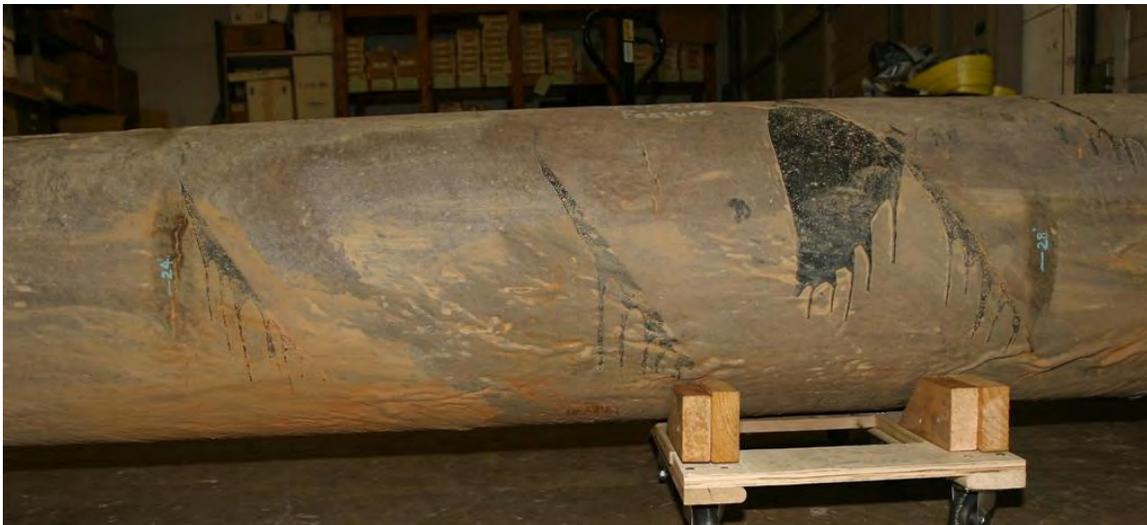
The photographs display overall views of the east side of the fractured pipe from 1:30 to 4:30 from 12' south to 16' south of the north girth weld, and from 16' south to 20' south of the north girth weld, respectively, in the as-received condition prior to removing the coating. The lower half of the pipe contains sagging and wrinkled coating.

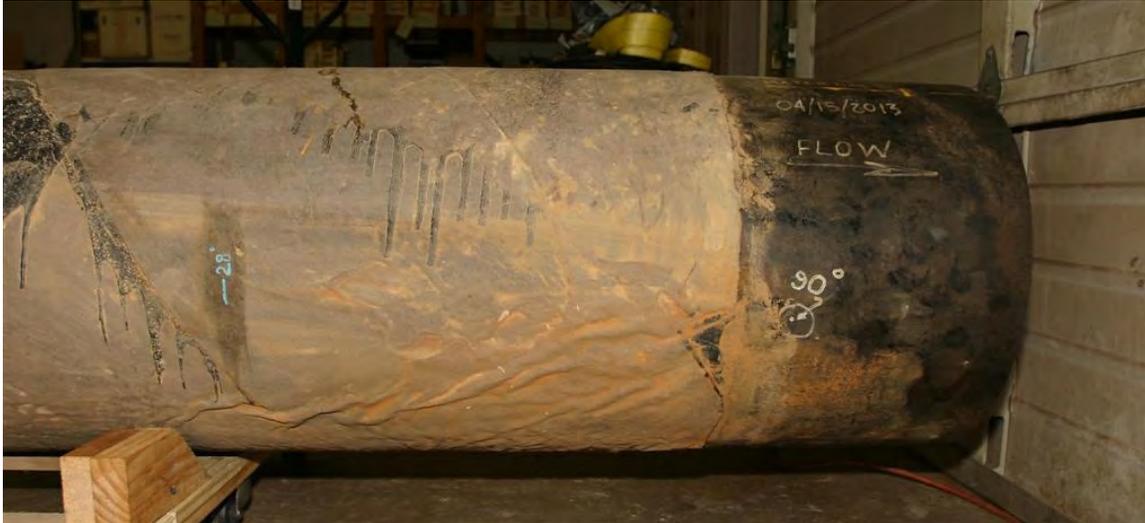
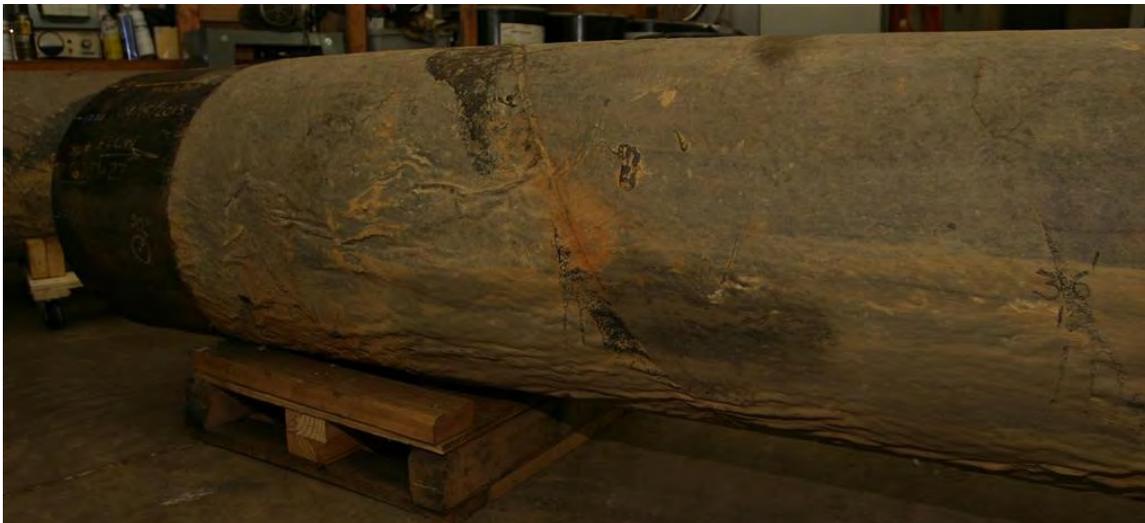
The photographs display overall views of the east side of the fractured pipe from 1:30 to 4:30 from 20' south to 24' south of the north girth weld, and from 24' south to 28' south of the north girth weld, respectively, in the as-received condition prior to removing the coating. The coating on the lower half of the pipe contains sagging and wrinkles.

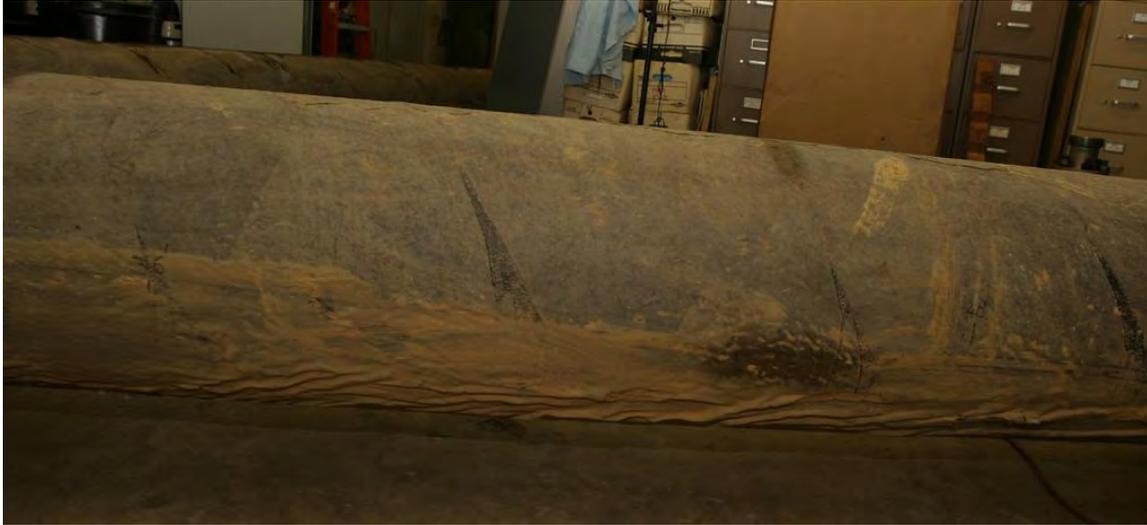
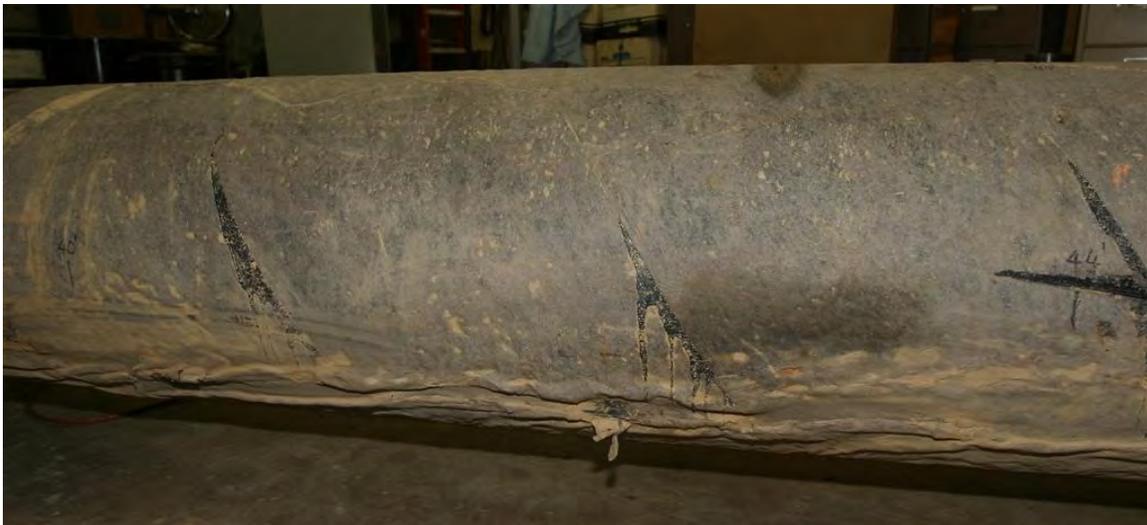
The photographs display overall views of the east side of the fractured pipe from 1:30 to 4:30 from 28' south to 31' south of the north girth weld, and from 31' south to 35' south of the north girth weld, respectively, in the as-received condition prior to removing the coating. The lower half of the pipe contains sagging and wrinkled coating.

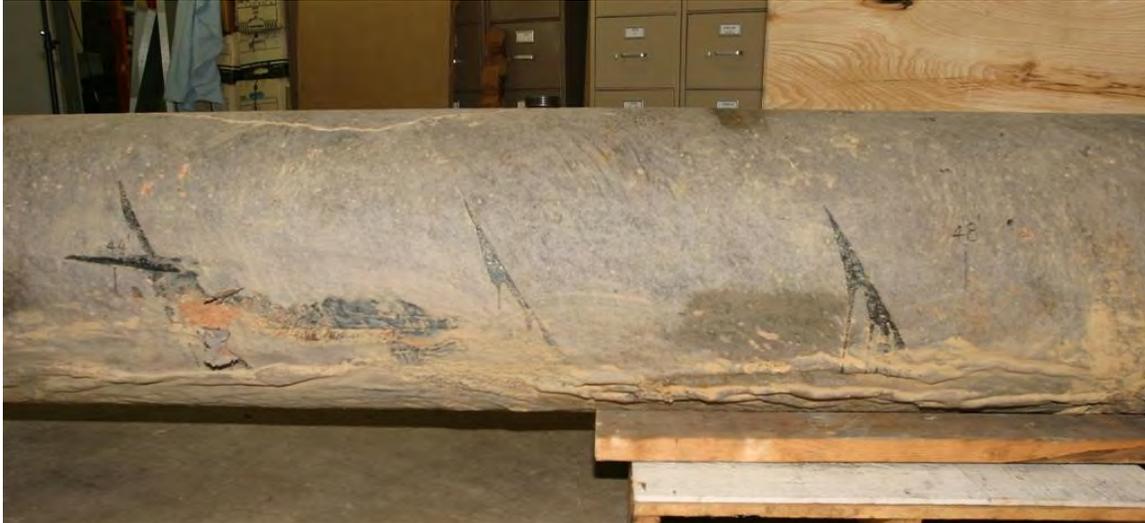
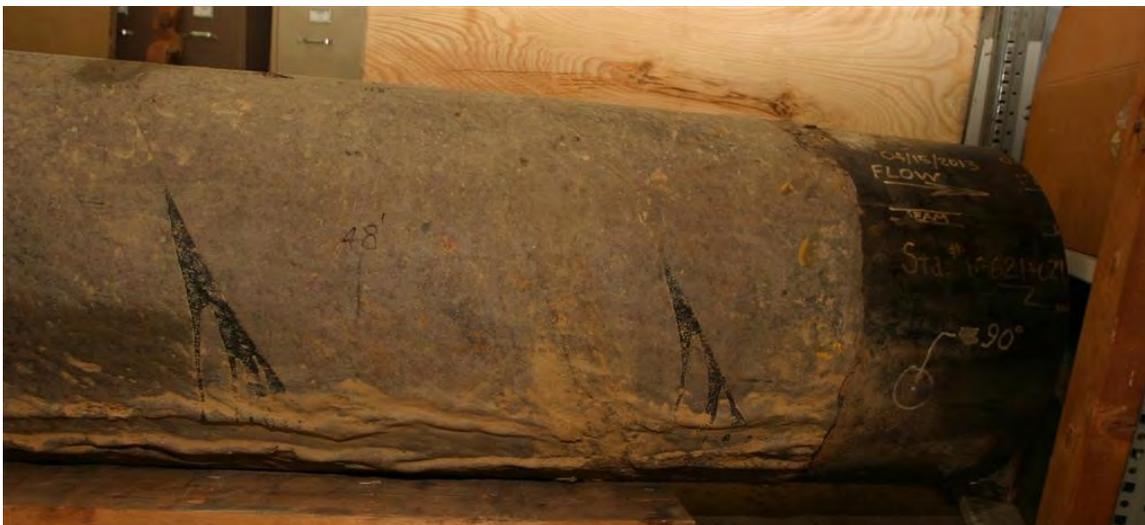
The photographs display overall views of the east side of the fractured pipe from 1:30 to 4:30 from 35' south to 39' south of the north girth weld, and from 39' south to 43' south of the north girth weld, respectively, in the as-received condition prior to removing the coating. The coating on the lower half is wrinkled and sagging.

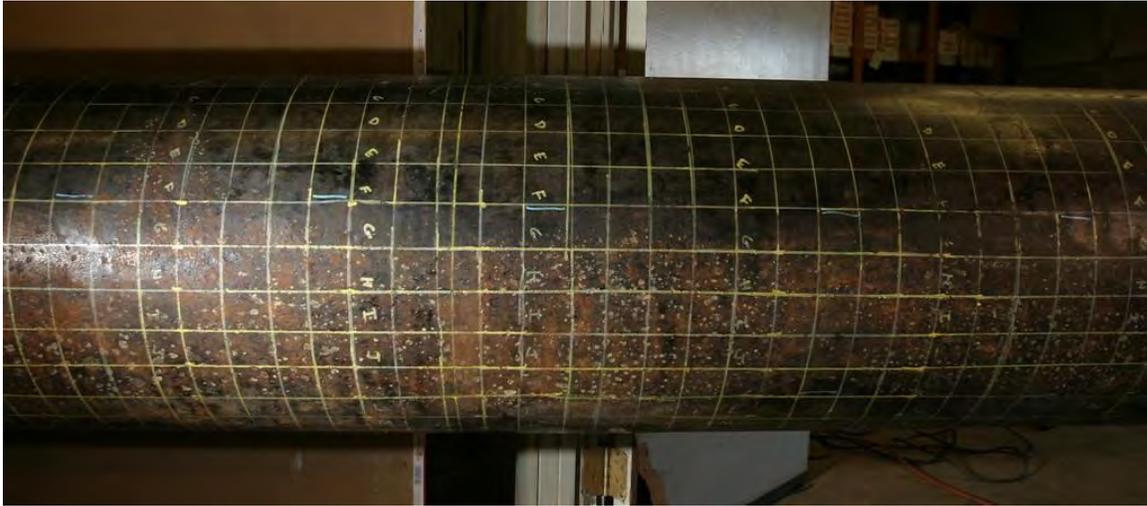
Circumferential Location	Distance from North Girth Weld	Depth of Corrosion Pitting		
		Minimum	Average	Maximum
6:41 o'clock to 10:07 o'clock	4' to 8'	0.002"	0.013"	0.037"
7:03 o'clock to 11:16 o'clock	8' to 12'	0.002"	0.011"	0.026"

The photographs display overall views of the west side of the fractured pipe from 4' south to 8' south of the north girth weld, and 8' south to 12' south of the north girth weld, respectively, after the removal of the coating. The lower half of the pipe shows corrosion pitting on the O.D. surface where the coating had wrinkled and sagged.

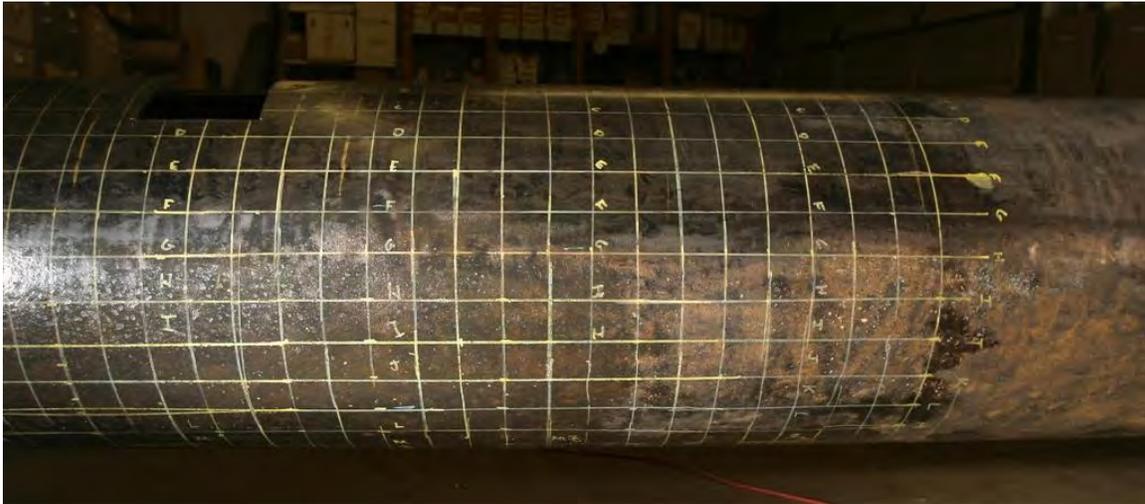
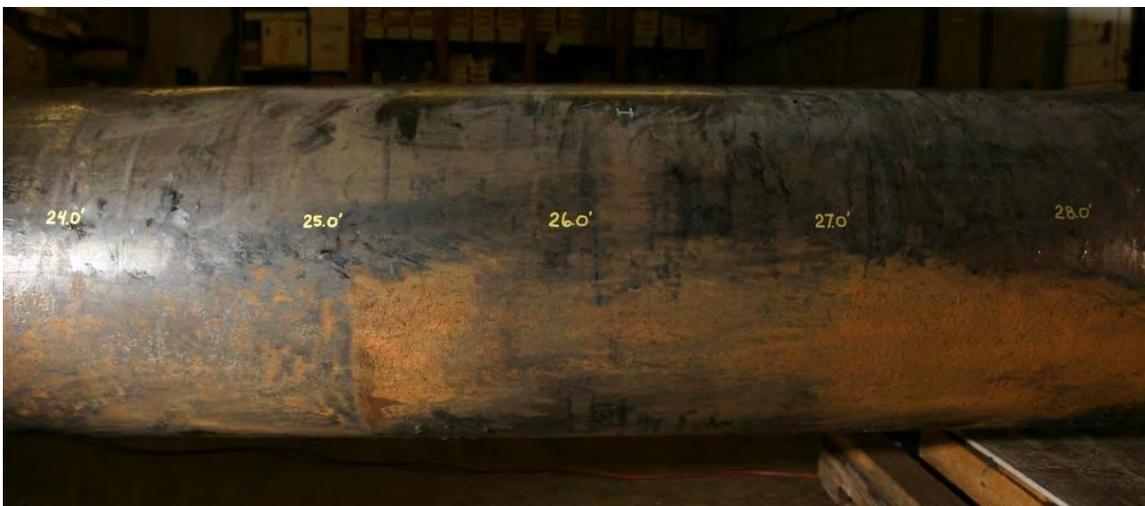
Circumferential Location	Distance from North Girth Weld	Depth of Corrosion Pitting		
		Minimum	Average	Maximum
6:29 o'clock to 9:55 o'clock	12' to 16'	0.003"	0.017"	0.031"
6:52 o'clock to 10:07 o'clock	16' to 20'	0.006"	0.012"	0.021"

The photographs display overall views of the west side of the fractured pipe from 12' south to 16' south of the north girth weld, and 16' south to 20' south of the north girth weld, respectively, after the removal of the coating. The lower half of the pipe shows corrosion pitting on the O.D. surface where the coating had wrinkled and sagged.

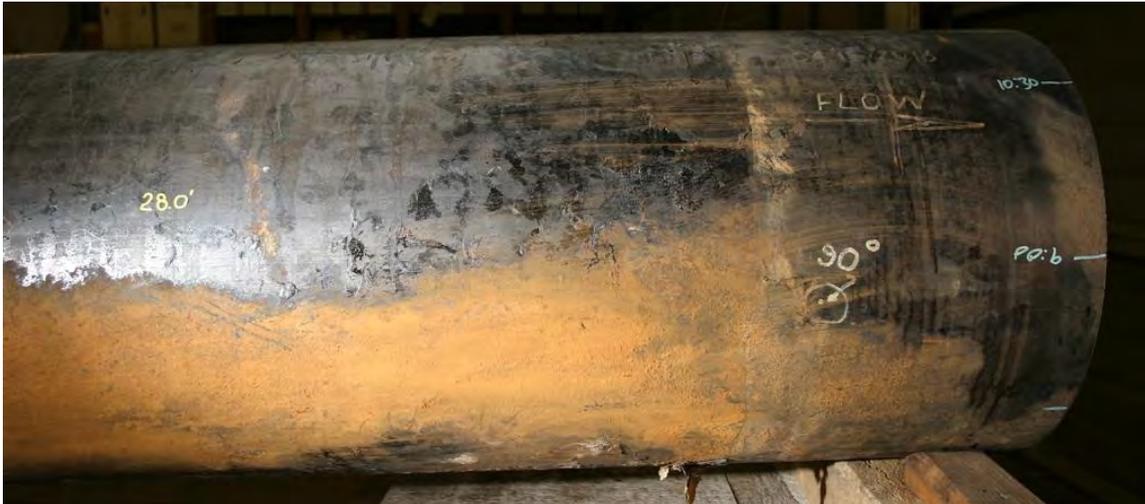
Photograph No. 73

Circumferential Location	Distance from North Girth Weld	Depth of Corrosion Pitting		
		Minimum	Average	Maximum
7:15 o'clock to 9:55 o'clock	20' to 24'	0.005"	0.010"	0.021"
All	24' to 28'	No Corrosion Pitting Visible

The photographs display overall views of the west side of the fractured pipe from 20' south to 24' south of the north girth weld, and 24' south to 28' south of the north girth weld, respectively, after the removal of the coating. The lower half of the pipe shows corrosion pitting on the O.D. surface where the coating had wrinkled and sagged.

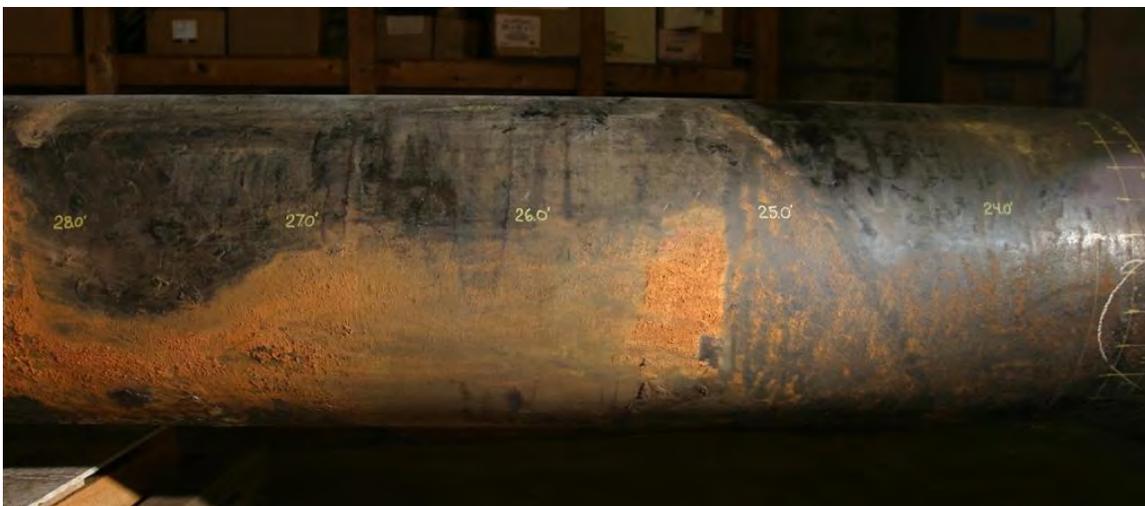
Circumferential Location	Distance from North Girth Weld	Depth of Corrosion Pitting		
		Minimum	Average	Maximum
3:03 o'clock to 4:57 o'clock	12' to 16'	0.003"	0.013"	0.033"
2:40 o'clock to 5:20 o'clock	16' to 20'	0.005"	0.015"	0.031"

The photographs display overall views of the east side of the fractured pipe from 12' south to 16' south of the north girth weld, and 16' south to 20' south of the north girth weld, respectively, after the removal of the coating. The lower half of the pipe shows corrosion pitting on the O.D. surface where the coating had wrinkled and sagged.

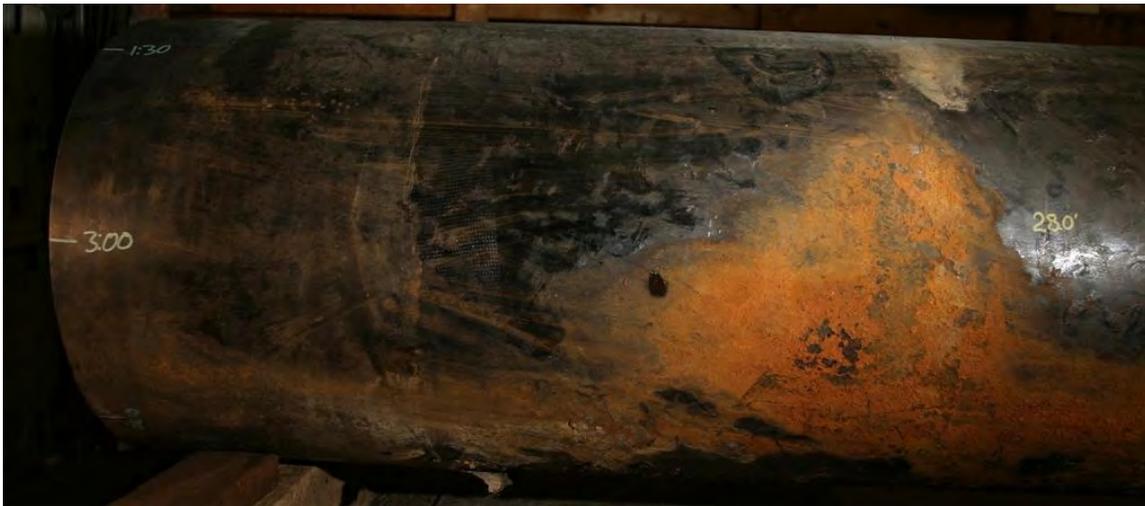
Photograph No. 82

Circumferential Location	Distance from North Girth Weld	Depth of Corrosion Pitting		
		Minimum	Average	Maximum
2:40 o'clock to 4:57 o'clock	20' to 24'	0.004"	0.020"	0.033"
All	24' to 28'	No Corrosion Pitting Visible

The photographs display overall views of the east side of the fractured pipe from 20' south to 24' south of the north girth weld, and 24' south to 28' south of the north girth weld, respectively, after the removal of the coating. The lower half of the pipe shows corrosion pitting on the O.D. surface where the coating had wrinkled and sagged.

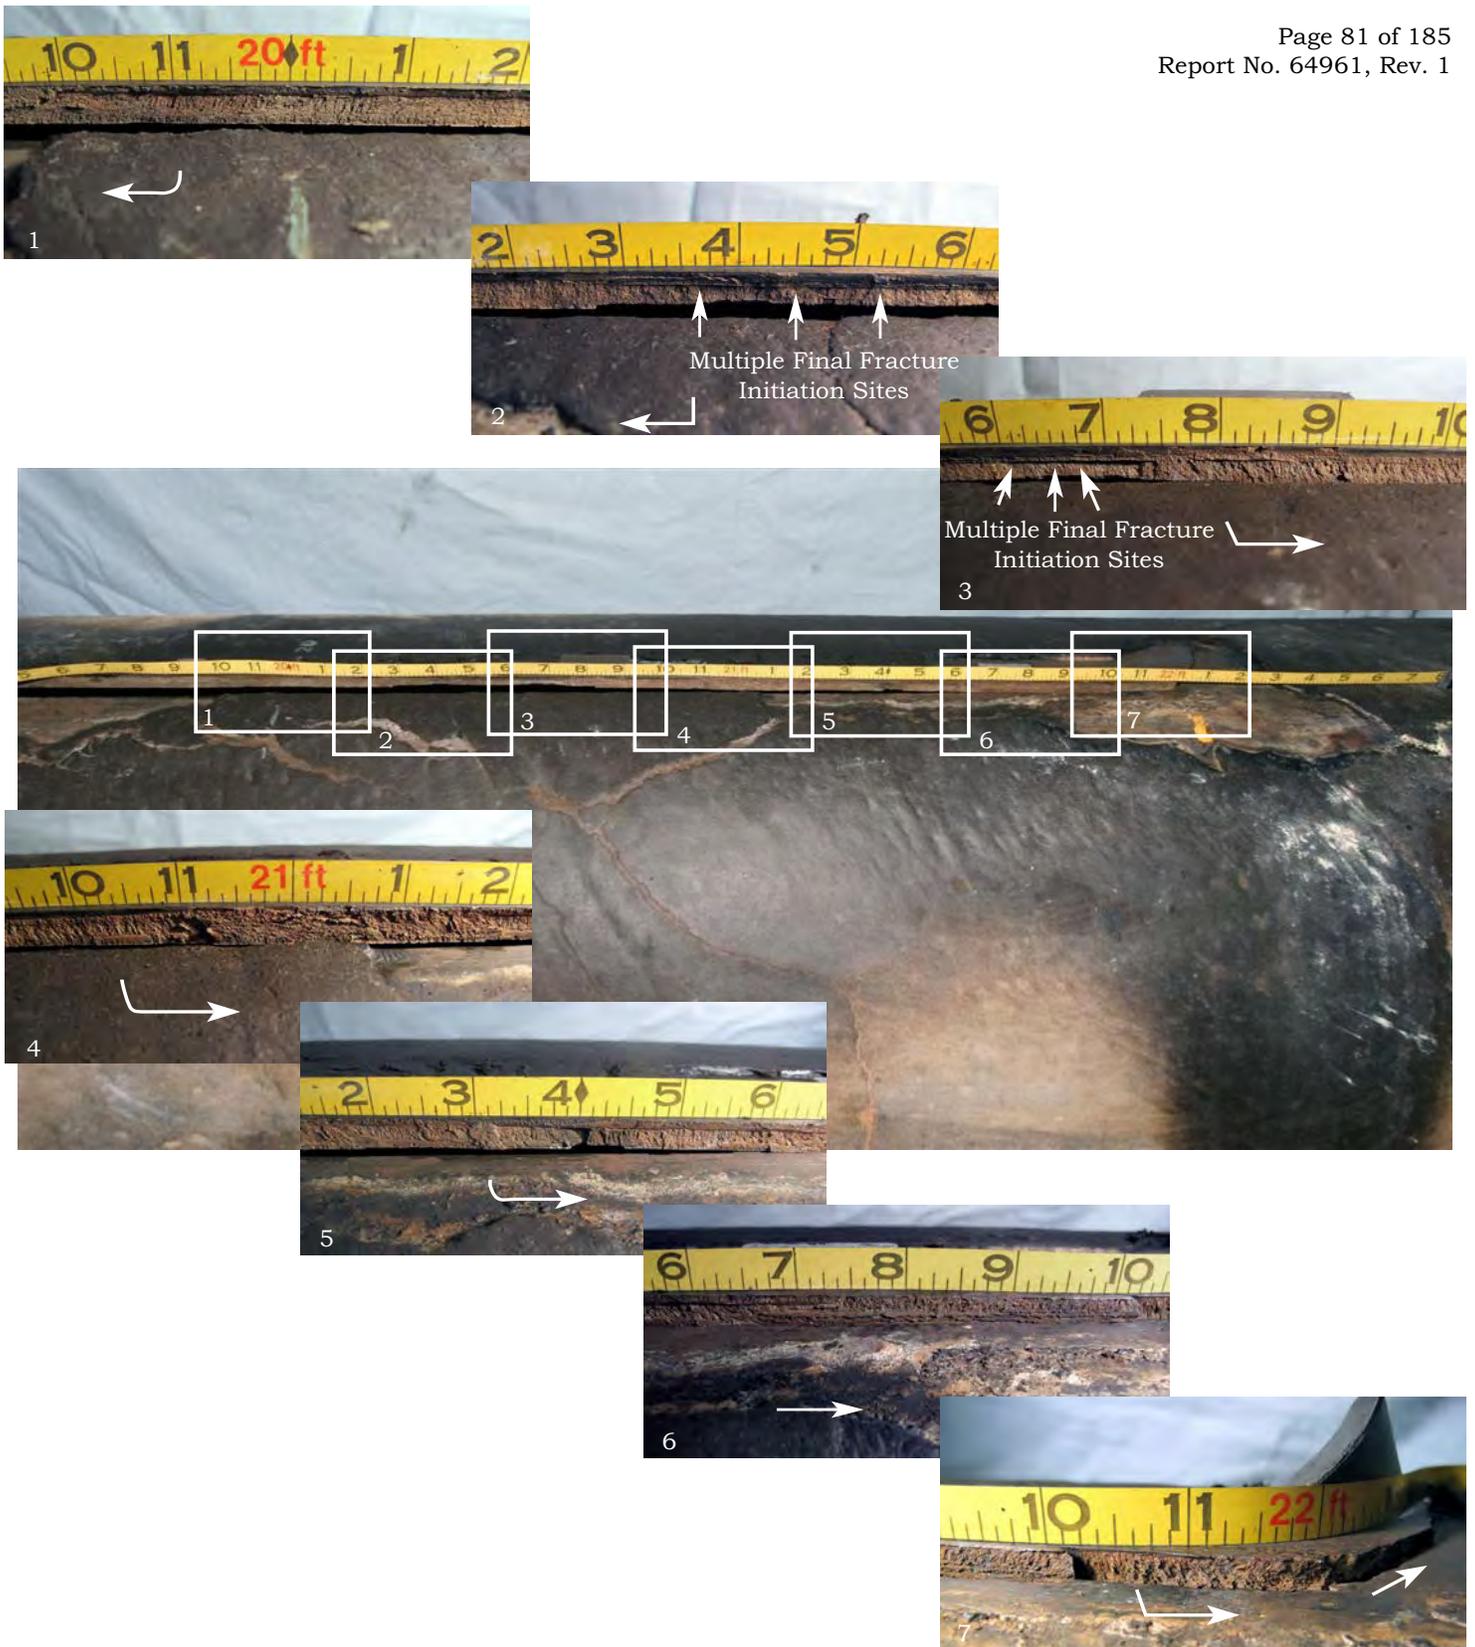
Photograph No. 87

The photographs display overall and close-up views of the 33' 11-1/2" long section of a fractured 20" O.D. x 0.312" wall pipe, which was removed from the Conway to Corsicana section of the Pegasus Crude Oil Pipeline at Milepost 314.77 in Mayflower, Arkansas.
