*METALLURGICAL INVESTIGATION OF A
FRACTURED SECTION OF THE 20" O.D.
PIPELINE AT MILEPOST 314.77 IN THE
CONWAY TO CORSICANA SEGMENT OF
THE PEGASUS CRUDE OIL PIPELINE*

REPORT NO. 64961, REV. 1

Prepared for
ExxonMobil Pipeline Company and the
Pipeline and Hazardous Materials Safety Administration
pursuant to Corrective Action Order CPF 4-2013-5006H

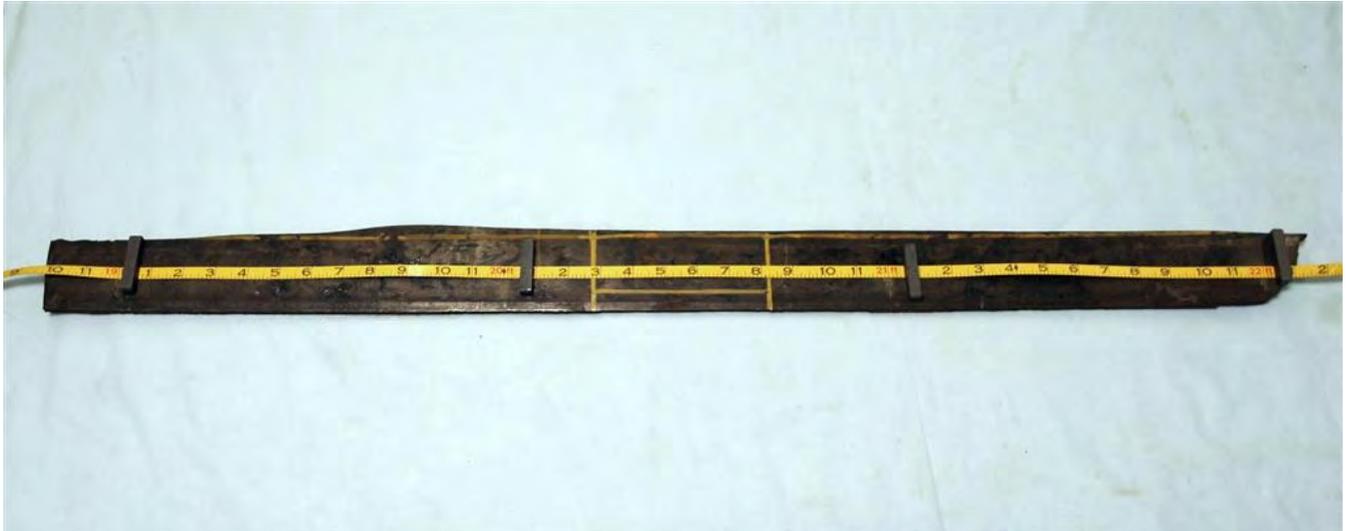
Photograph No. 95

The photographs display evidence of chevron marks pointing downstream toward the fracture origins. The arrows point to some of the fine chevrons.

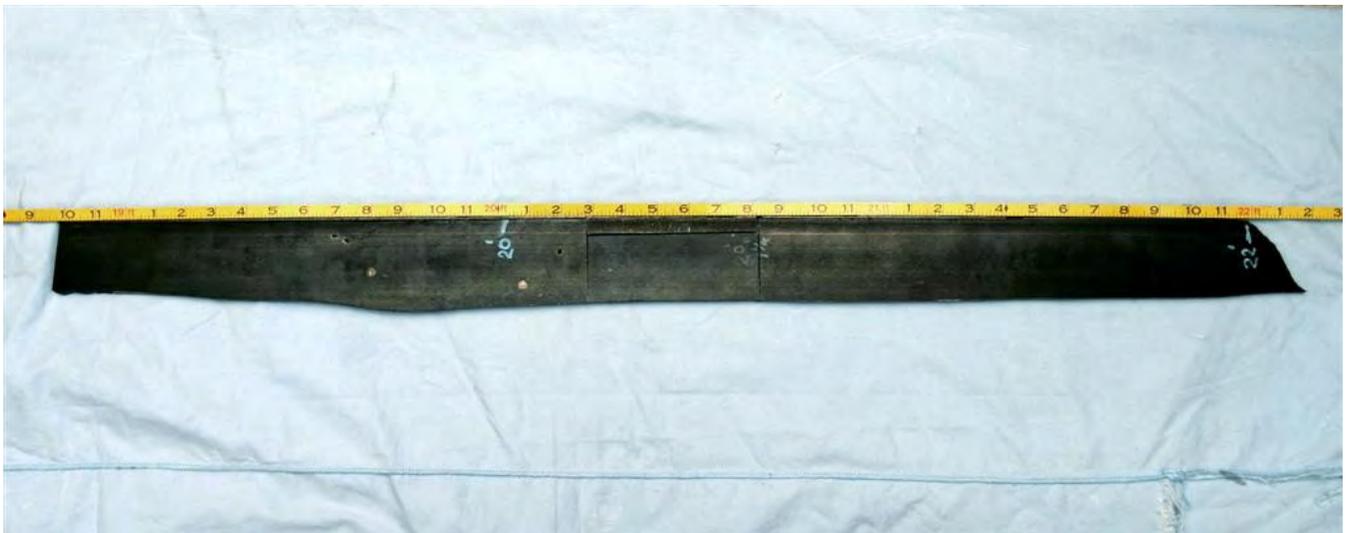
Photograph No. 96

The photographs display the O.D. and I.D. surfaces of a section of the pipe that was removed between a distance of 18' 10" and 22' as measured from the north girth weld and which contained hook cracks along the ERW seam, from where the final failure initiated on March 29, 2013.

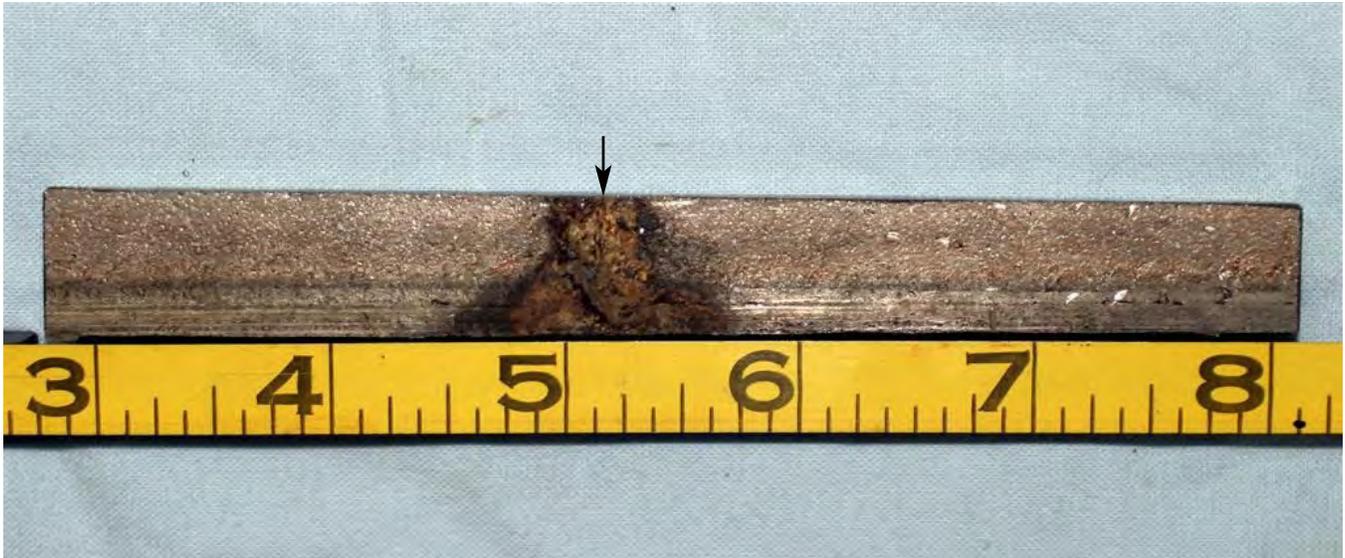
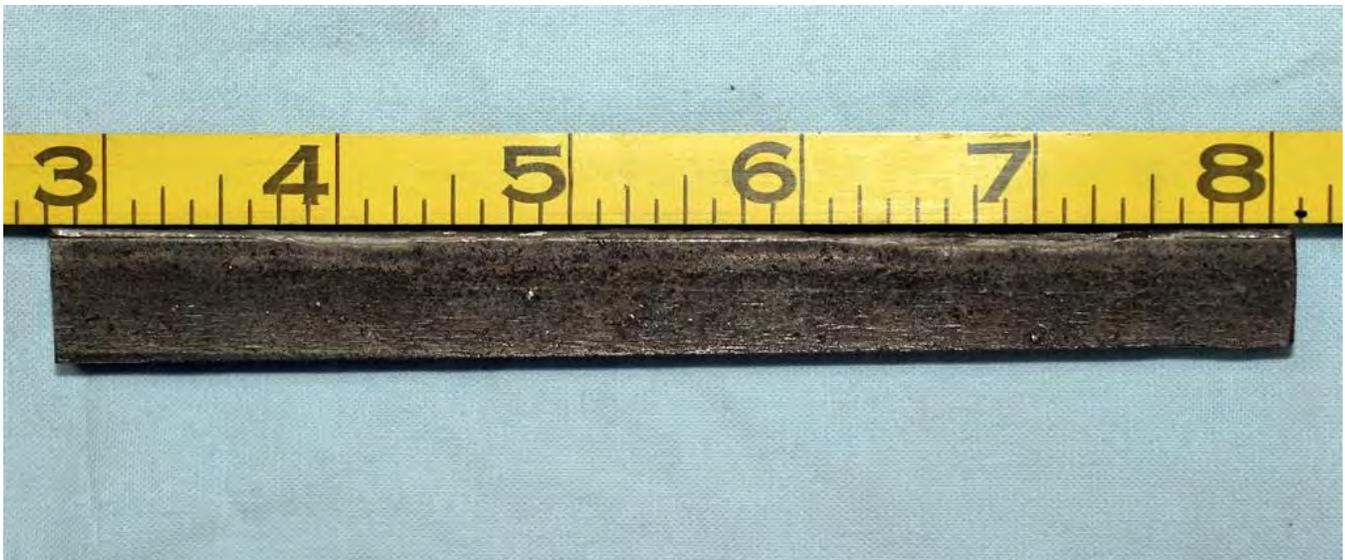
The photographs display the O.D. and I.D. surfaces adjacent to one of the mating fracture faces which contained multiple hook cracks. The arrow points to an area where the coating was apparently damaged prior to the incident.

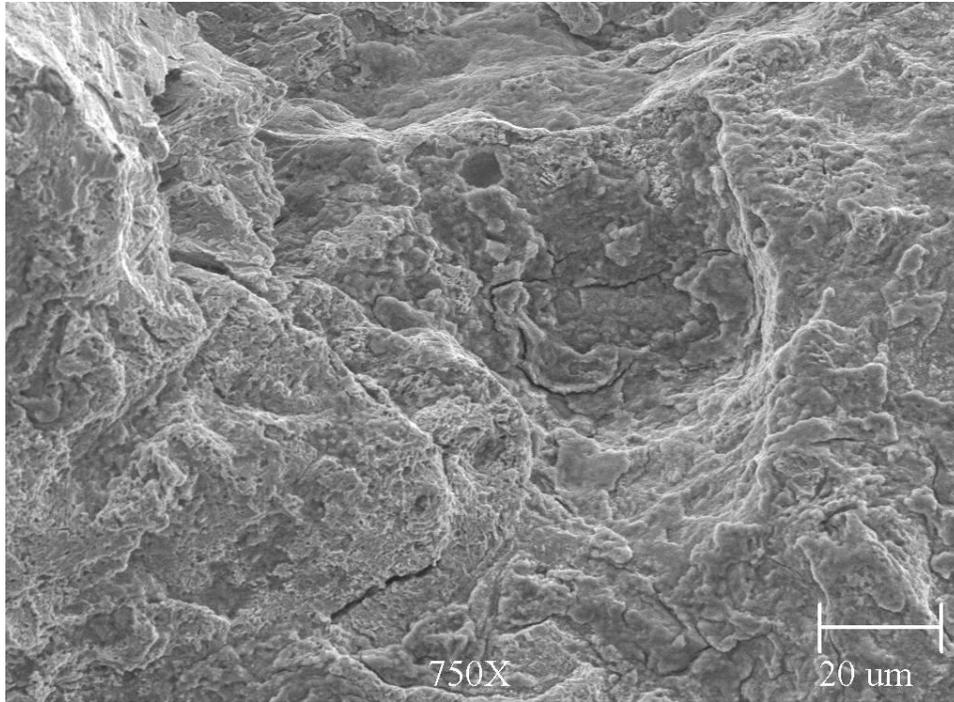
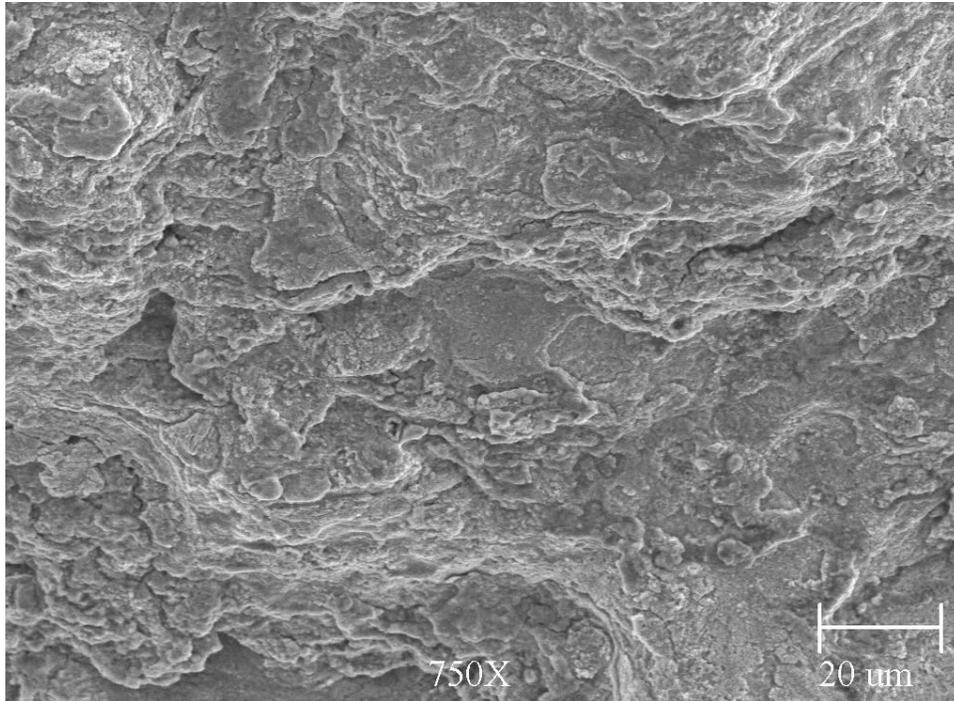
The SEM fractographs taken of the Area-C at Location-3C and Location-3D of the hook crack zone, as displayed in Photograph No. 129, reveal tightly adhered oxidation product.

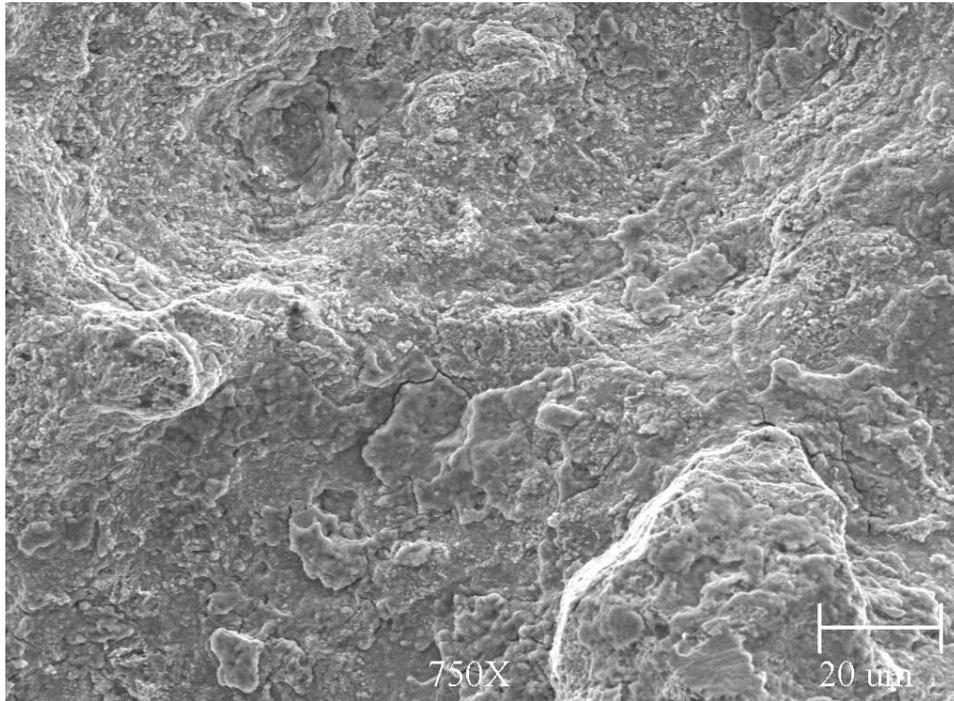
Area-D within the rectangle
Photograph No. 135

The SEM fractograph taken of the Area-D within the rectangle of the hook crack zone, as displayed in Photograph No. 134, reveals tightly adhered oxidation product.

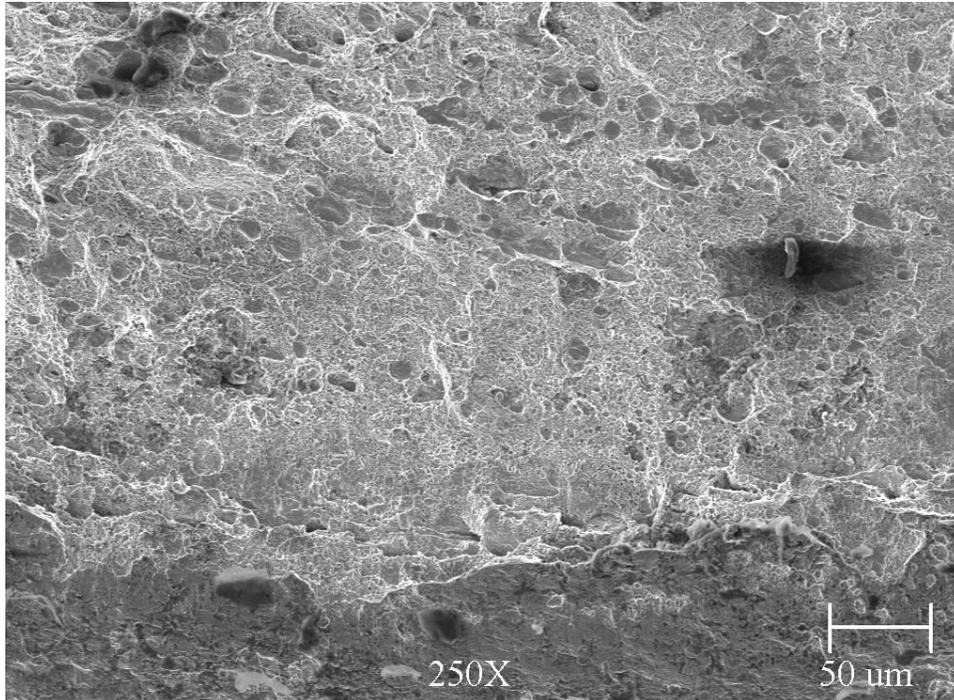
The SEM fractographs taken of the Area-4 of the final shear fracture zone at the I.D. of the pipe reveal evidence of microvoid coalescence, indicative of rapid ductile failure.

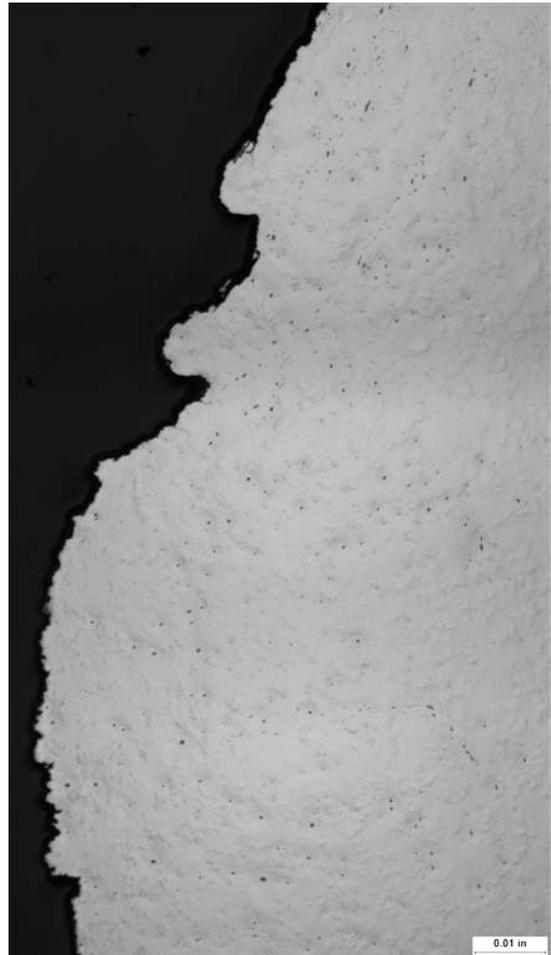
The micrographs display the upturned inclusions essentially parallel to the fusion line in the ERW upset/HAZ area, as well as along the fracture faces. Note that vertically aligned inclusions are one of the main contributing factors to the formation of hook cracks.

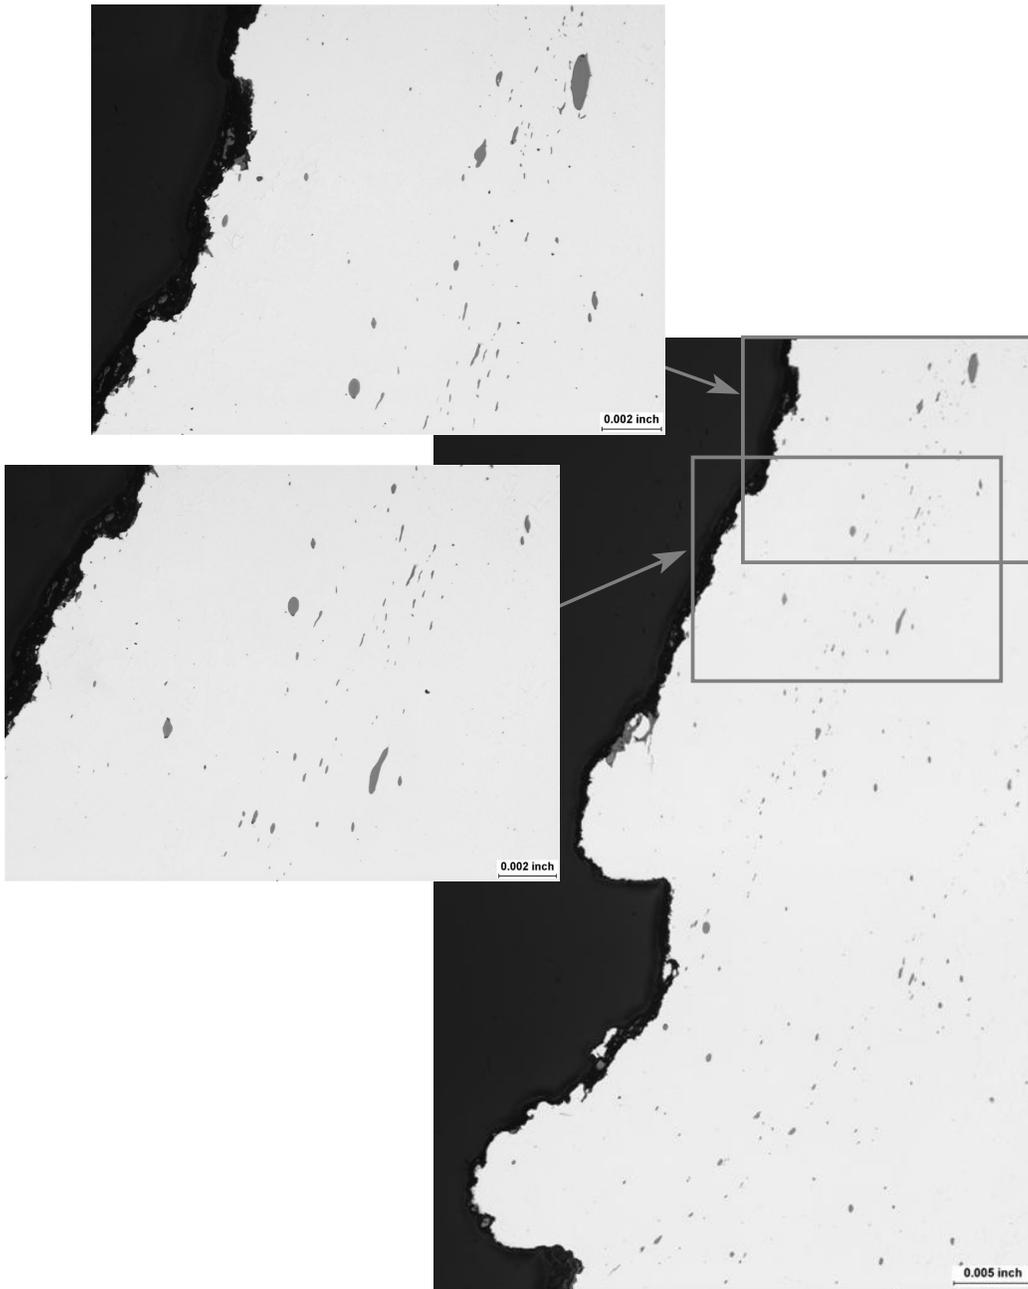
The micrographs display evidence of folds at the O.D. surface at the fusion line, which was apparently not fully fused, and the presence of post-fracture oxidation at the mid-wall area along the hook crack fracture face.

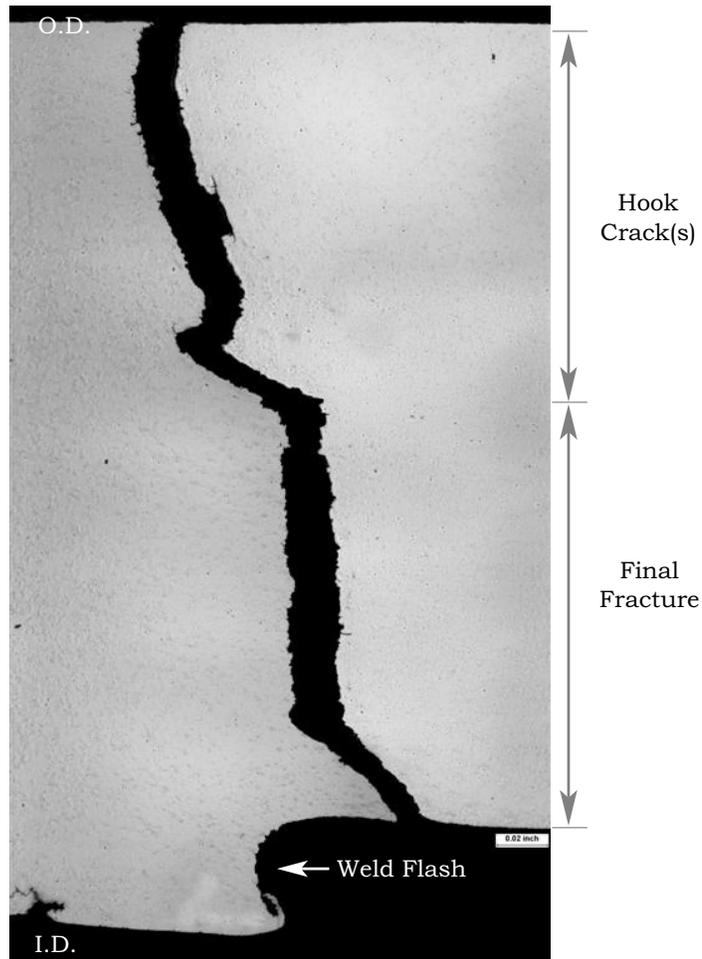
The micrographs display the microstructure of the material in the upset/HAZ between the O.D. and the mid-wall where the upturned bands were formed during the ERW seam manufacturing, consisting of the untempered brittle martensite in the banded area and essentially grain boundary ferrite and unresolved bainite with some patches of untempered martensite in the non-banded area.

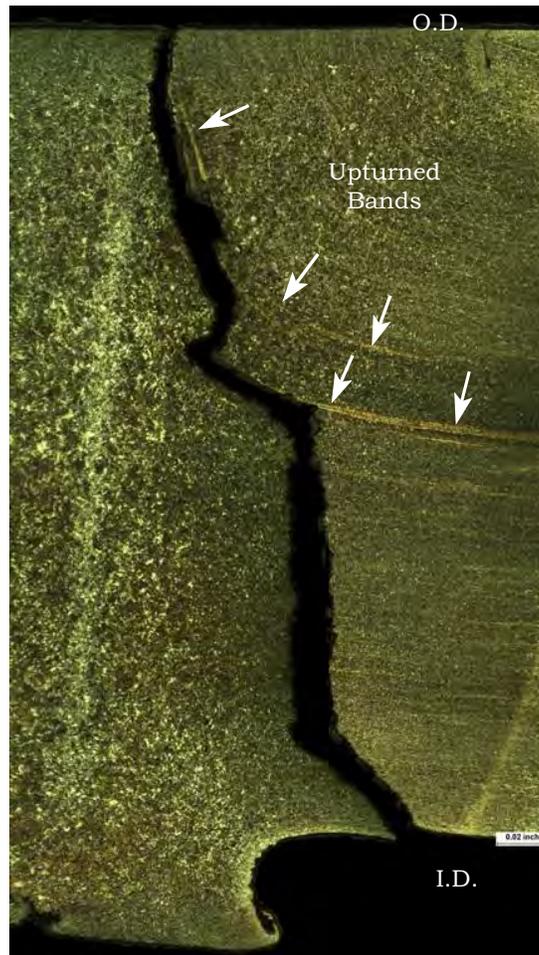
20' 6-13/16" from the North Girth Weld
2% Nital etch, ~20x
Photograph No. 177

The composite view of the mating cross-sections removed through the fracture origins area at a distance of 20' 6-13/16" from the north girth weld and prepared for metallographic evaluation shows hook crack(s) following the upturned grains and inclusions in the upset/HAZ area.

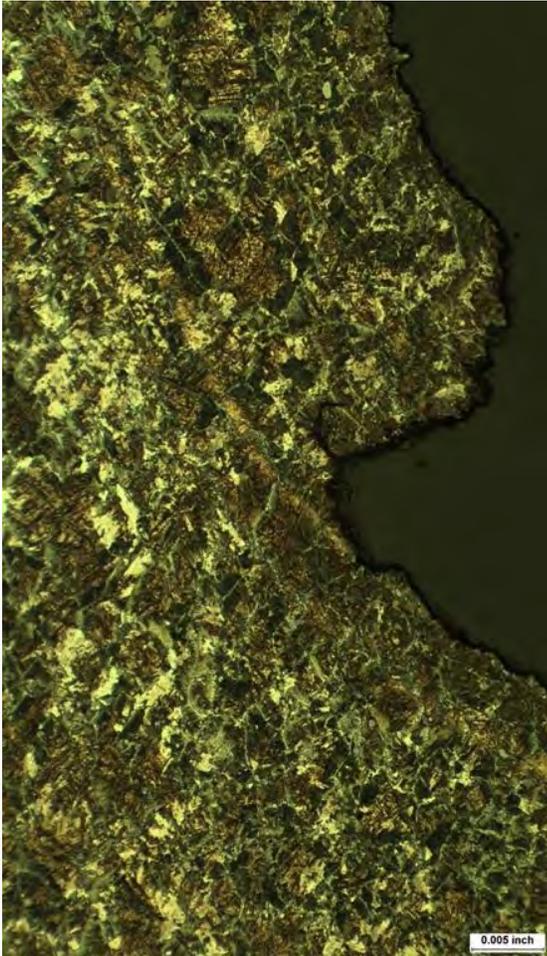
The micrographs display the mating faces of the hook crack(s) at the O.D. in the ERW seam. The microstructure consists of grain boundary ferrite and unresolved bainite with some acicular martensite.

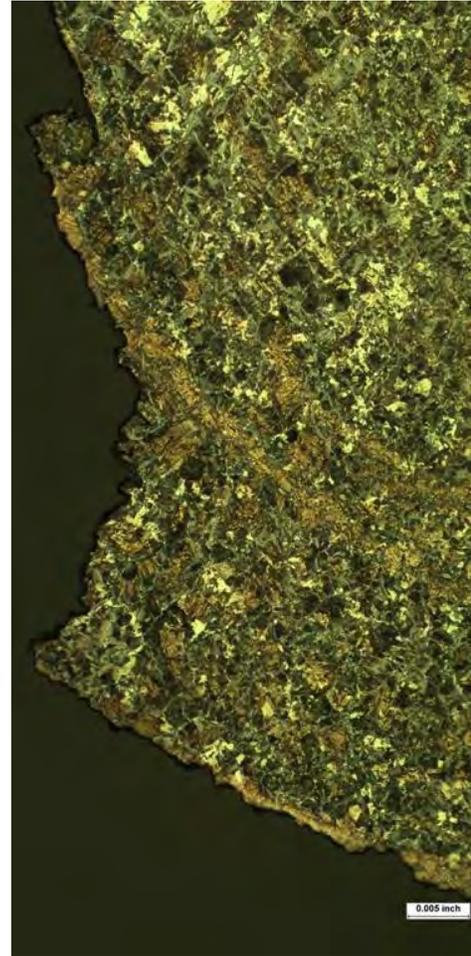
The micrographs display hook crack(s) following the upturned bands of acicular martensite and manganese sulfide inclusions.

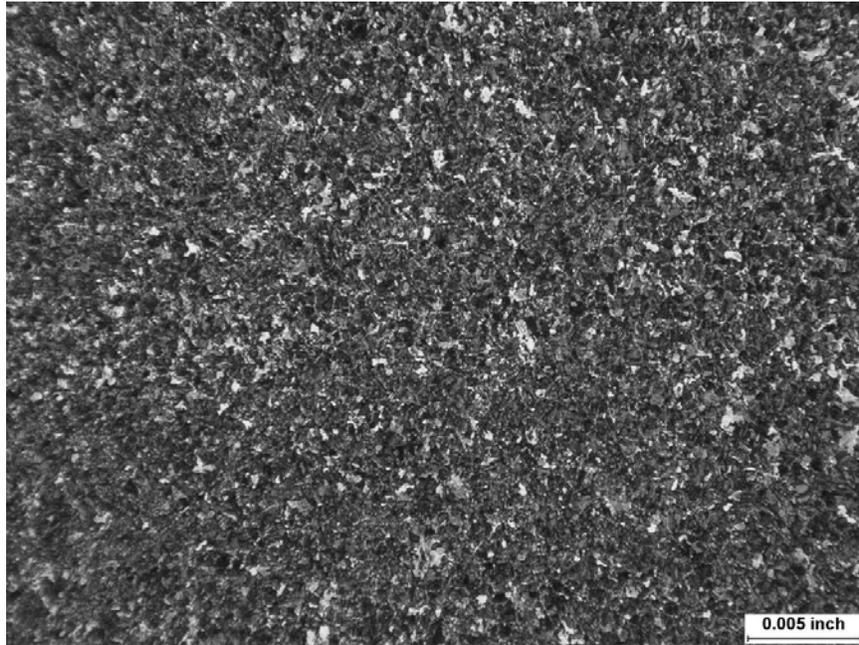
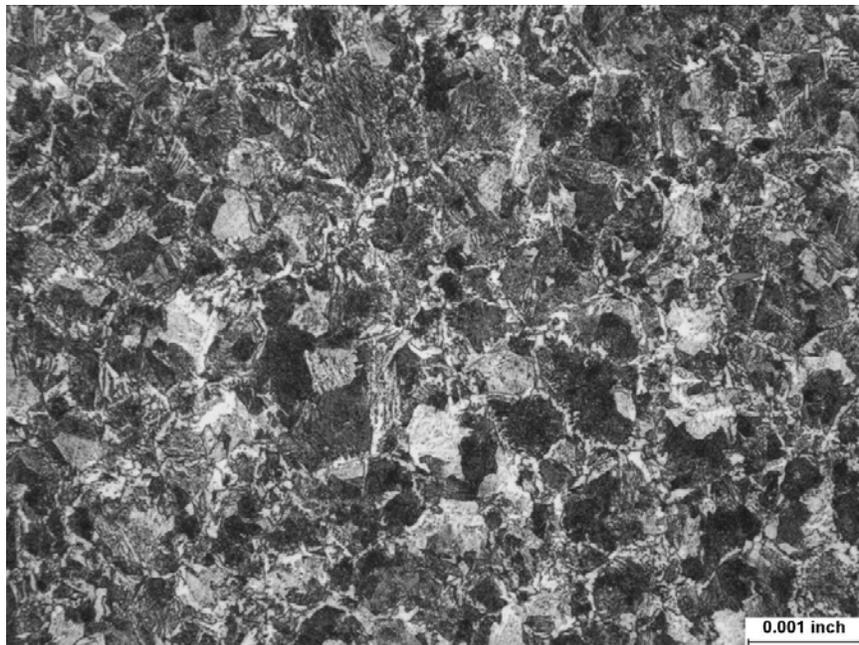
The micrographs of the secondary HAZ display essentially the grain boundary ferrite and unresolved pearlite.

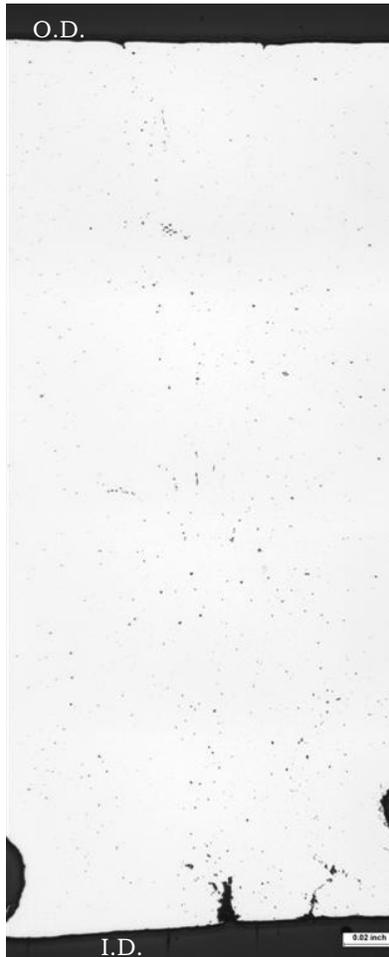
35' 8-1/2" from the North Girth Weld
As-polished, ~25x
Photograph No. 203

The micrograph of a cross-section removed from the intact ERW seam at a distance of 35' 8-1/2" from the north girth weld displays an excessive amount of manganese sulfide inclusions, some aligned parallel and diagonal to the fusion line during the seam welding process.

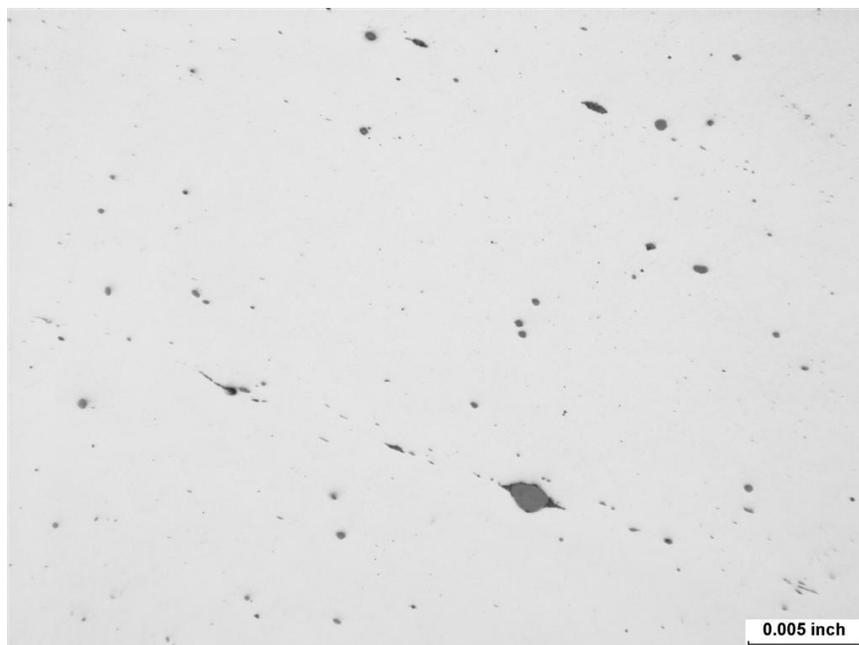
The micrographs display an excessive amount of manganese sulfide inclusions aligned parallel and diagonal to the fusion line in the upset/HAZ near the mid-wall of the ERW seam joint.

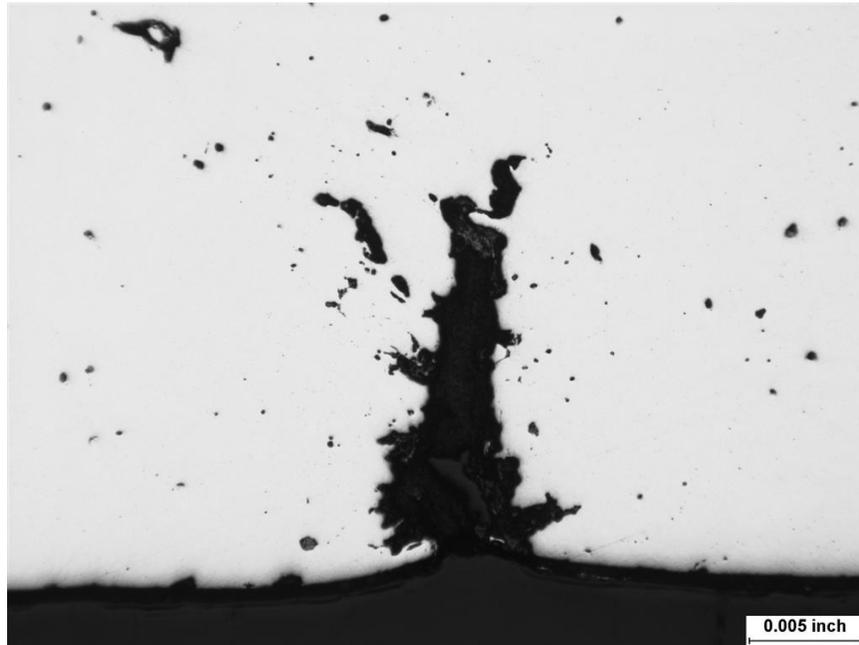
The micrographs display unfused, expelled weld flash near the I.D. of the ERW seam joint.

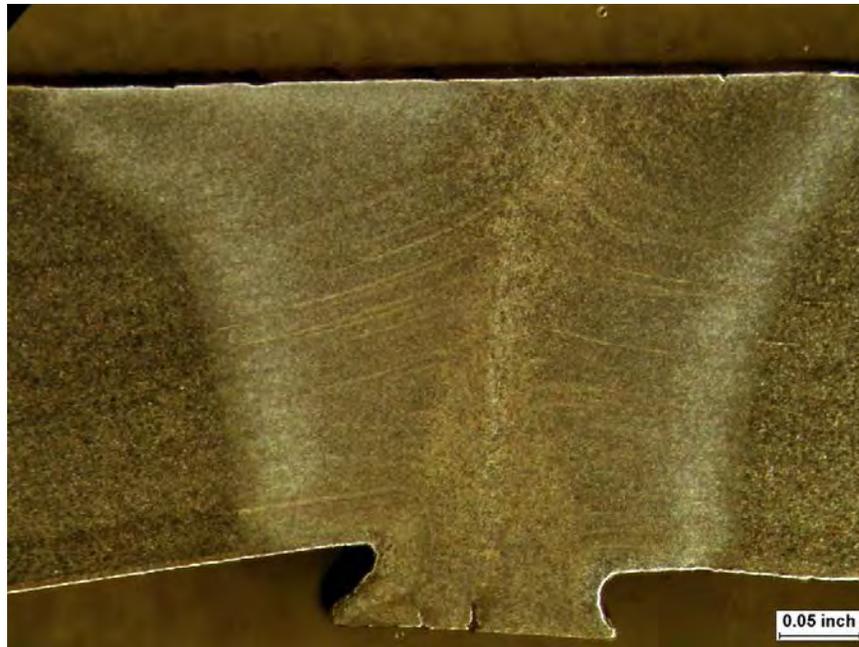
35' 8-1/2" from the North Girth Weld
2% Nital etch, ~20x
Photograph No. 214

The micrograph of the cross-section removed through the intact ERW seam at a distance of 35' 8-1/2" from the north girth weld and prepared for metallographic examination shows upturned as well as downturned bands in the upset/HAZ, with some bands aligned parallel to the fusion line.

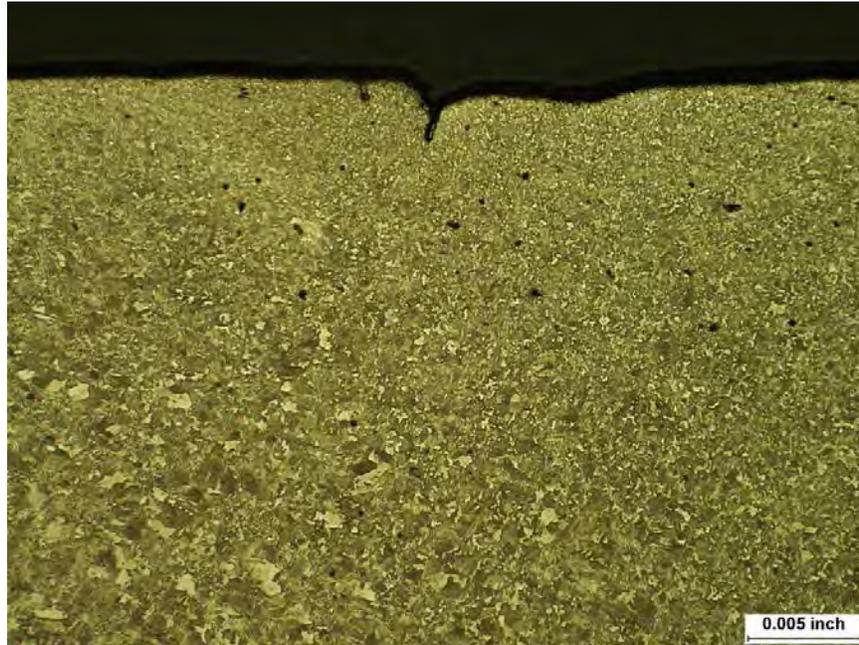
The micrographs display evidence of some oxidation near the O.D. in the upset/HAZ of the ERW seam joint. The microstructure near the O.D. consists of essentially ferrite and pearlite.

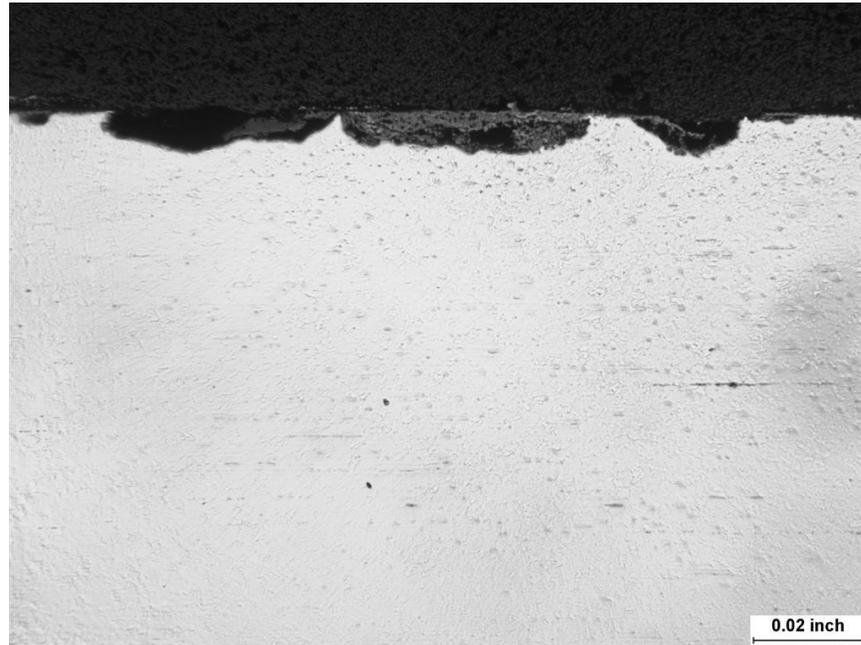
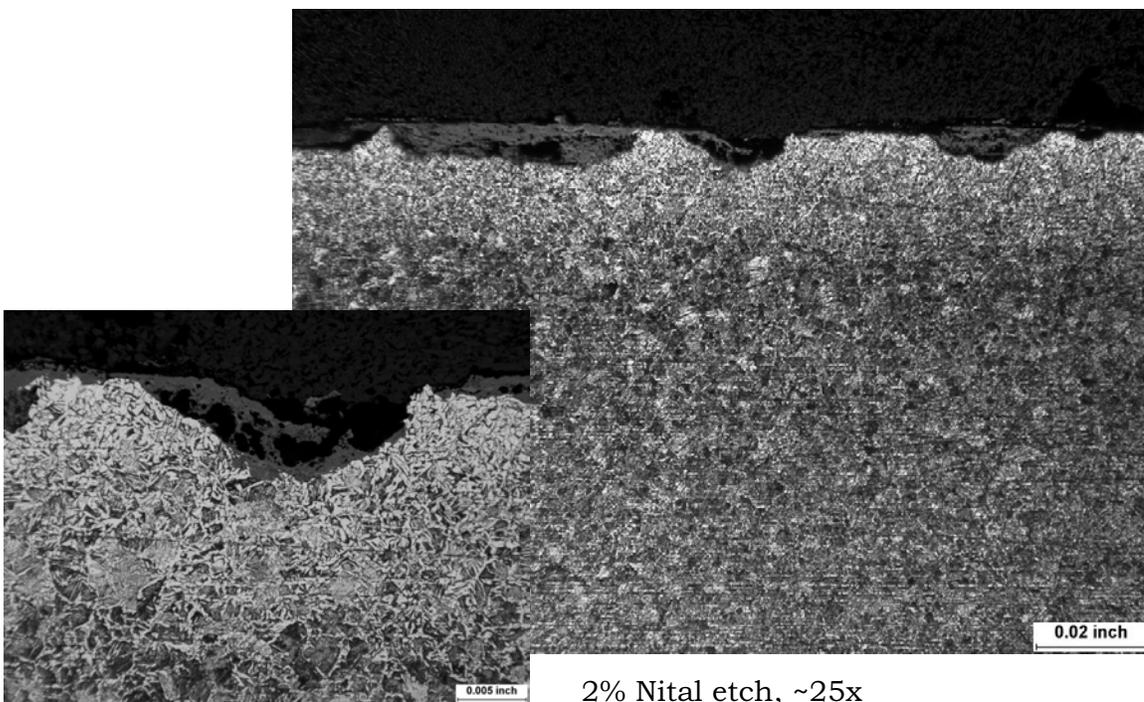
The micrographs display the microstructural condition at a representative area of the O.D. surface of the pipe, showing the loss of material due to pitting corrosion and the corrosion products adhered to the surface. The insert photograph shows a higher magnification view of a single corrosion pit. The maximum depth of the corrosion pits at this location measured 0.008".

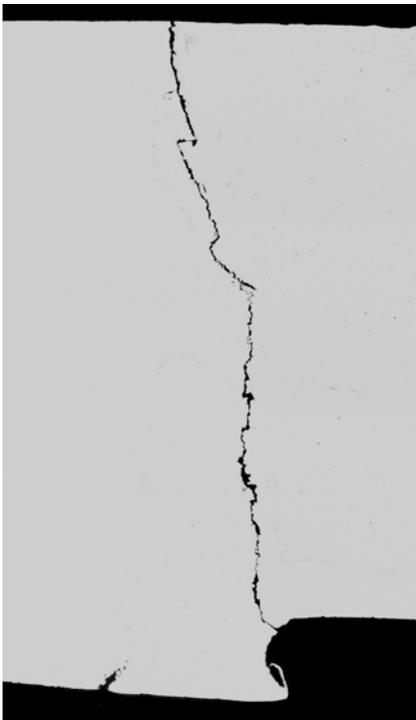
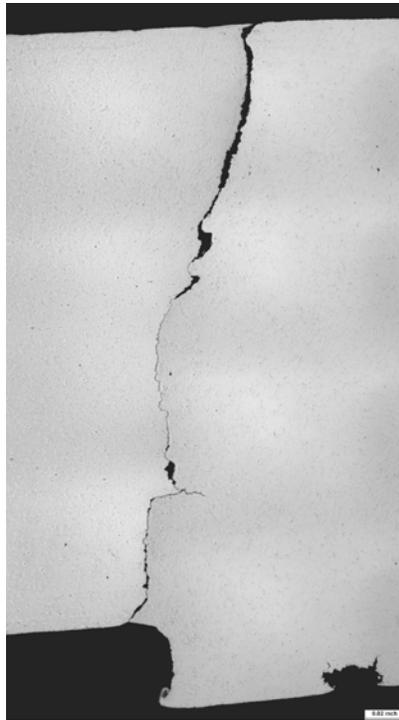
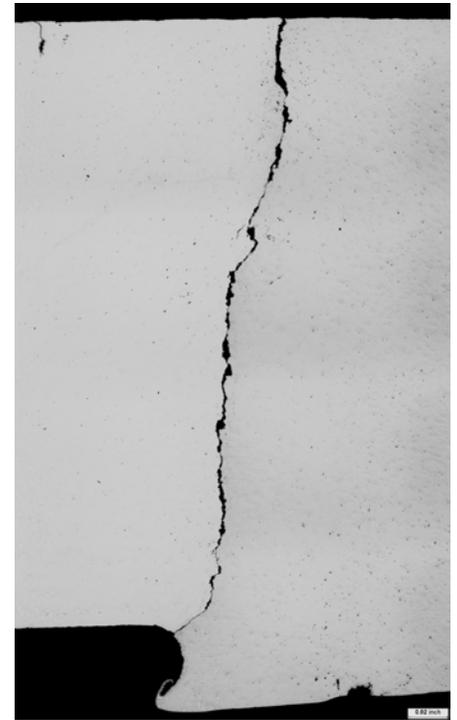
Distance from the North Gird Weld	Hook Crack Width			Hook Crack Depth
	Minimum	Average	Maximum	
20' 3-3/4"	0.0008"	0.0013"	0.0023"	0.145"
20' 4-7/8"	0.0018"	0.0028"	0.0038"	0.145"
20' 5-1/2"	0.0006"	0.0016"	0.0031"	0.133"

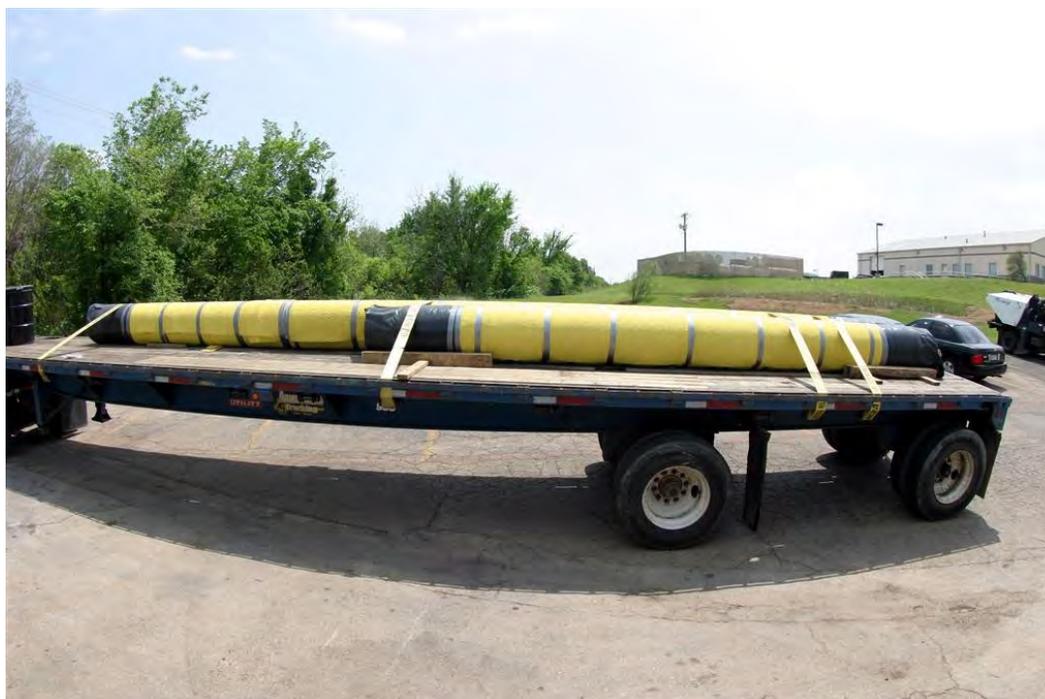
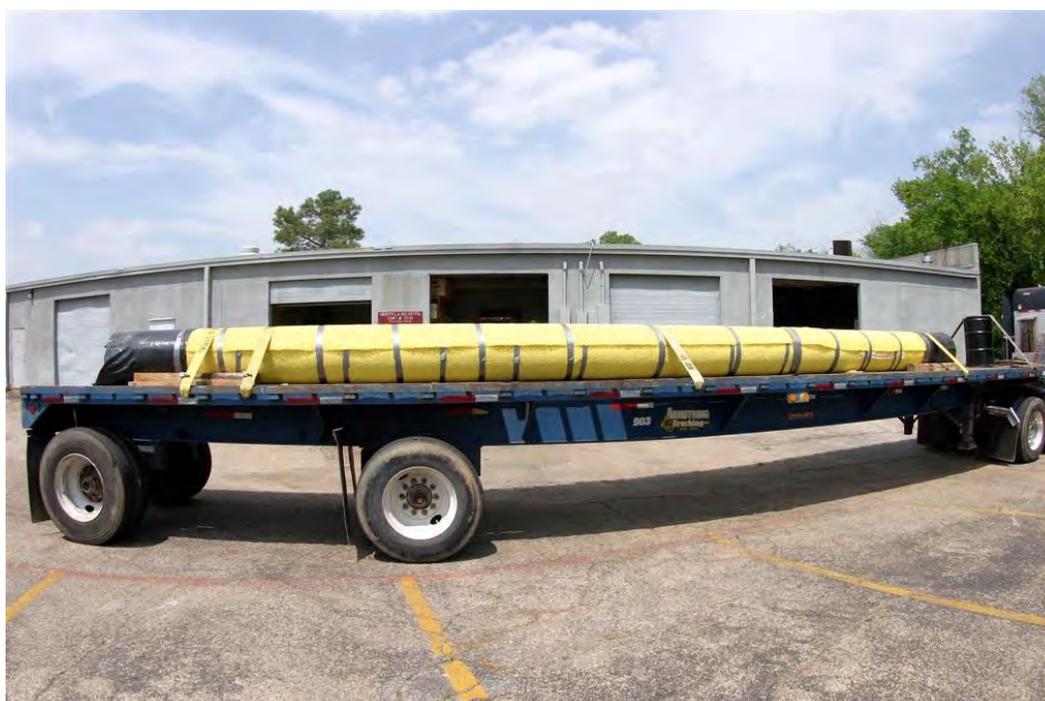
The photographs display two (2) perspective views of the pipe section in the as-received condition.

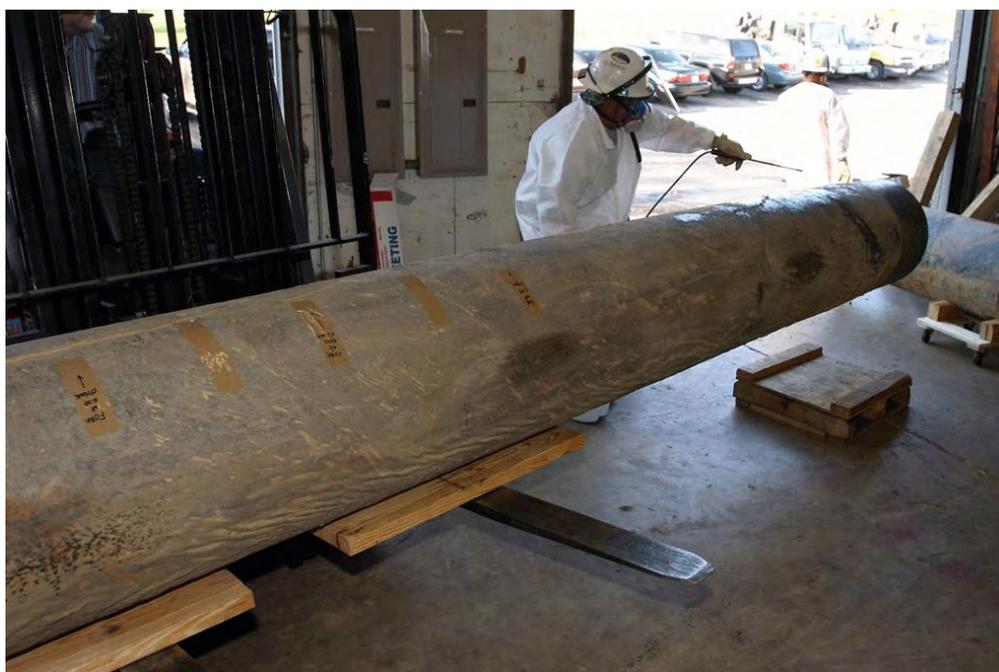
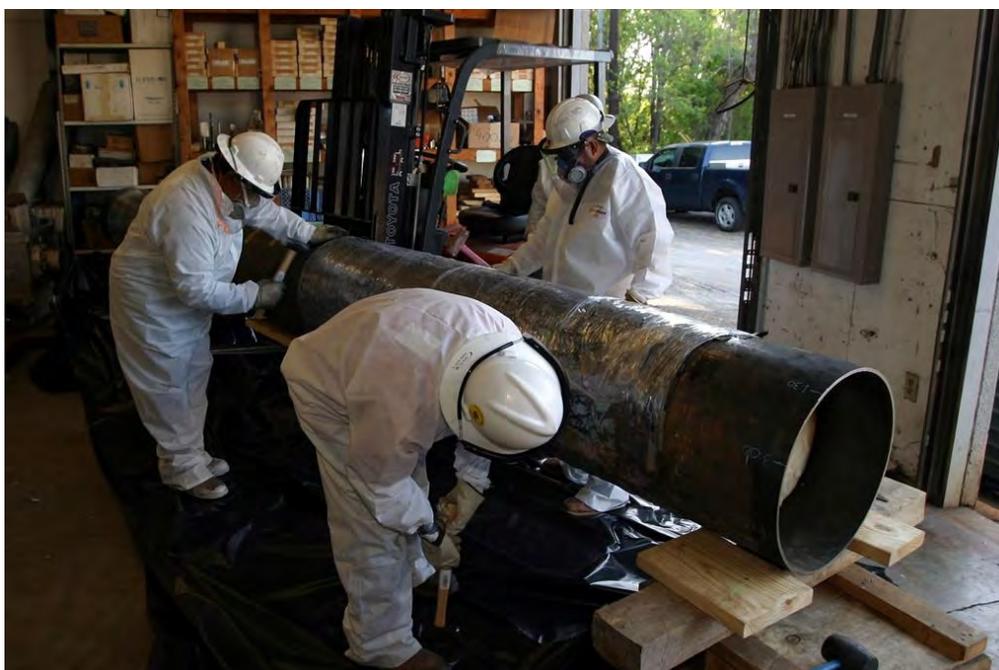
The photographs display the coating removal that was carried by impacting with steel or composite hammers.

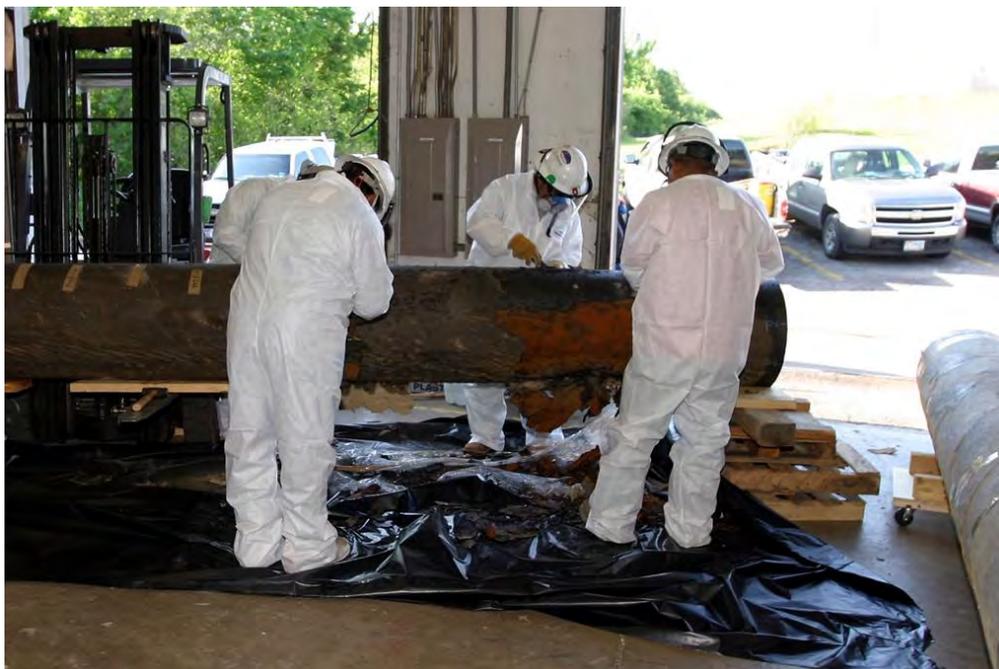
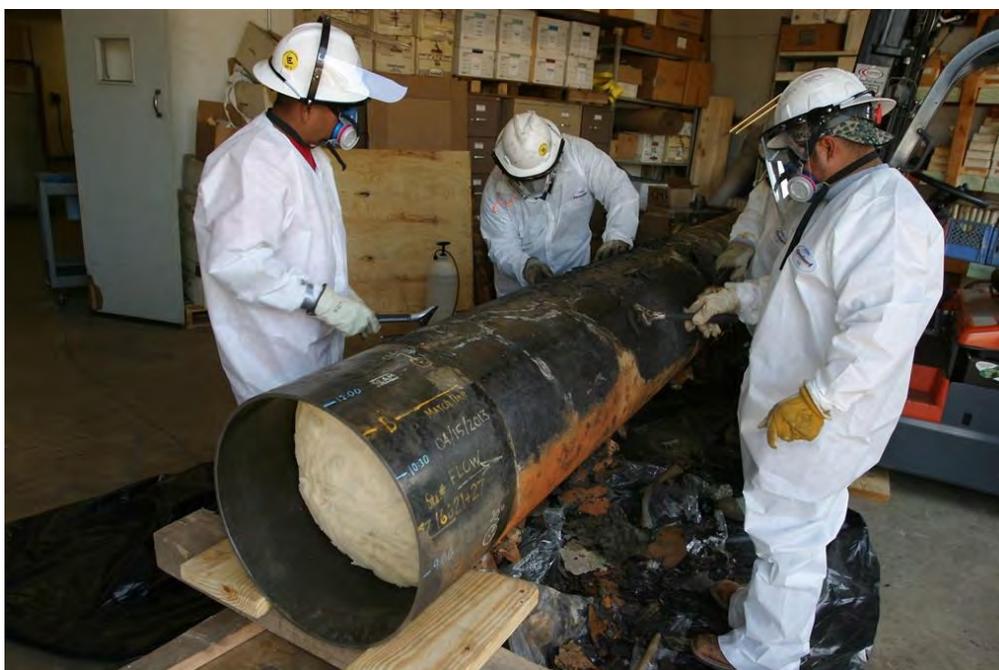
The photographs display the hand removal process of the coating which remained on the pipe after initial removal with hammer.

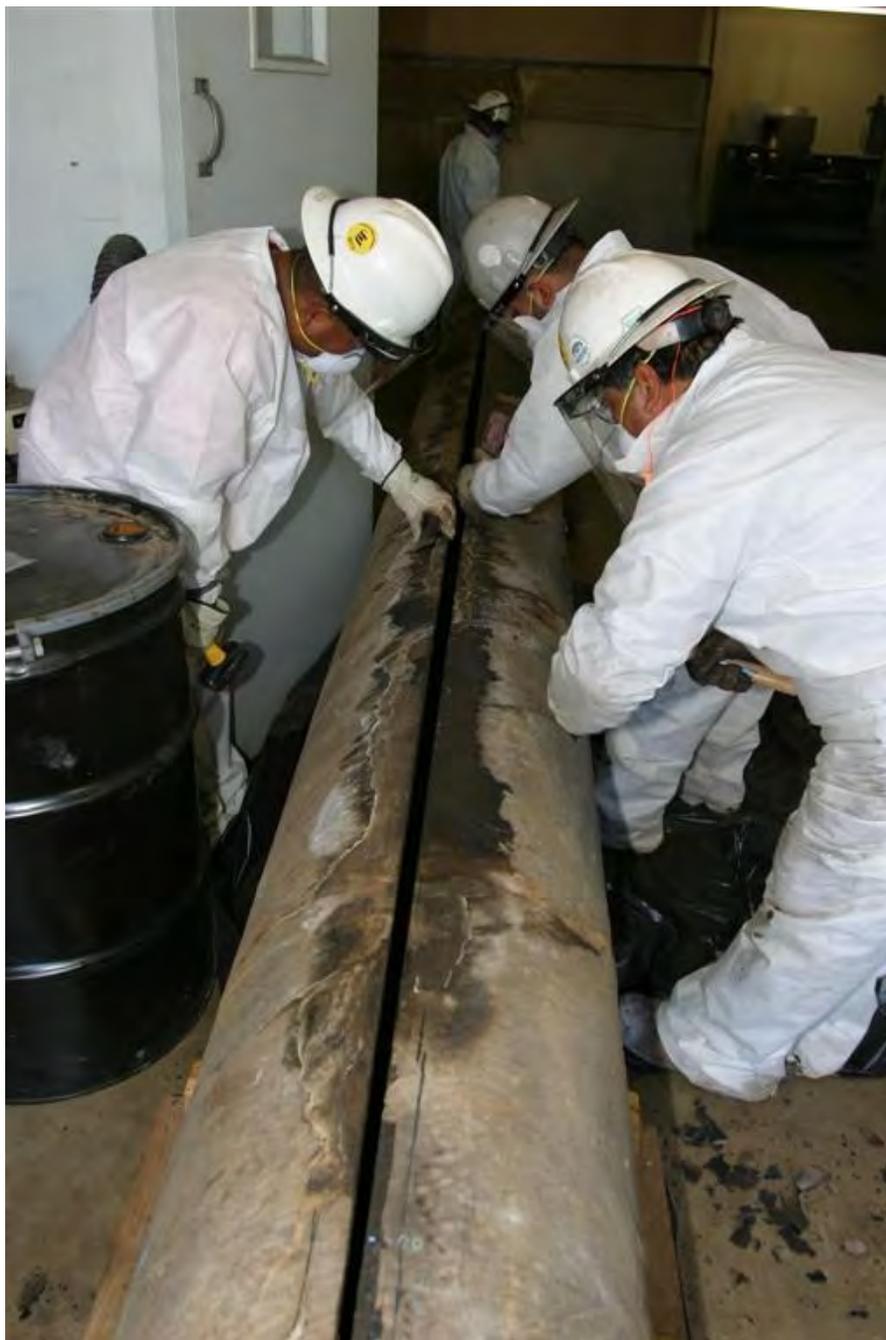
The photograph displays the careful hand removal process of the coating adjacent to the crack.

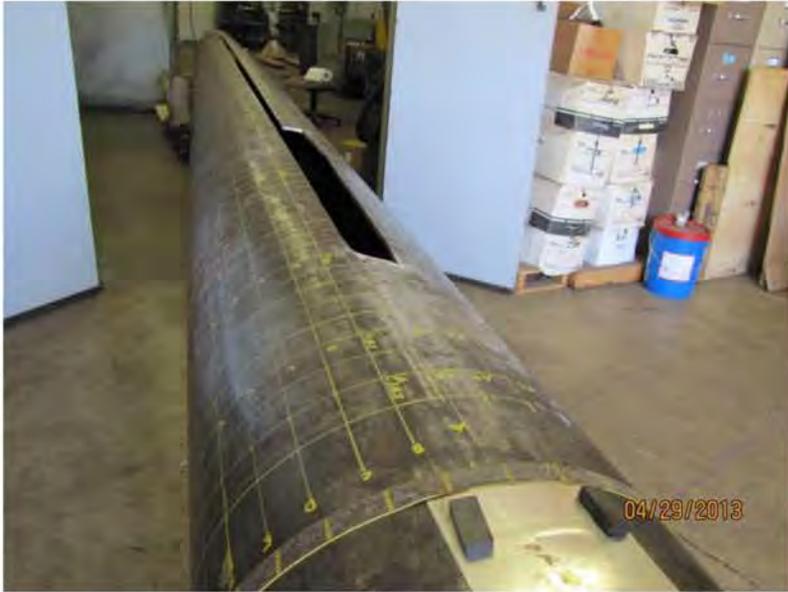
Description of photograph
	Gridded Pipe looking upstream (pipe gridded 12" downstream of rupture).
