Mechanical Damage FINAL REPORT

**U.S. Department of Transportation
Pipeline and Hazardous Materials Safety Administration
Office of Pipeline Safety**

**Integrity Management Program
Under Delivery Order DTRS56-02-D-70036
(Technical Task Order 16)**

APRIL 2009

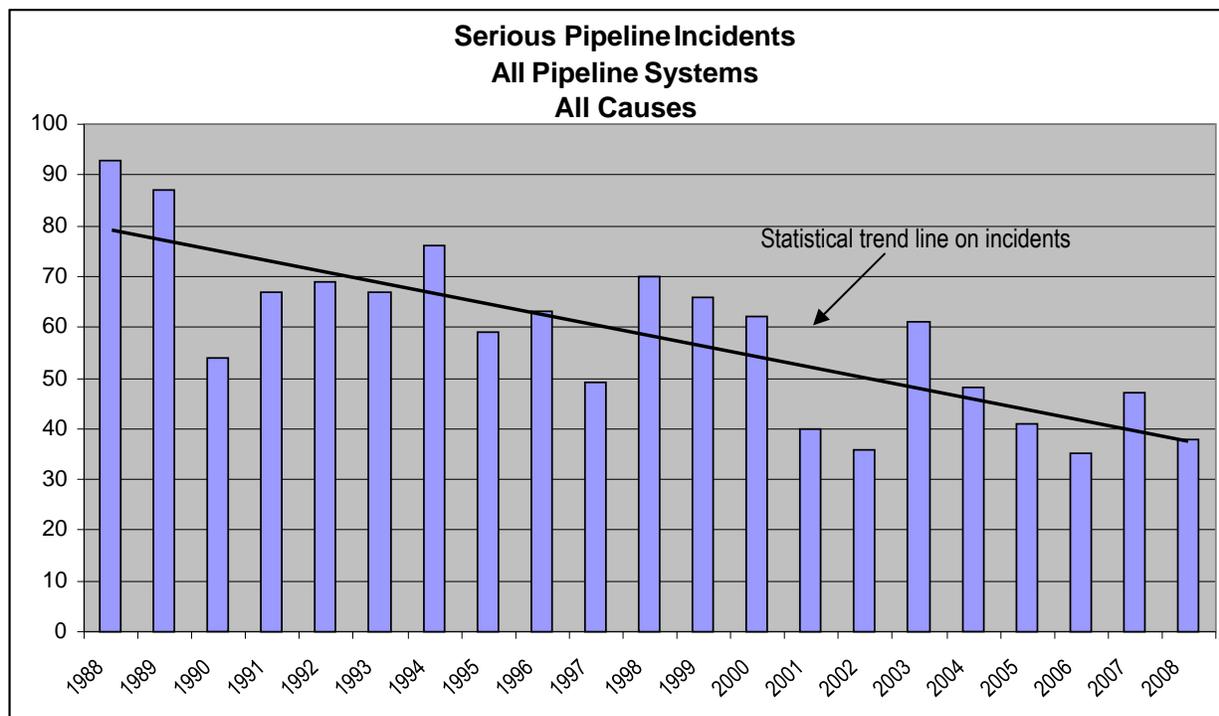
Figure 1.1 – Serious Pipeline Incidents – All pipeline systems (onshore and offshore)
Source: DOT/PHMSA Pipeline Incident Data

injury requiring in-patient hospitalization) from all causes including excavation damage, corrosion, human error, natural force damage, material failure and other outside force damage. As illustrated in Figure 1.1, the data indicates a downward trend of serious incidents from all causes on all types of pipelines from 1988-2008.

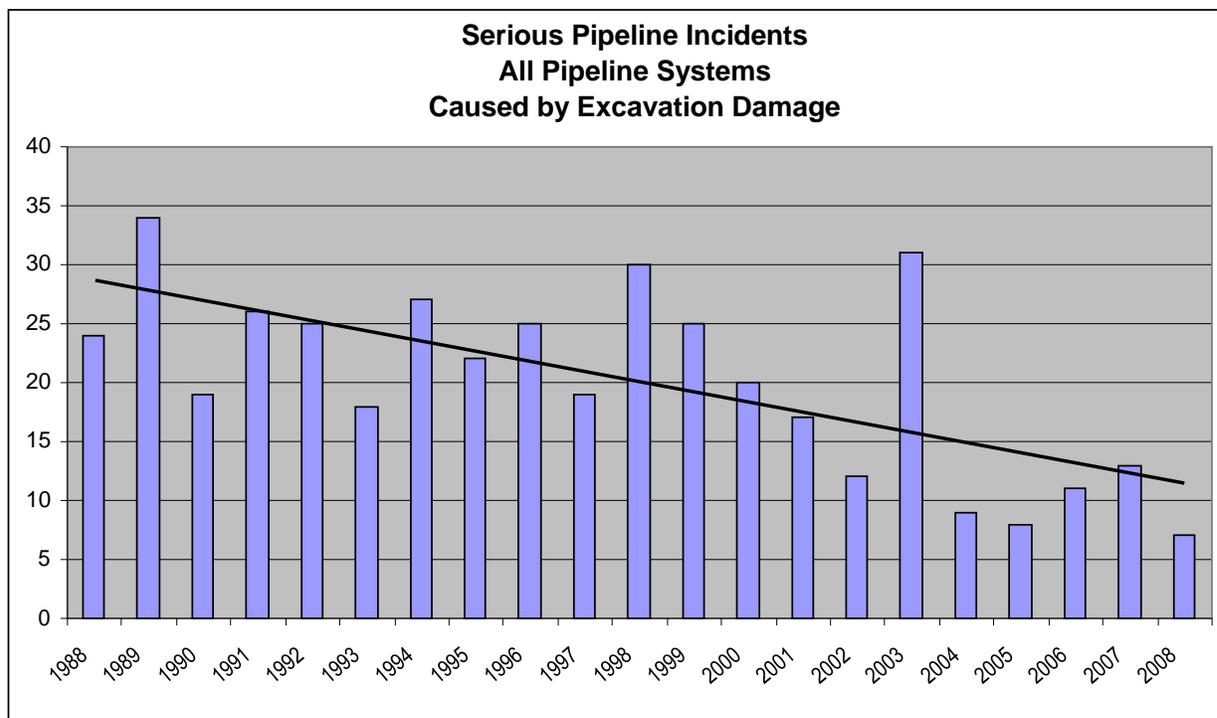
Figure 1.2 – Serious Pipeline Incidents Caused by Excavation Damage - All pipeline systems (onshore and offshore)
Source: DOT/PHMSA Pipeline Incident Data

Figure 1.2 indicates a similar trend for serious pipeline incidents caused by excavation damage for the same 20- year period. This positive trend is the result of a broad array of initiatives at all levels designed to engage all stakeholders in efforts to reduce the risk of damage to underground facilities.

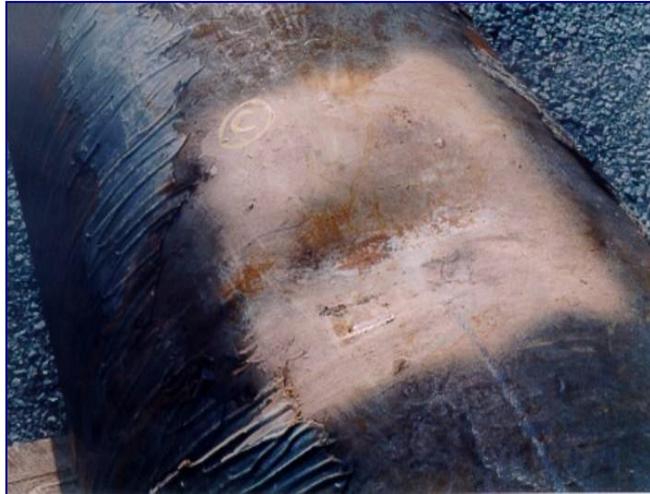
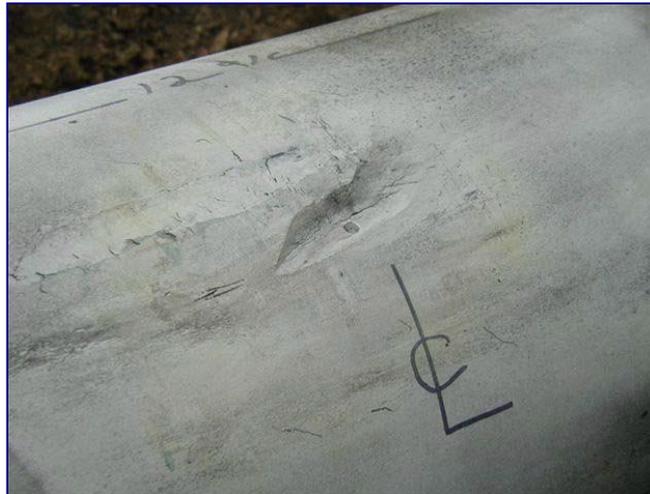
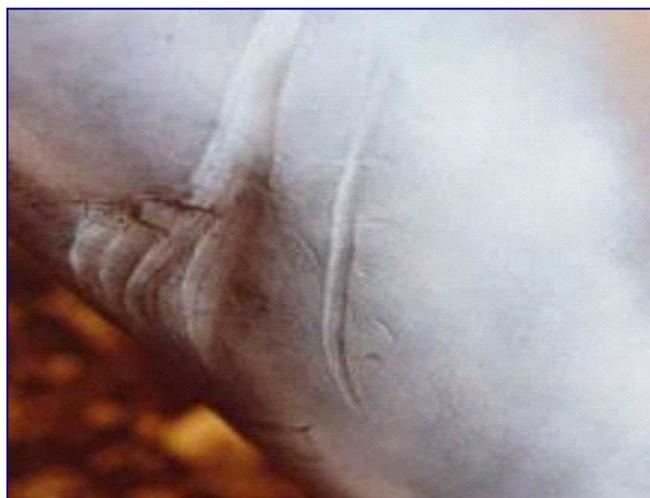
A. Dent

B. Gouge

C. Dent with Gouge

Figure 4.1 – Examples of Mechanical Damage Features

In this section, mechanical damage is discussed in three broad categories: dents, gouges, and combined dent/gouge defects. Figure 4.1 shows examples. Each mechanical damage defect reflects a unique combination of conditions, such as the indenter size and shape, as well as force, angle, orientation, and duration of impact. The different forms of damage can be generalized to facilitate assessment and prioritization of repairs, as explained below (Cosham and Hopkins, 2002).

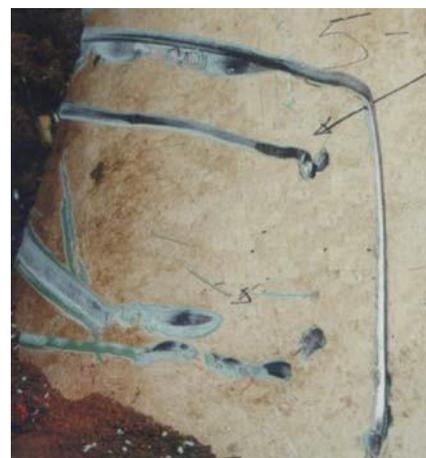
Figure 4.2 – Gouge Characteristics

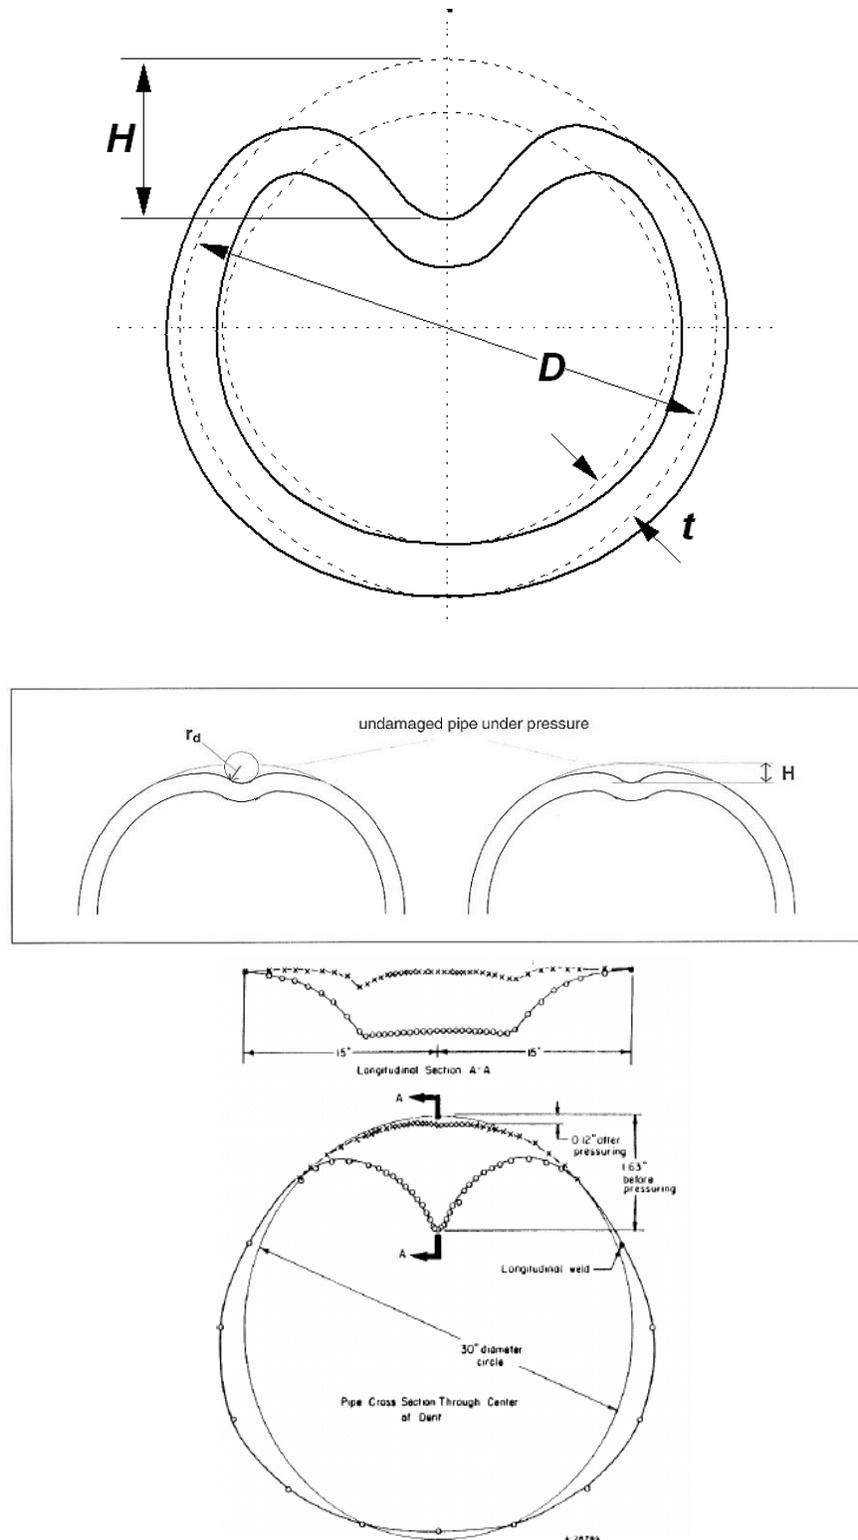
Figure 4.3 – Dent Depth Measurement (Hopkins and Leis, 2003)

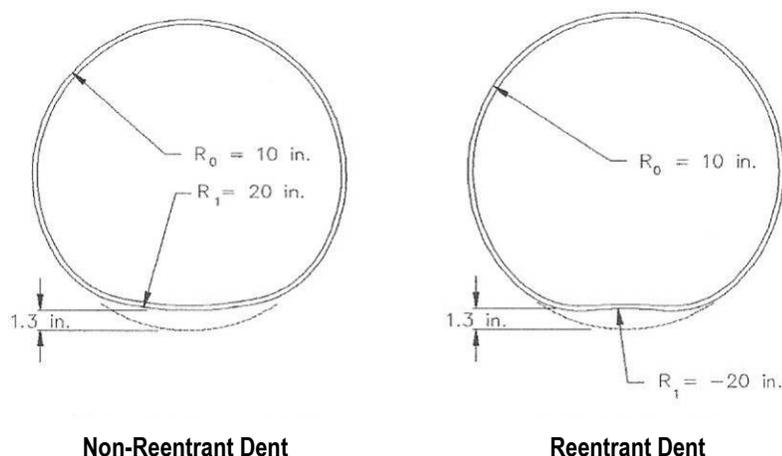
Figure 4.4 – Measurement of Re-Entrant and Non-Re-Entrant Dent Depth (Baker, Jr., M., 2004)

Dents can be described as either non-reentrant or reentrant (Figure 4.4). A positive radius value defines a non-reentrant dent, in which the outer surface of the pipe is flattened but retains its convexity. A negative radius value defines a reentrant dent, in which the outer surface of the pipe is dented deeply enough that it becomes concave. Dent shape has also been described in terms of the maximum angle subtended by the flanks of the dent (Baker, 2004)

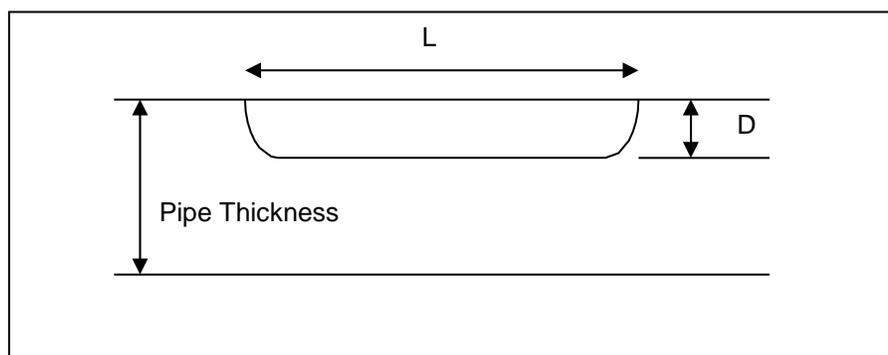
Figure 4.5 – Gouge Depth Measurement (OPS TTO10, 2004)

The geometric parameters used to characterize a gouge are the depth, length, width, and angle to axis, etc. These are usually measured from the undeformed outer radius of the pipe (Figure 4.5).

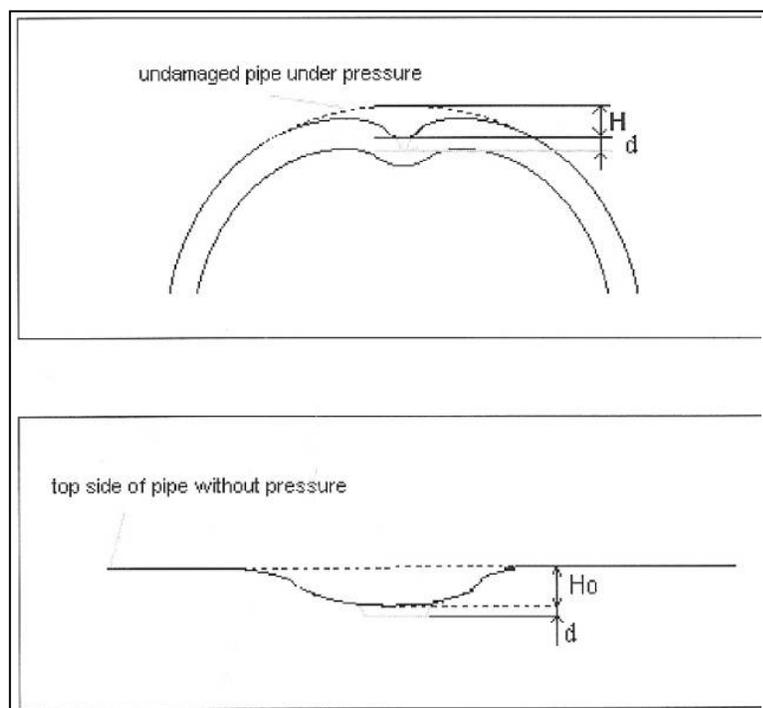
Figure 4.6 – Depth Measurement for Combined Dents and Gouges

For combined dents and gouges, the gouge length and depth are usually measured from the metal surface at the shoulder of the gouge – that is, not including the depth or length of the dent (Figure 4.6). Similarly, the depths of cracks are measured from the metal surface, excluding the depth or length of the associated dent and/or gouge. However, for assessment purposes, it sometimes may be appropriate to add the gouge and crack depths (see Section 7).

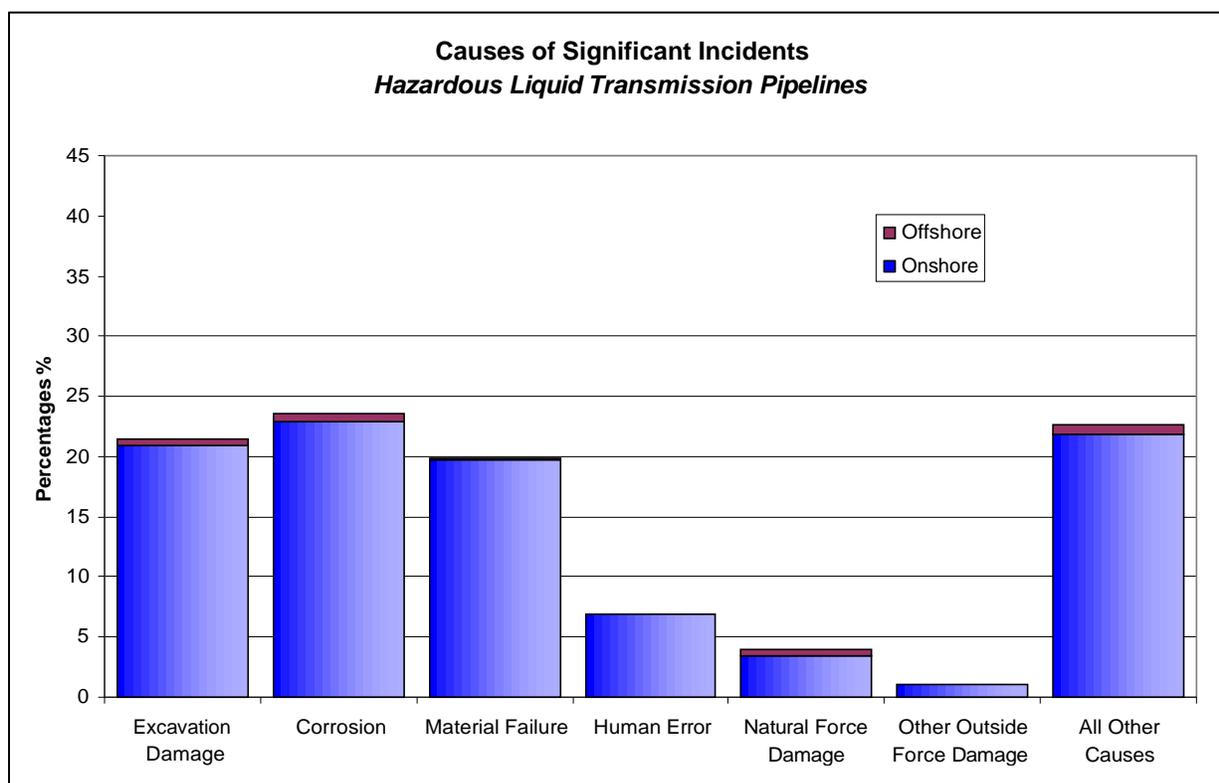
Figure 4.7 – Causes of Significant Pipeline Incidents on Hazardous Liquid Transmission Pipelines from 1988-2008
Source: DOT/PHMSA Pipeline Incident Data

Figure 4.7 shows the breakdown of significant pipeline incidents by cause for hazardous liquid transmission pipelines for the period 1988-2008. During this period, there were 43 fatalities reported and 234 injuries requiring hospitalization, all on onshore pipelines. Of these, 14, or 33 percent of fatalities, and 87, or 37 percent of inquiries, were the result of excavation damage. Only by a slightly larger percentage were fatalities and injuries attributed to “all other causes.” This category includes those incidents whose causes could not be specifically determined. Total property damage costs in excess of \$1.54 billion were reported for all liquid pipeline incidents, with 14 percent, or \$223 million, resulting from excavation damage. Eighty-five percent of the excavation damage property cost was to onshore pipelines.

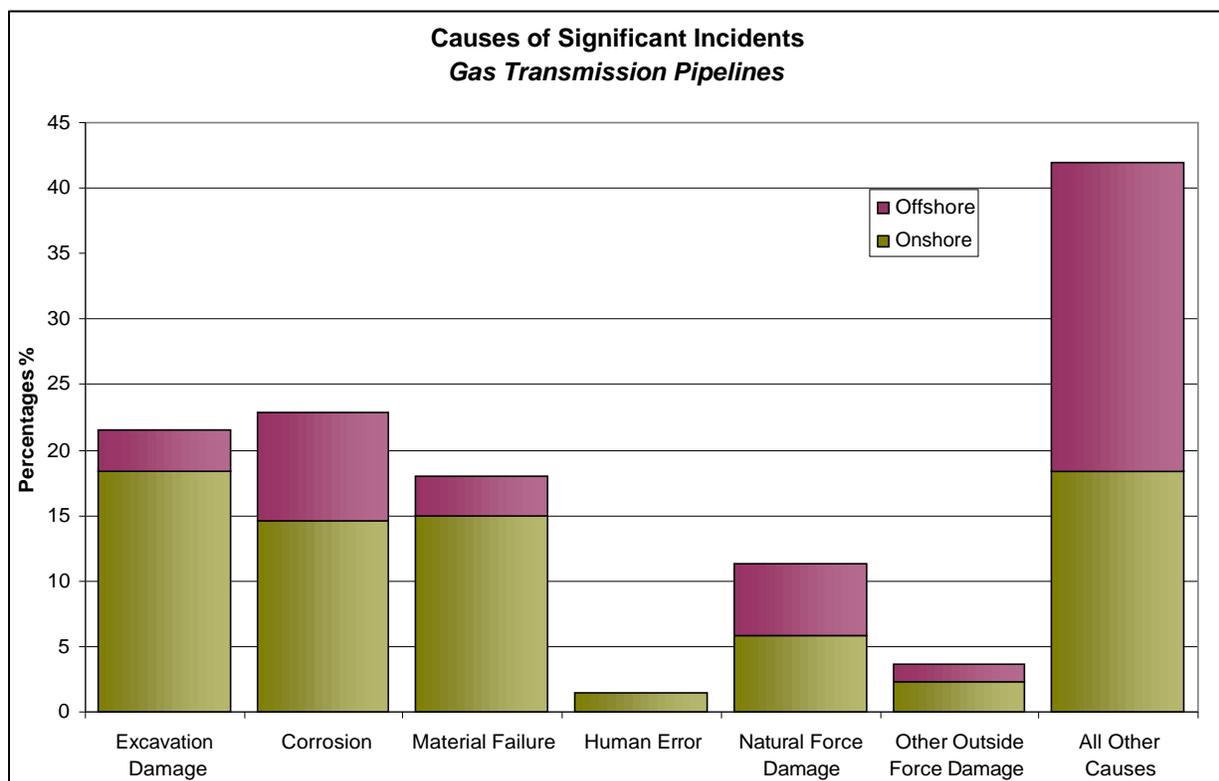
Figure 4.8- Causes of Significant Pipeline Incidents on Gas Transmission Pipelines from 1988-2008
Source: DOT/PHMSA Pipeline Incident Data

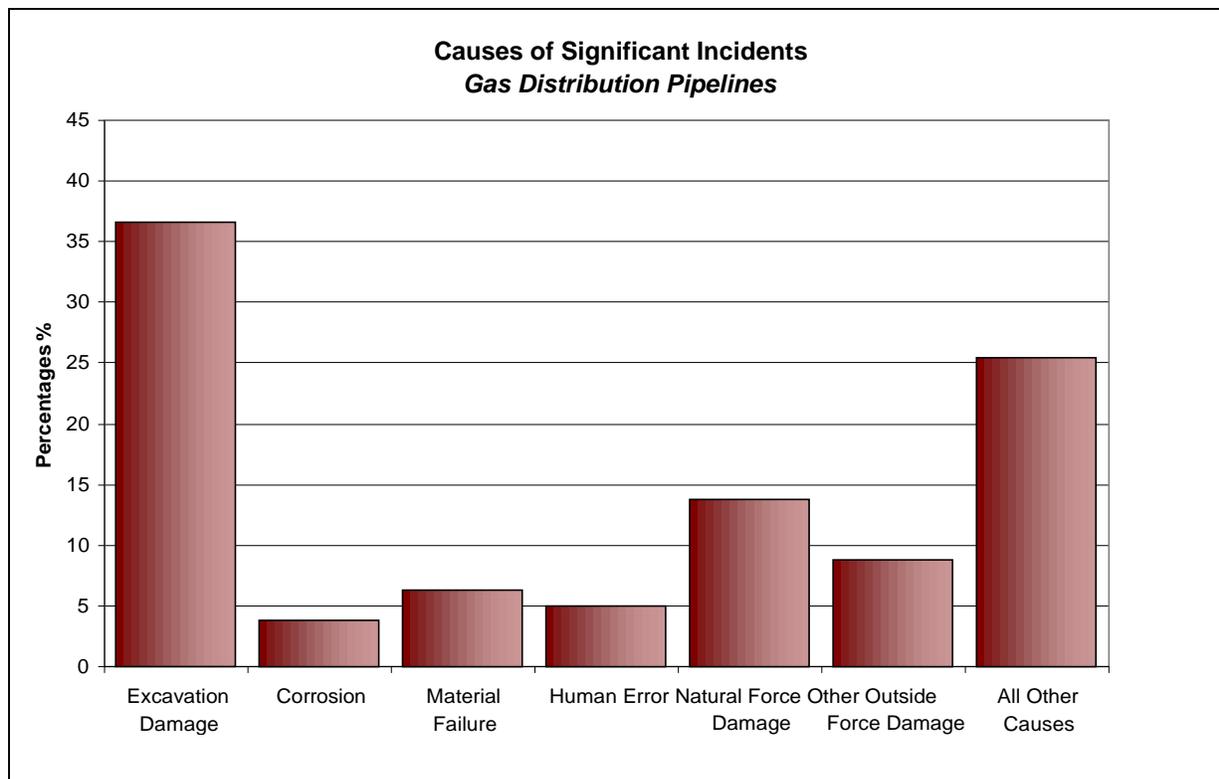
Figure 4.9 - Causes of Significant Pipeline Incidents on Gas Distribution Pipelines from 1988-2008
Source: DOT/PHMSA Pipeline Incident Data

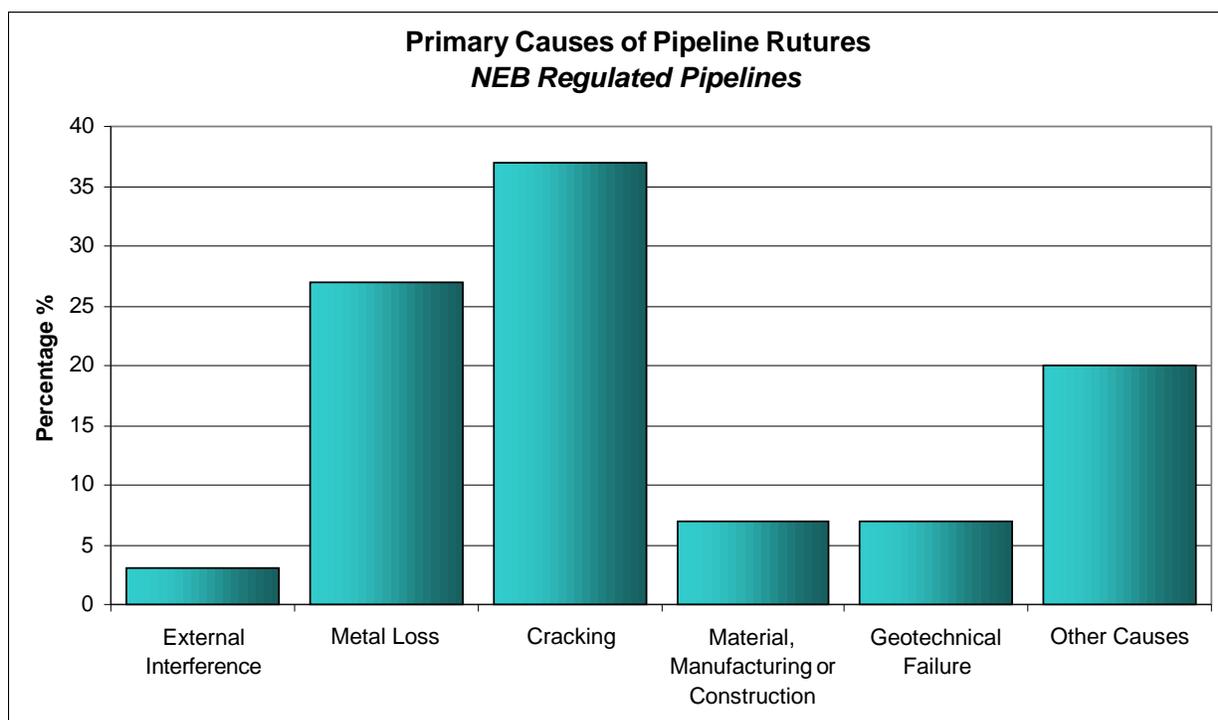
Figure 4.10 – Primary Causes of Pipeline Ruptures on NEB Regulated Pipeline (NEB, 2008)

Figure 4.10 shows that the primary cause of ruptures on pipelines regulated by Canada's National Energy Board (NEB) between 1991 and 2006 was cracking, followed by metal loss. Cracking includes hydrogen-induced and mechanical damage delayed cracking, stress corrosion, and corrosion fatigue. Metal loss includes both internal and external corrosion. The category of "Other Causes" includes improper operation, fire, and yet-to-be-determined causes. The NEB defines a rupture for natural gas pipelines as any unintended or uncontrolled release of natural gas, and as any unintended or uncontrolled release of liquid hydrocarbons associated with pipe body failure and a release volume in excess of 1.5 cubic meters. It should be noted that the total number of ruptures reported during this time period was 30, with only one rupture attributed to external interference. The low number of ruptures due to excavation damage has been primarily attributed to the remoteness of most NEB-regulated pipelines. (NEB, 2008)

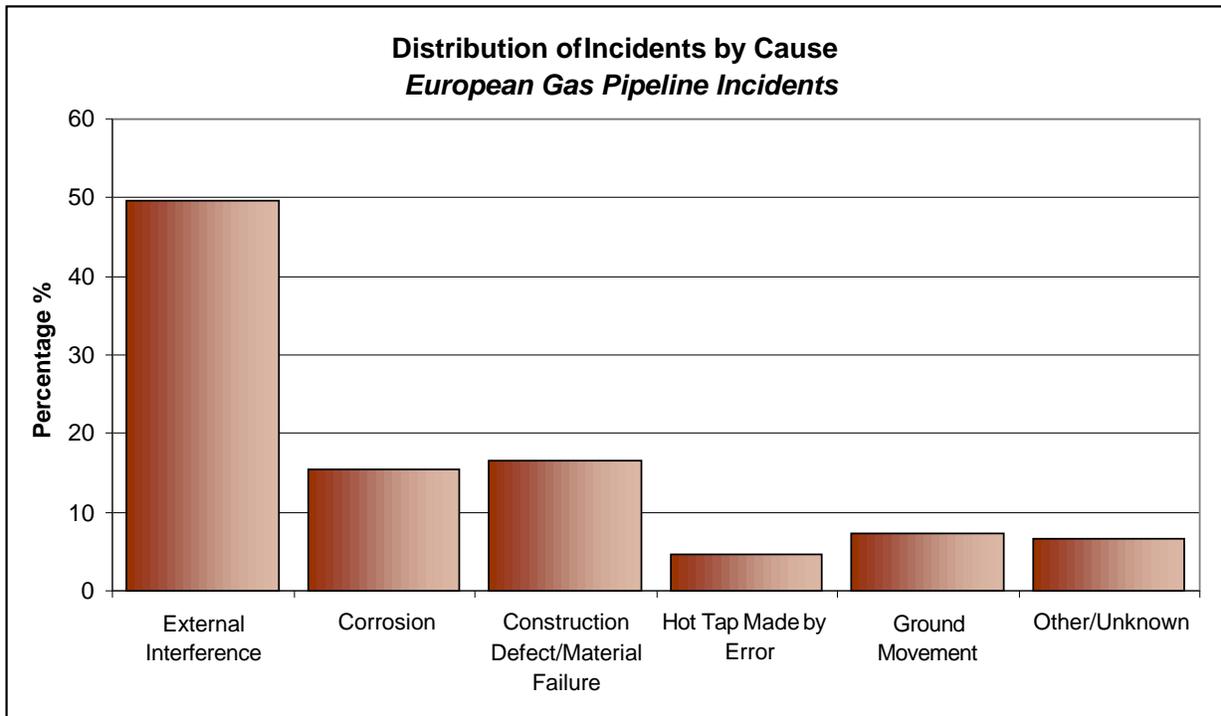
Figure 4.11 – Distribution of Incidents by Cause
(7th EGIG Report 1970-2007, Doc. No. EGIG 08.TV-B.0502, December 2008)

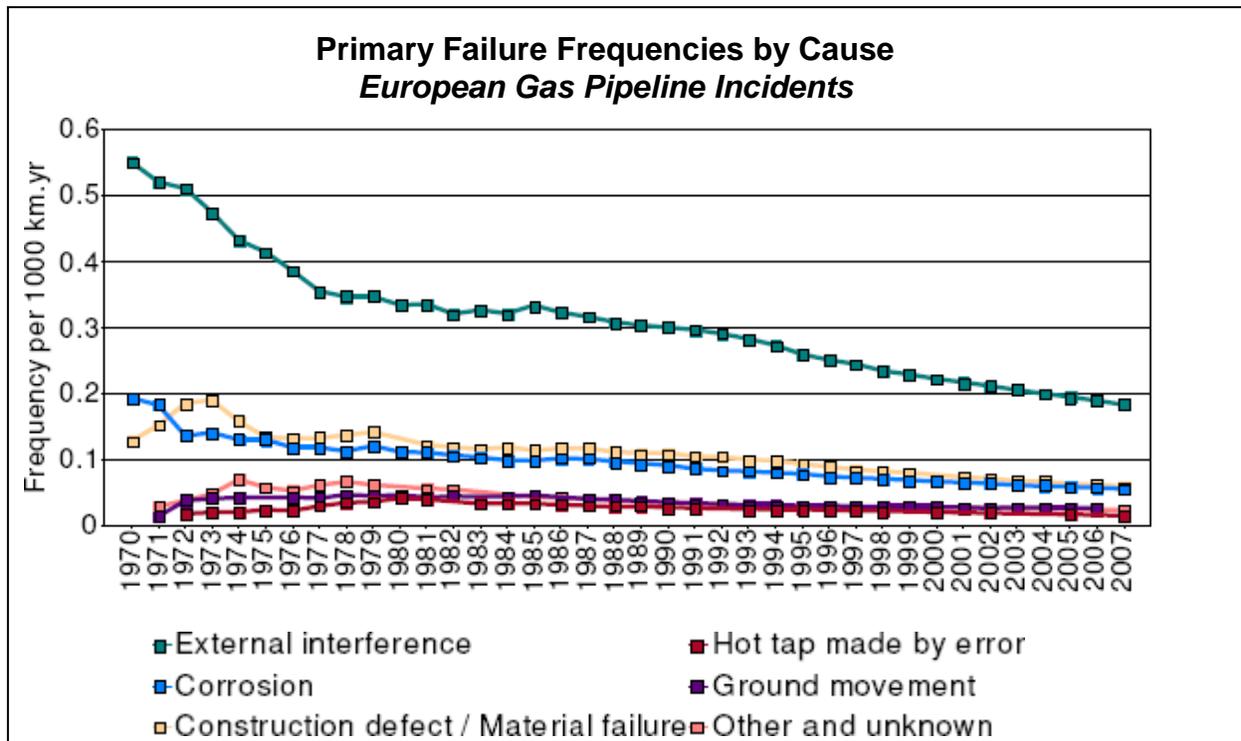
Figure 4.12– Primary Failure Frequencies by Cause - (1970-2007) The 7th EGIG Report 1970-2007, Doc. No. EGIG 08.TV-B.0502, December 2008)

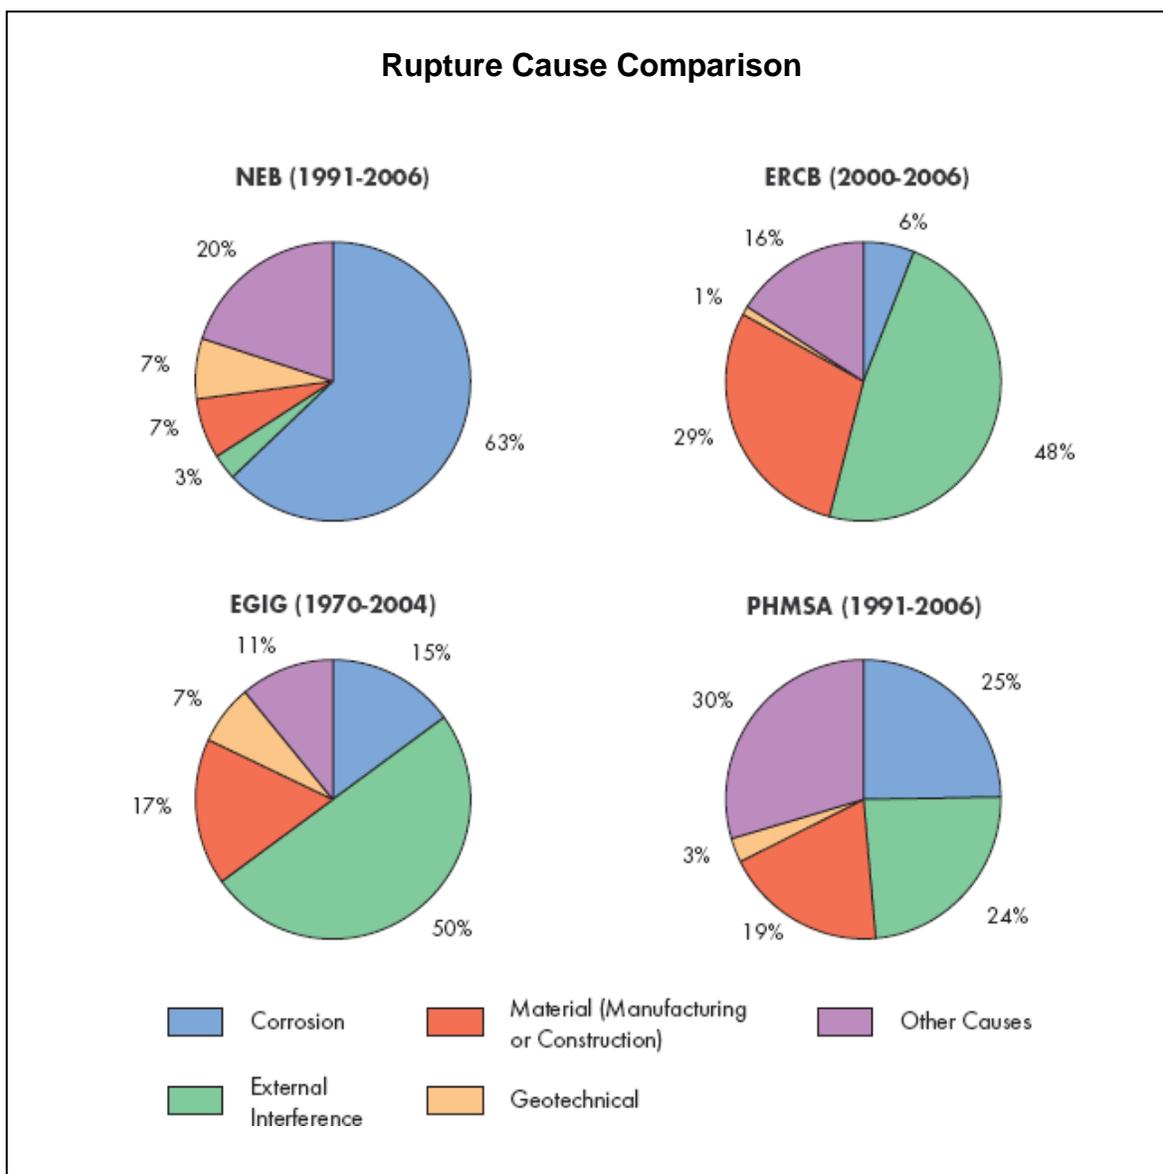
Figure 4.13 – Comparison of Pipeline Ruptures by Cause (National Energy Board, 2008)

Figure 4.13 shows the comparison of Canada's NEB-regulated pipeline ruptures since 1991 by cause to those reported by the Energy Resources Conservation Board (ERCB) (formerly the Alberta Energy and Utility Board [EUB]), EGIG, and PHMSA. Table 4.1 clarifies the definition of "rupture" for purposes of comparison. Note that the requirements for reporting vary, and there may be some differences in terminology. While each organization reports different time frames over which rupture causes are examined, the results suggest that the leading cause of ruptures generally remains constant over time.

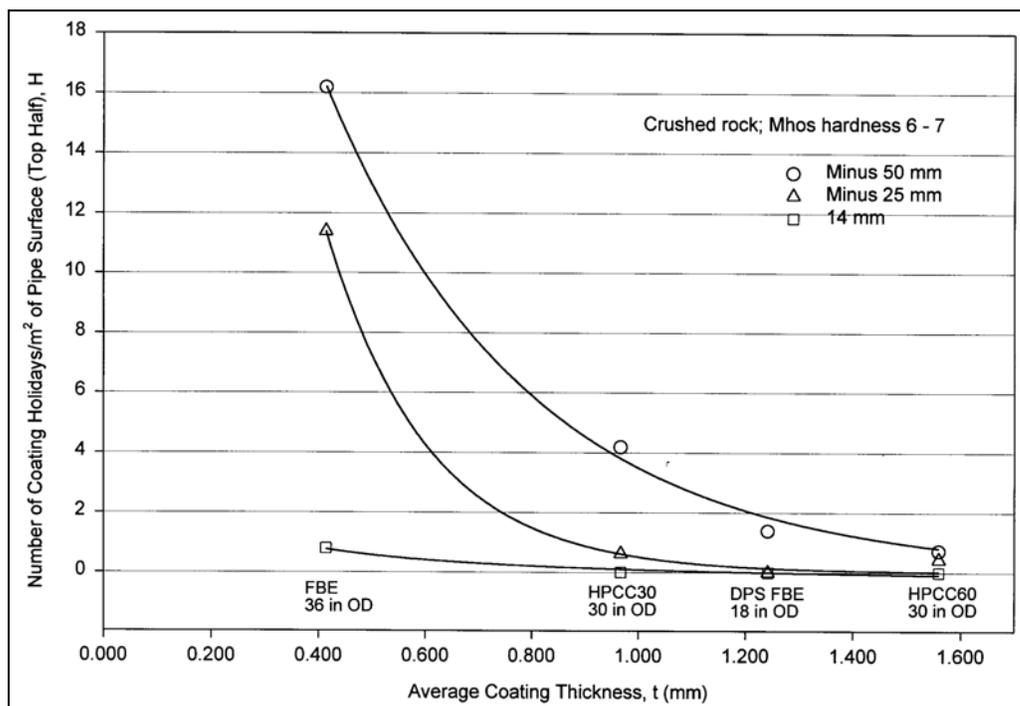
Figure 5.2 – Number of Coating Holidays/m² of Pipe Surface (top half) Caused During a 12 Day Test of Coating Performance on Buried Pipe

coating type. A quantitative relationship between coating damage and coating thickness was defined, as shown in Figure 5.2.

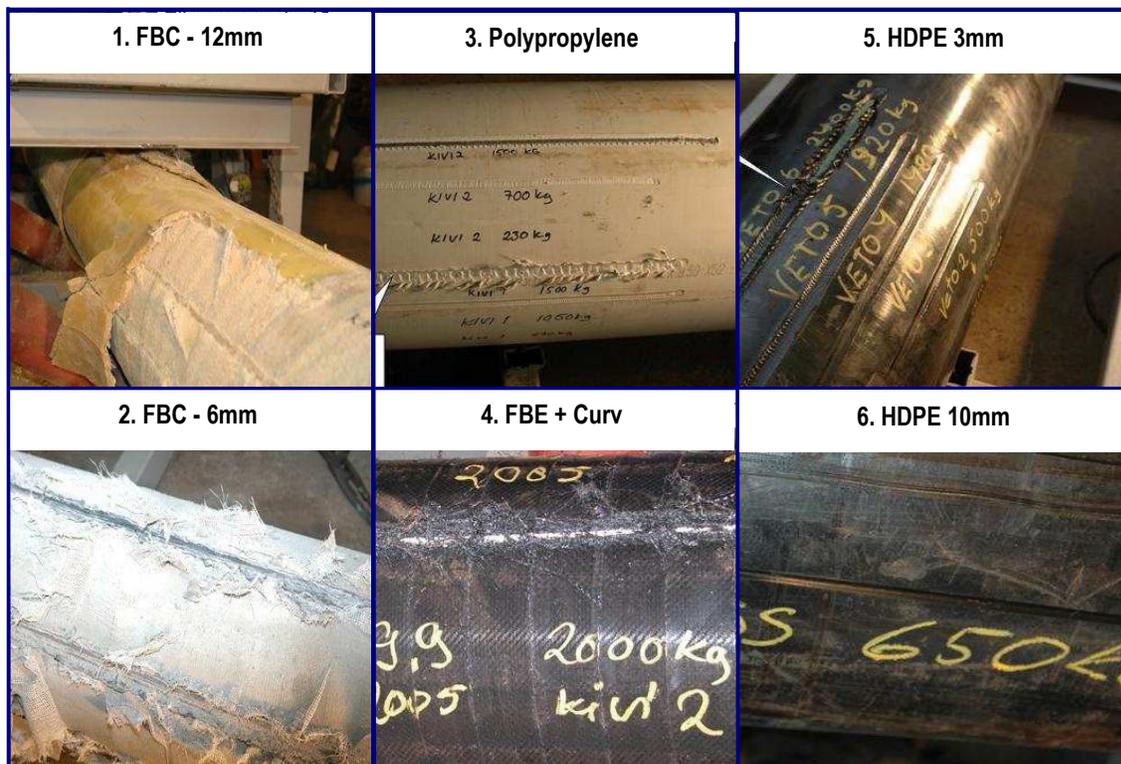
Figure 5.3 – Pipeline Coatings Tested for Severe Construction Conditions (Christianson, 2006)

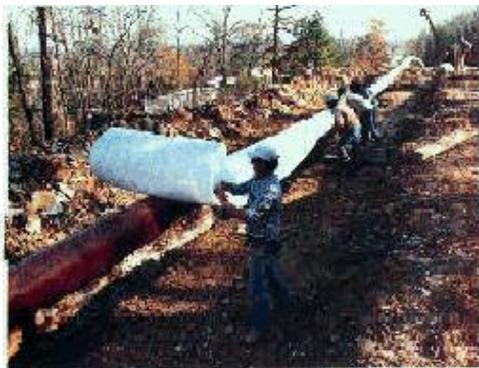
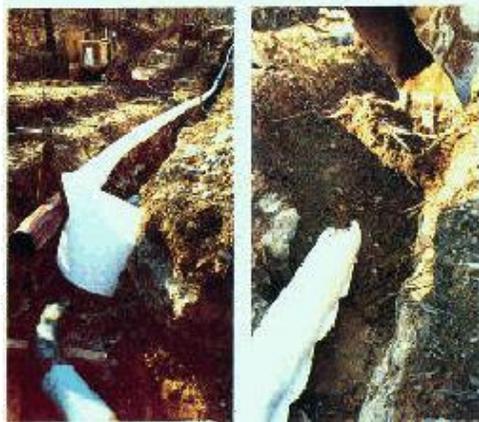
Composite Foam Cushion Wrap
(<http://www.farwestcorrosion.com>)

Rock Shields. There are a variety of coating types that are meant to protect the pipe from being damaged by rocks in the backfill. Many are wraparound products, similar in many respects to the geotextiles discussed above. Others are flexible mats placed above, below, or around the pipe. Still others are sprayed on in the ditch. Figure 5.4 illustrates such examples.

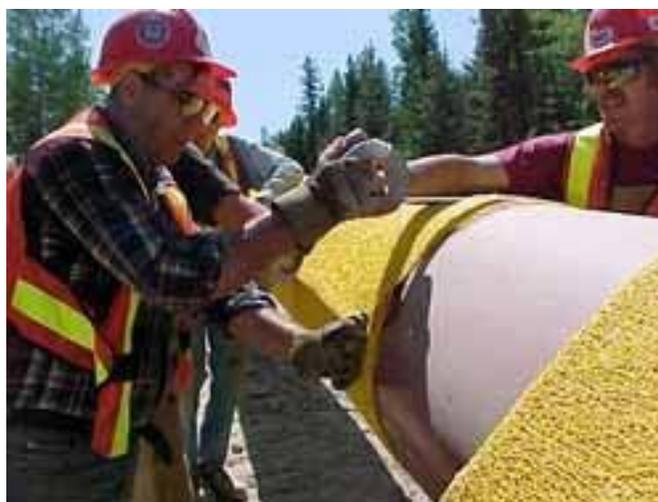
Wrapped Rock Shield (<http://www.tuff-n-enough.com>)

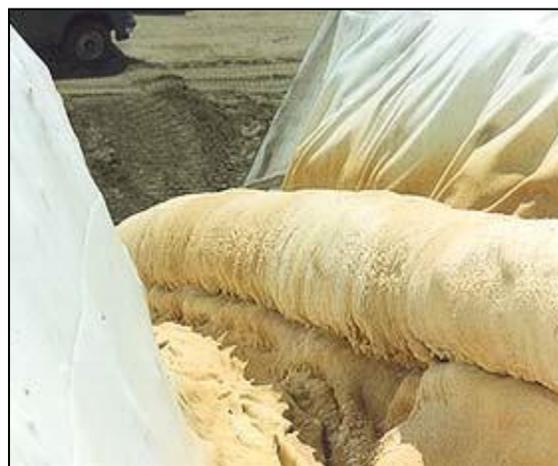
Polyurethane Foam Rock Shield (<http://www.pedero.com/>)

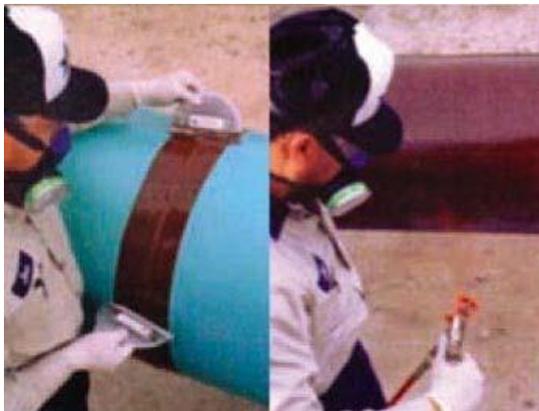
Figure 5.5 – Powercrete® pipeline coating application (<http://www.petropages.com/vendors/v19548.htm>)

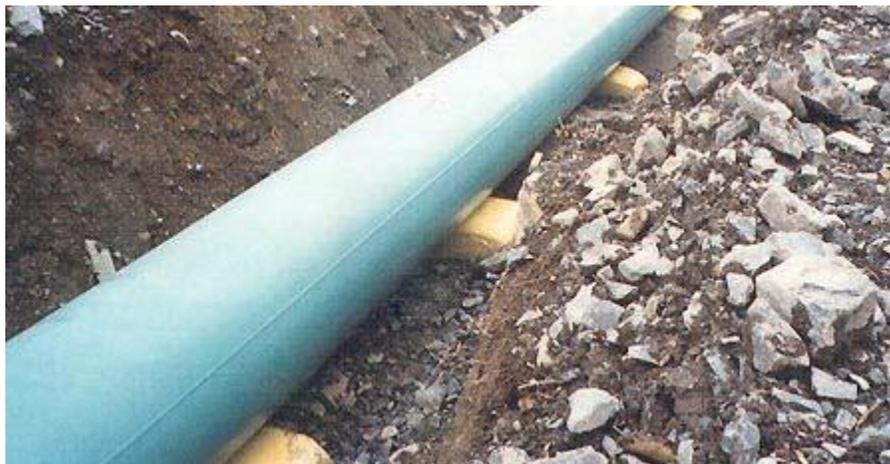
Figure 5.6 – Pipeline on Foam Supports (<http://www.pedero.com>)

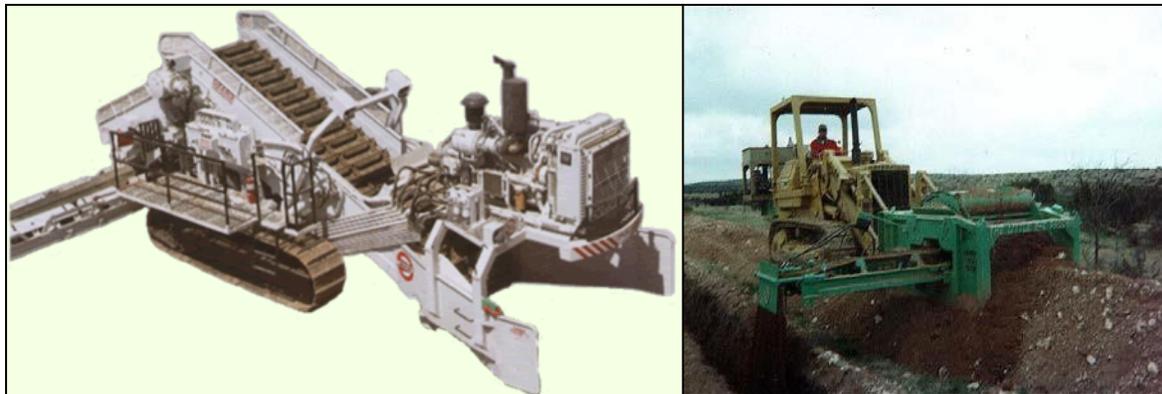
Figure 5.7 – Backfill Screening and Padding Machines
[\(http://www.ozzies.com/](http://www.ozzies.com/) (left); <http://www.ezpadding.com/> [right]).

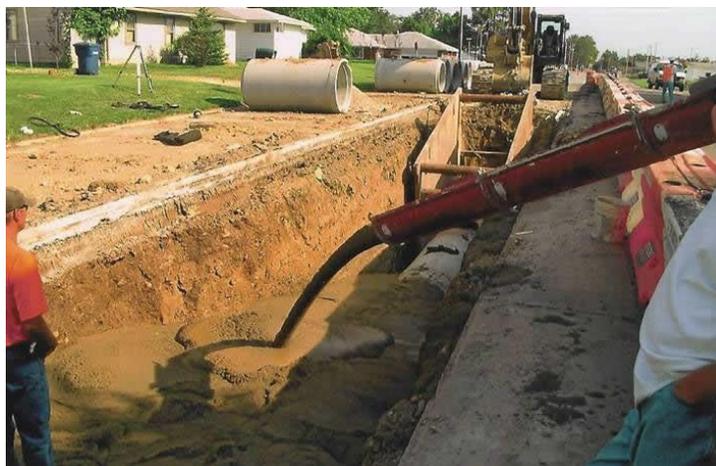
Figure 5.8 – Flowable fill being poured to fill the pipe excavation area. (<http://www.irmca.com/Topics/flow.asp>)

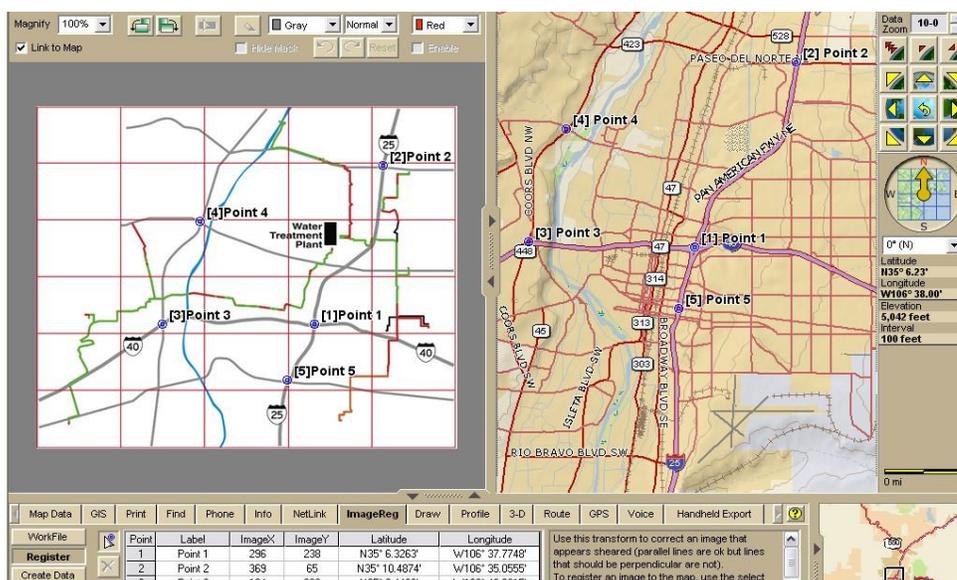
Figure 5.10 – GIS Image of a Pipeline Network

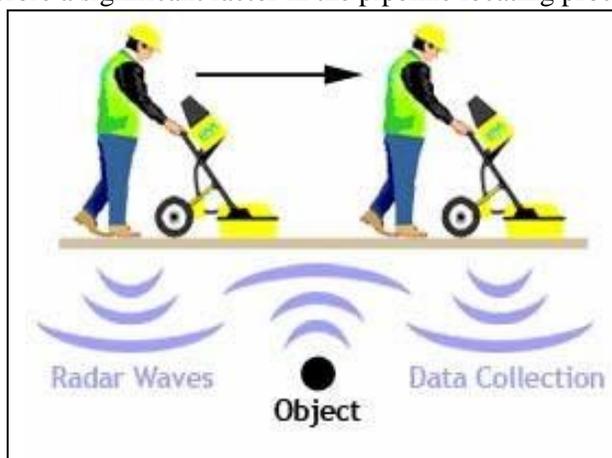
Figure 5.12 – Ground Penetrating Radar (GPR)
Technique (Courtesy: <http://www.worksmartinc.net>)

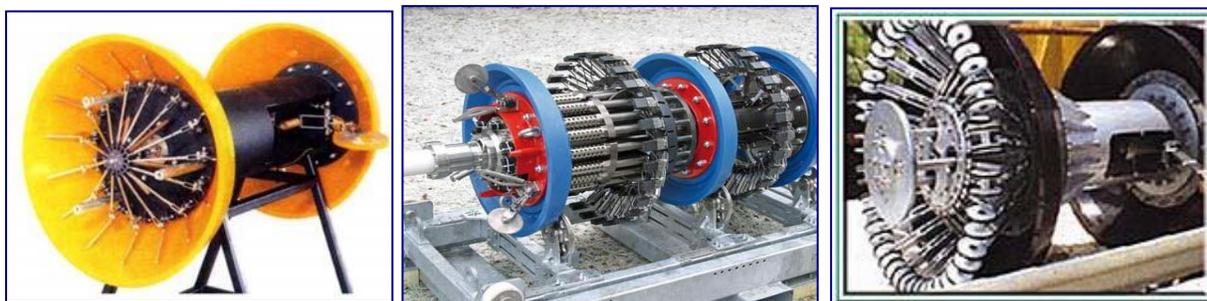
Figure 6.1 – Mechanical Caliper Tools (photos courtesy of Enduro, Rosen, and RAS GmbH)

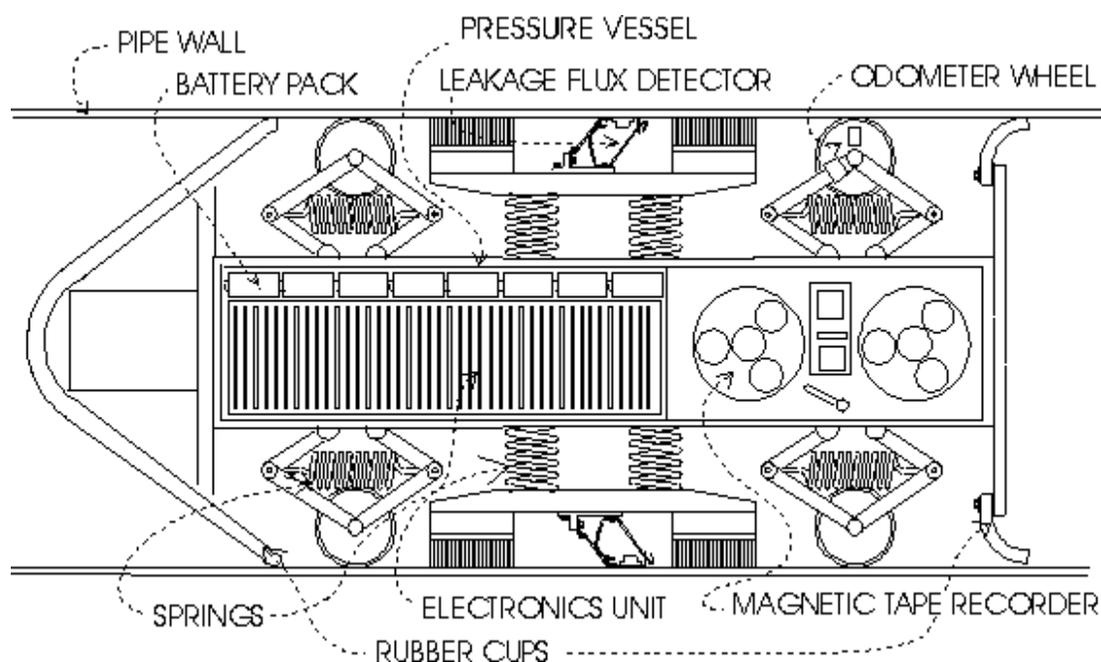
Figure 6.2 – Schematic of MFL Principle (Clapman et al., 2002)

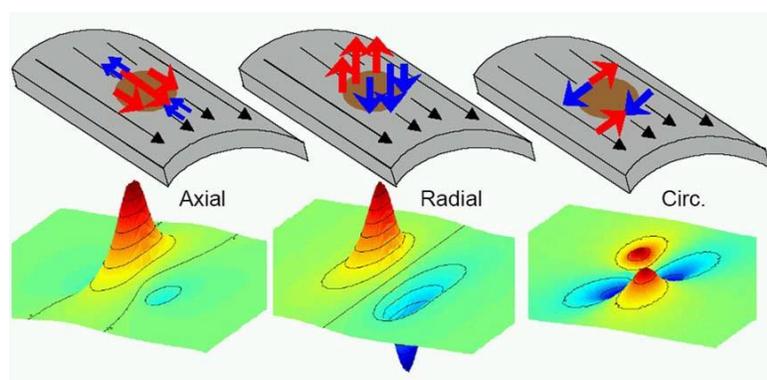
Figure 6.3 – Example of Axial, Radial and Circumferential MFL Signal at Metal Loss Region.

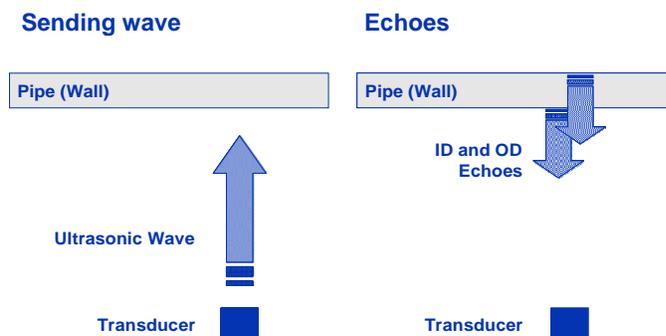
Figure 6.4. Ultrasonic Wall Thickness Concept

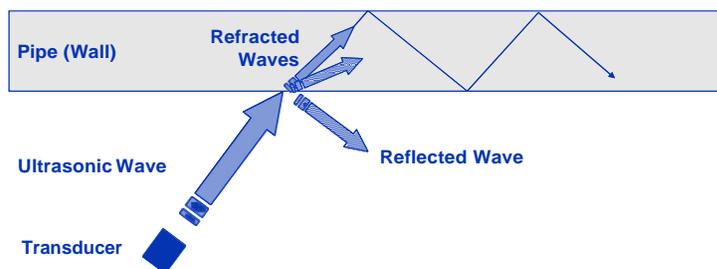
Figure 6.5. Ultrasonic Shear Wave

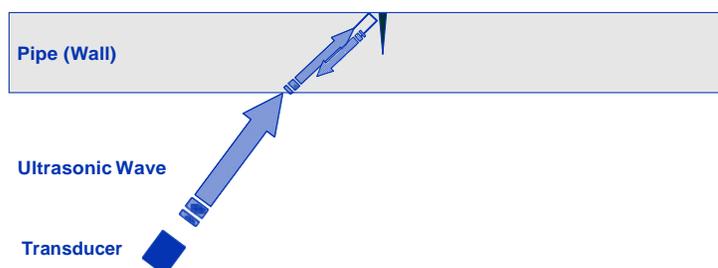
Figure 6.6. Ultrasonic Wave Reflection from Crack

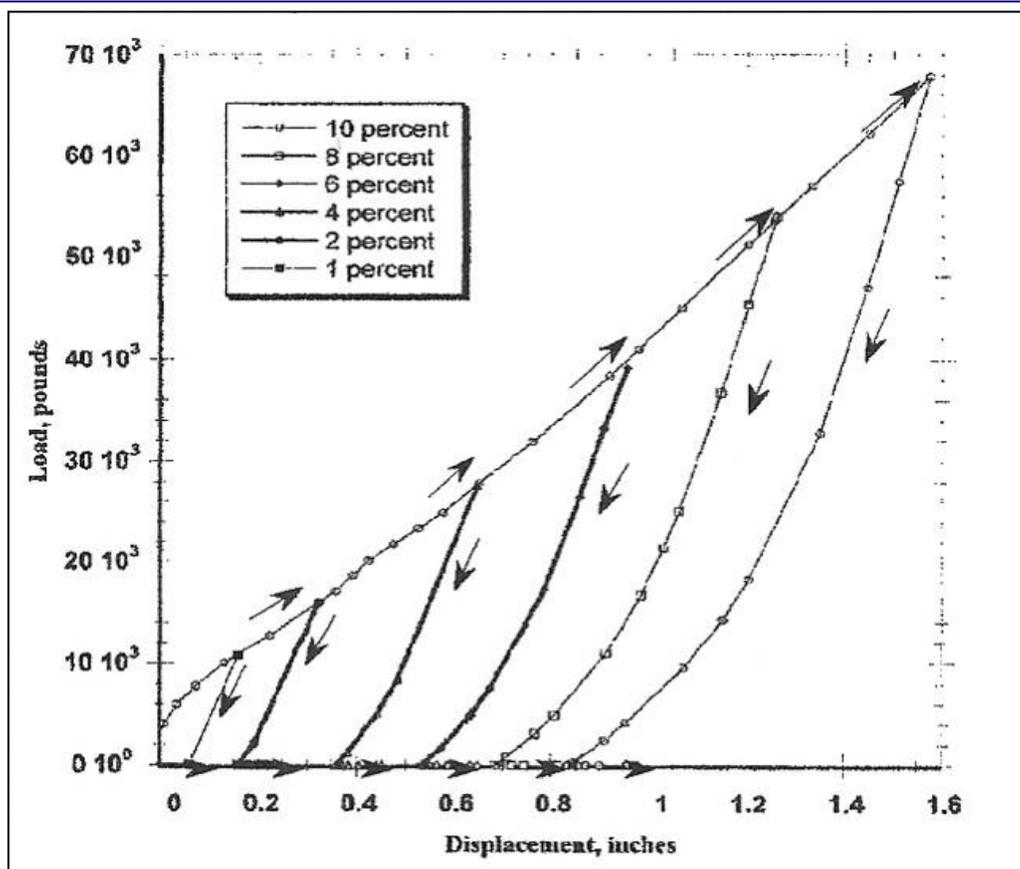
Figure 7.2 – Effect of Initial Dent Depth on Load-Displacement Behavior During Denting and Re-Rounding (Leis and Hopkins, 2003)
