Mechanical Damage FINAL REPORT

**U.S. Department of Transportation
Pipeline and Hazardous Materials Safety Administration
Office of Pipeline Safety**

**Integrity Management Program
Under Delivery Order DTRS56-02-D-70036
(Technical Task Order 16)**

APRIL 2009

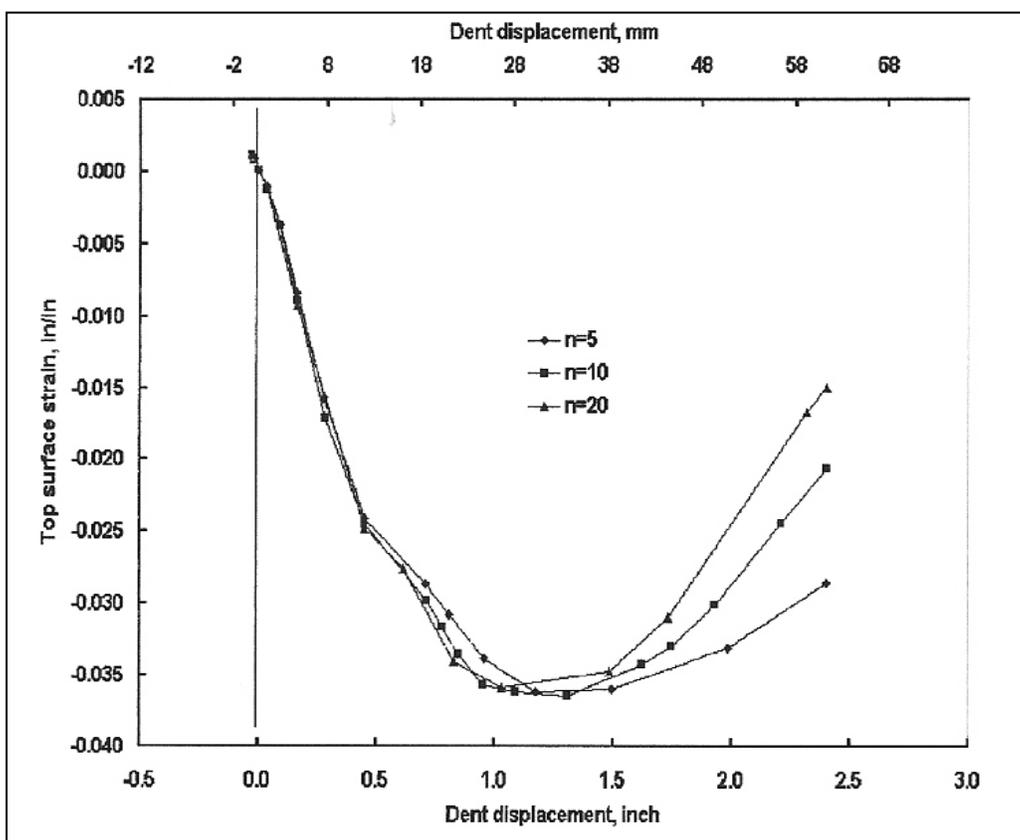
Figure 7.3 – Non-Linear Relationships Between Strain and Displacement at the Outside Centre of a Dent, During Denting to 8% of the Pipe Diameter (Leis and Hopkins, 2003)

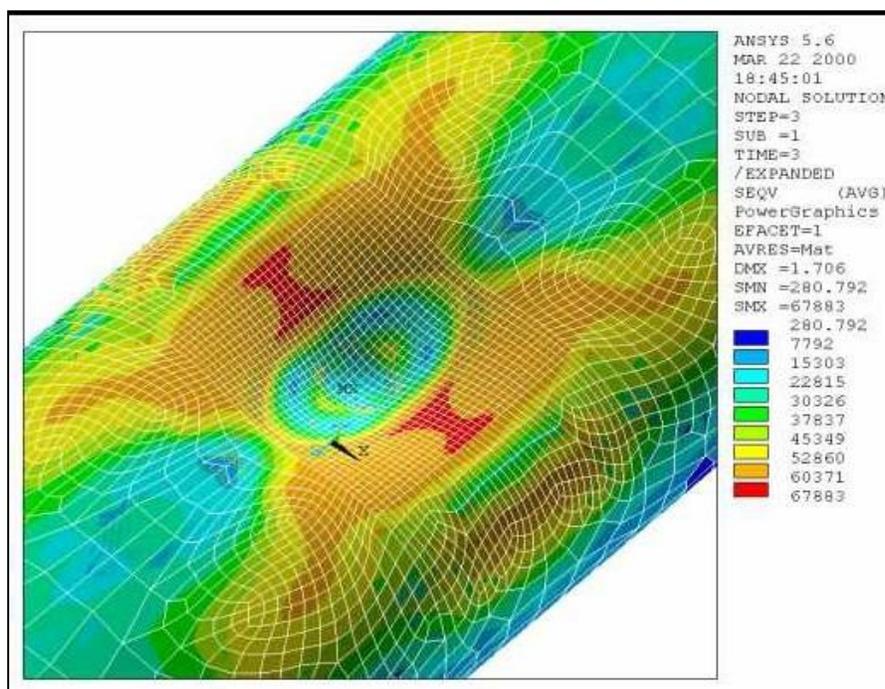
Figure 7.4 – Finite Element Model of Stress Distribution Around a Re-Rounded Dent (Ironside and Carroll, 2002)

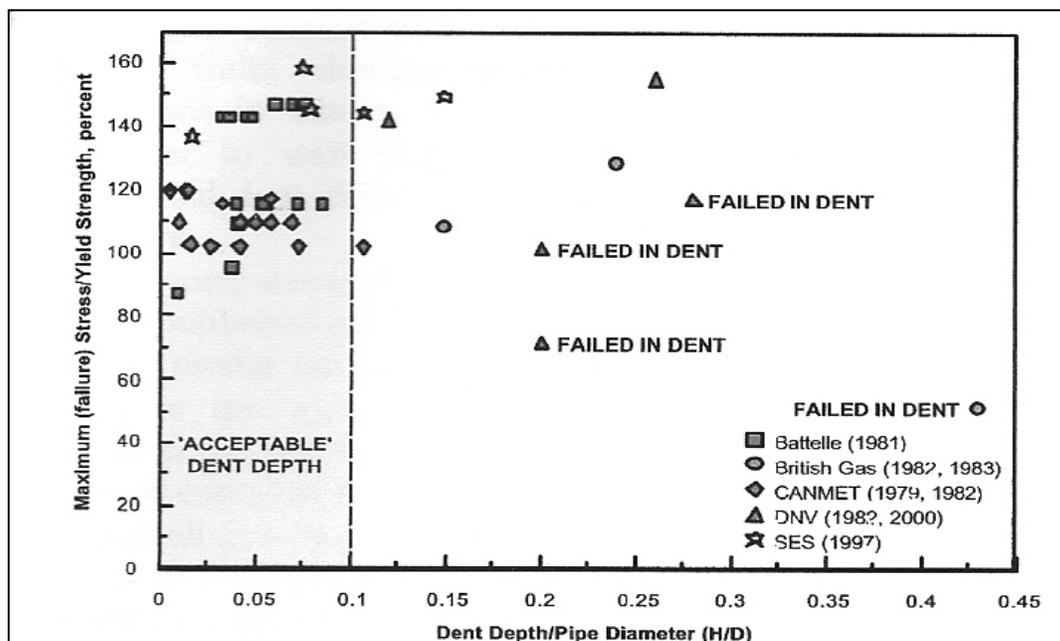
Figure 7.5 – Failure Behavior in Full-Scale Tests on Plain Dents (Cosham and Hopkins, 2004)

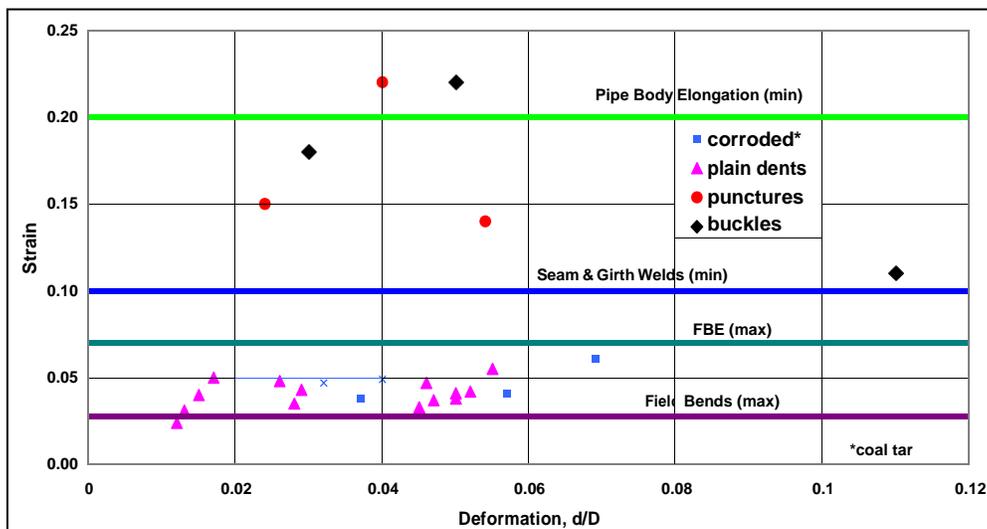
Figure 7.6 – Observed Relationship Between Strain Component, Degree of Damage, and Dent Depth (Rosenfeld, Pepper, and Lewis, 2002)

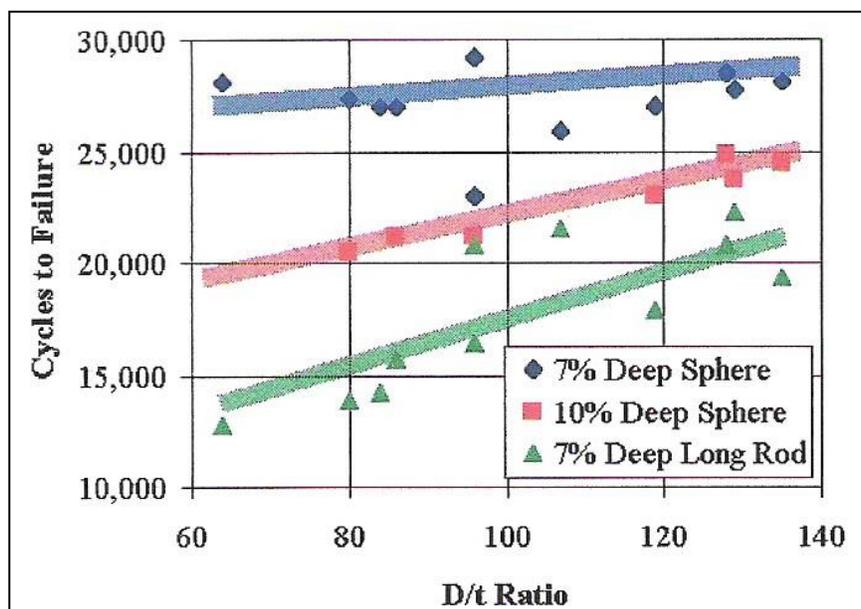
Figure 7.7 – Effect of D/t Ratio and Damage Type on the Fatigue Life of Plain Dents (Dinovitser et al.,2002)

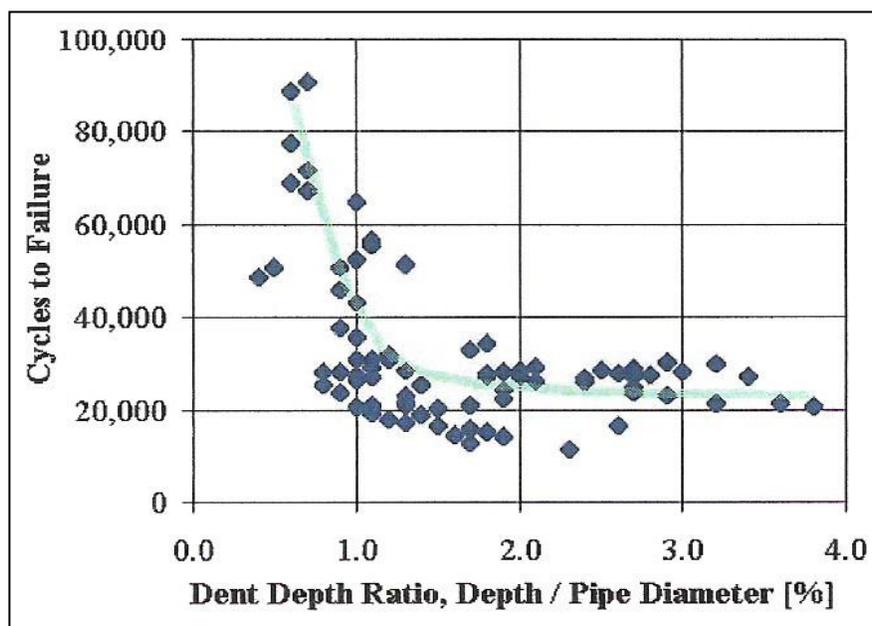
Figure 7.8 – Effect of Dent Depth on Fatigue Life of Plain Dents (Dinovitser et al.,2002)

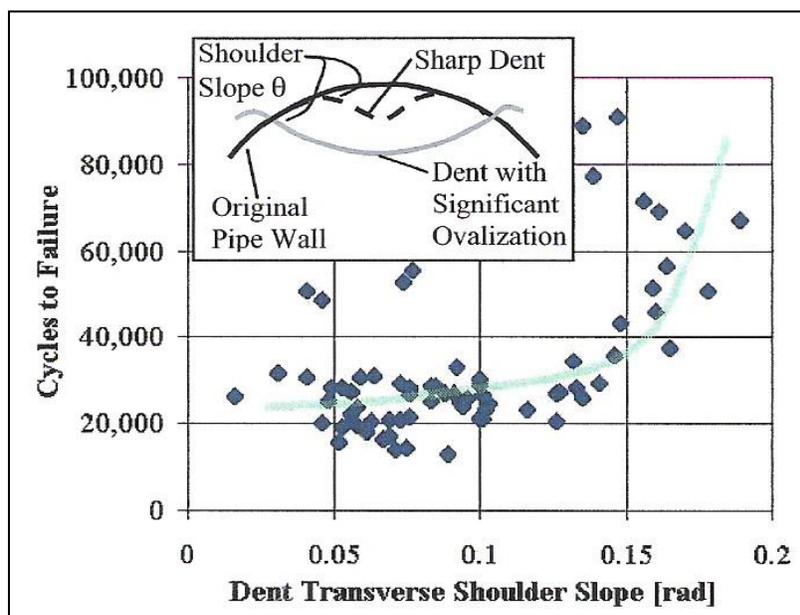
Figure 7.9 – Effect of Dent Profile on Fatigue Life of Plain Dents
(Dinovitzer et al., 2002)

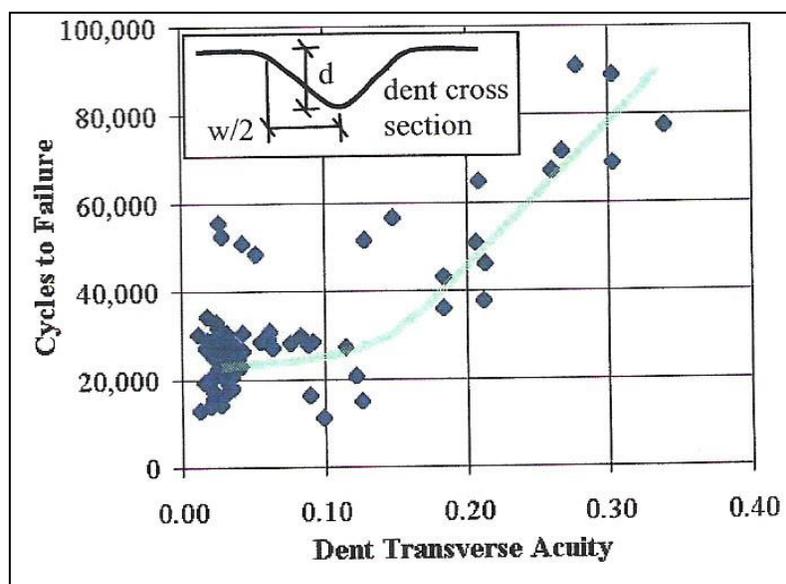
Figure 7.10 – Effect of Acuity ($w/2d$) on the Fatigue Life of Plain Dents
(Dinovitzer et al., 2002)

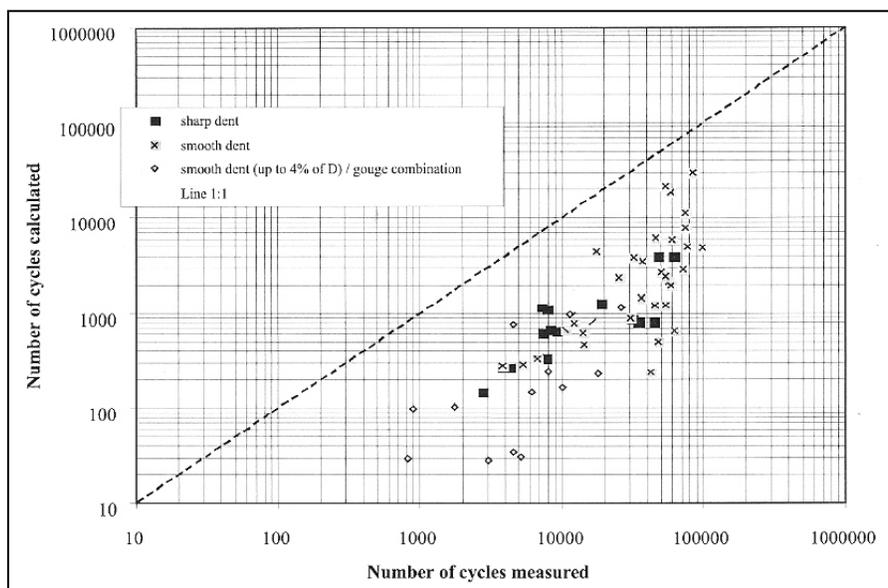
Figure 7.11 – Comparison of Measured and Calculated Dent Fatigue Life, Including an Adjustment Factor of 10 on Predicted Fatigue Life (EPRG, 1999)

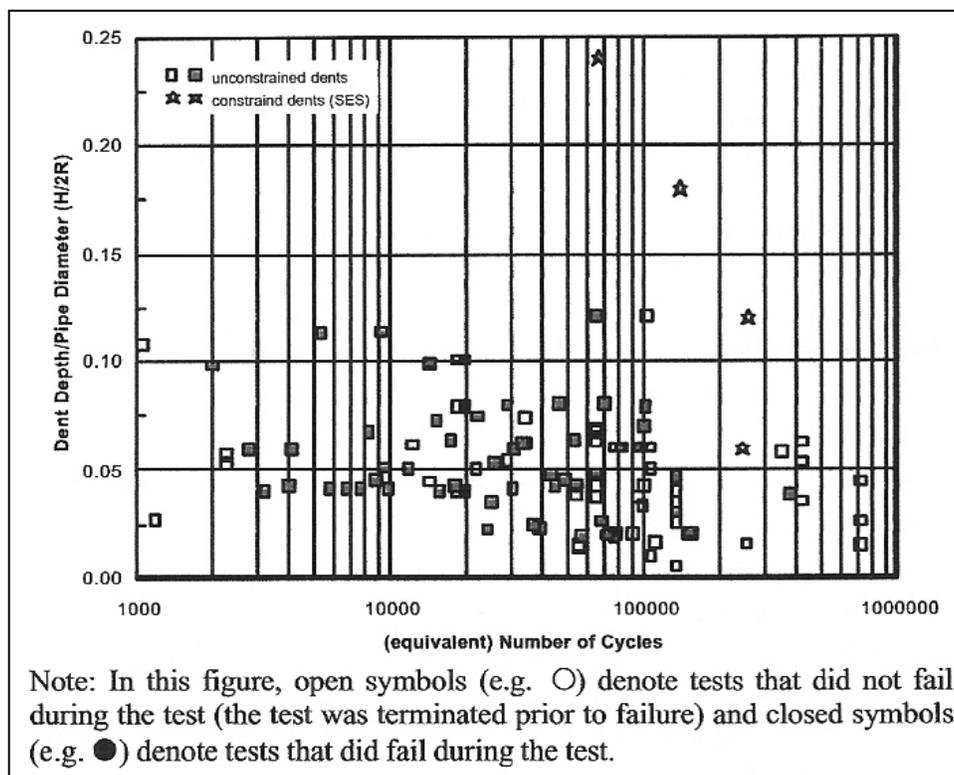
Figure 7.12 – Fatigue Lives of Constrained and Unconstrained Plain Dents (Cosham and Hopkins, 2004)

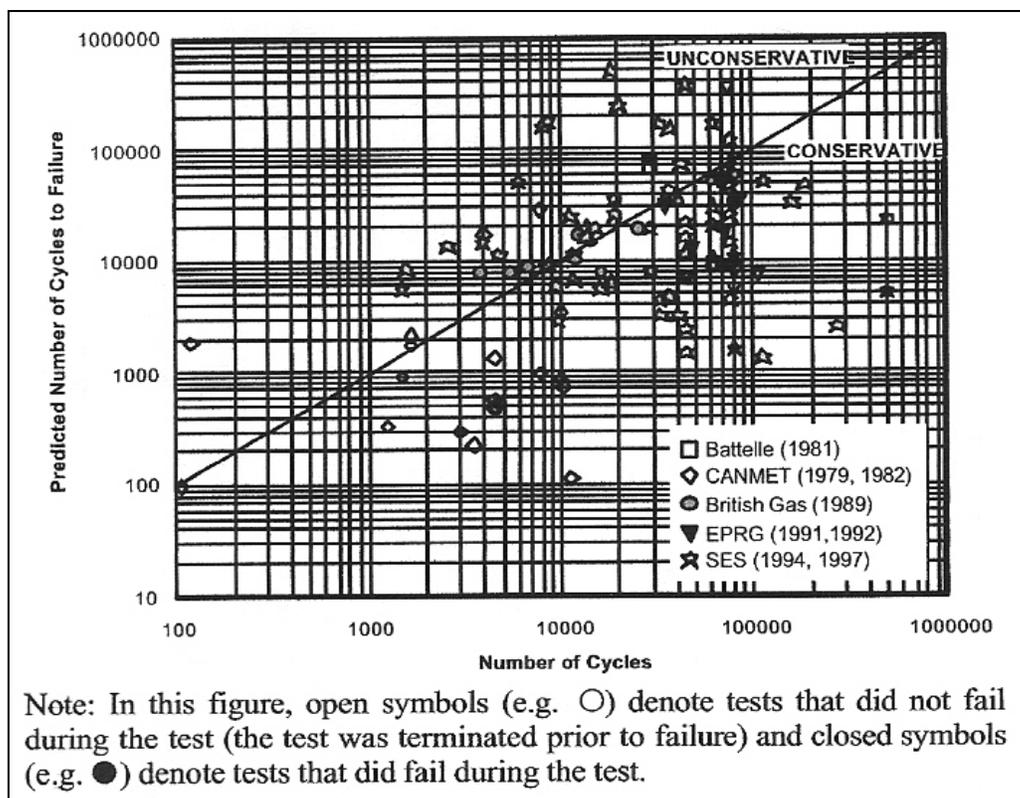
Figure 7.13 – Predictions of the Fatigue Life of Plain Dents using the EPRG Model (Cosham and Hopkins, 2004)

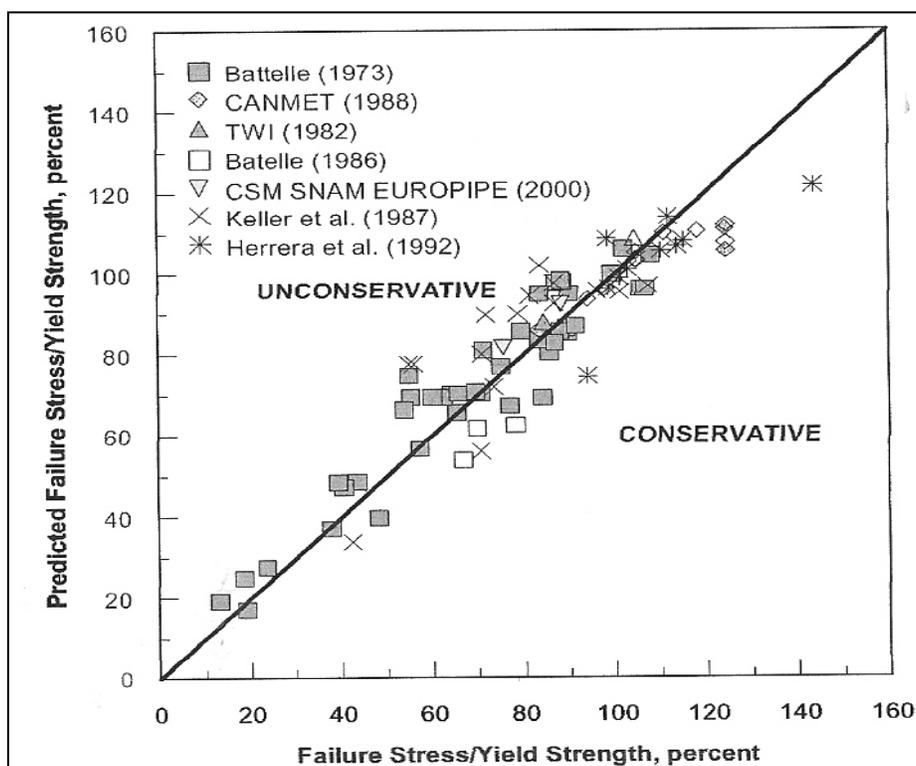
Figure 7.14 – Predictions of the Failure Pressure of Axially Oriented Gouges Using the NG-18 Equation (Cosham and Hopkins, 2002)

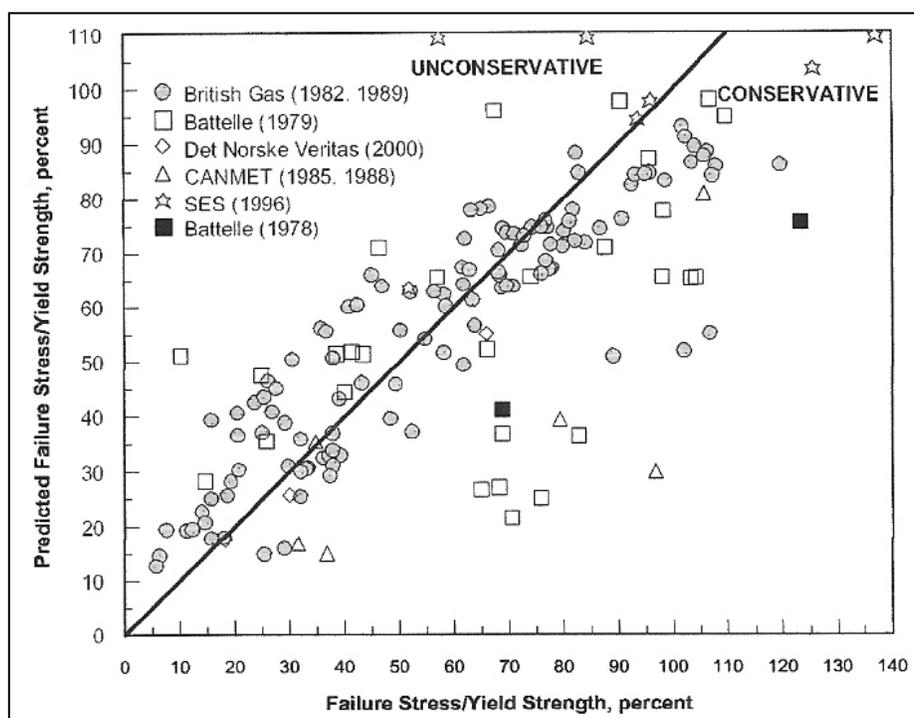
Figure 7.15 – Failure Behavior of Combined Dent and Gouge Damage Predicted Using the Dent Fracture Model (Cosham and Hopkins, 2002)

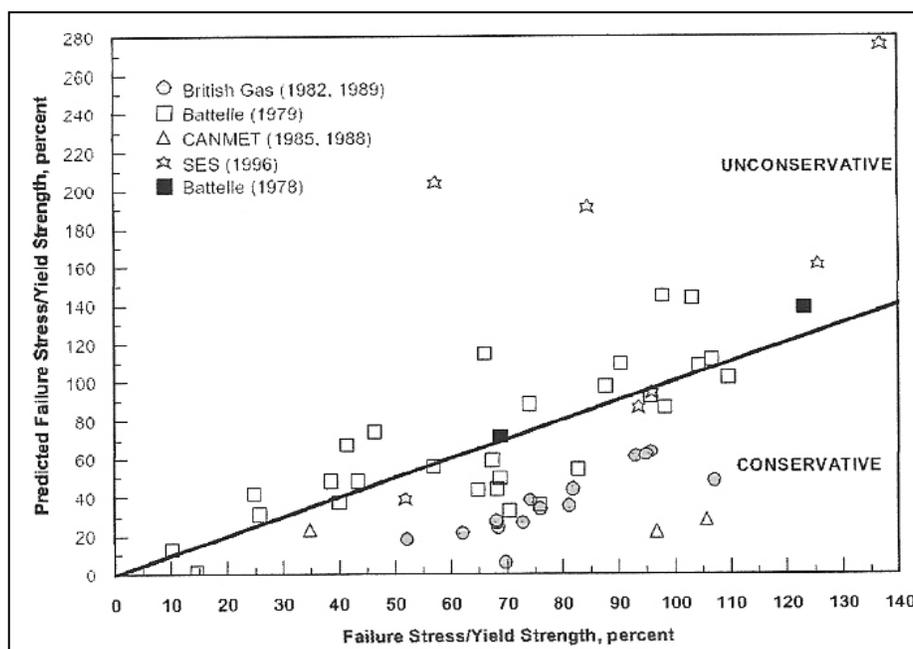
Figure 7.16 – Failure Behavior of Combined Dent and Gouge Damage Predicted Using the Q-Factor Model (Cosham and Hopkins, 2002)

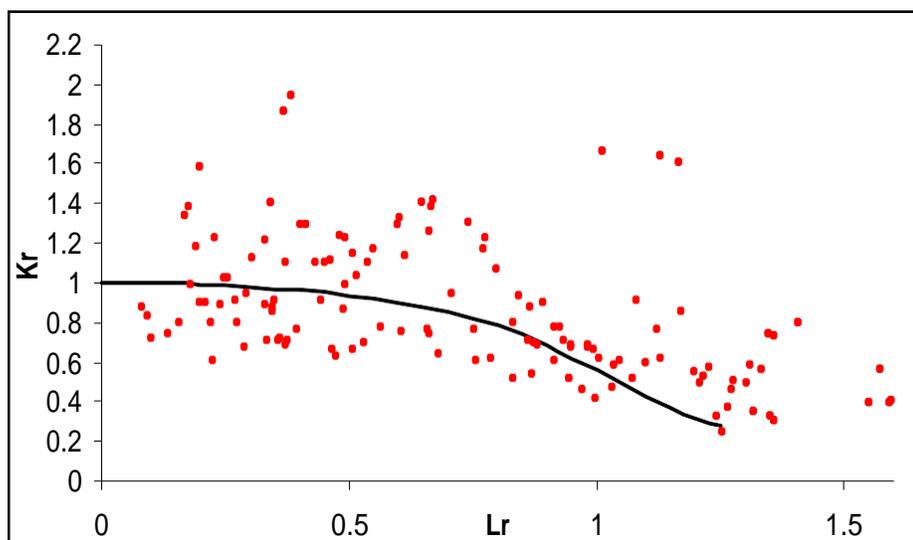
Figure 7.17 – Comparison of the Dent Fracture Model Incorporating the New Limit State Function, with Full Scale Combined Dent and Gouge Damage Test Results (Francis et al., 2005)

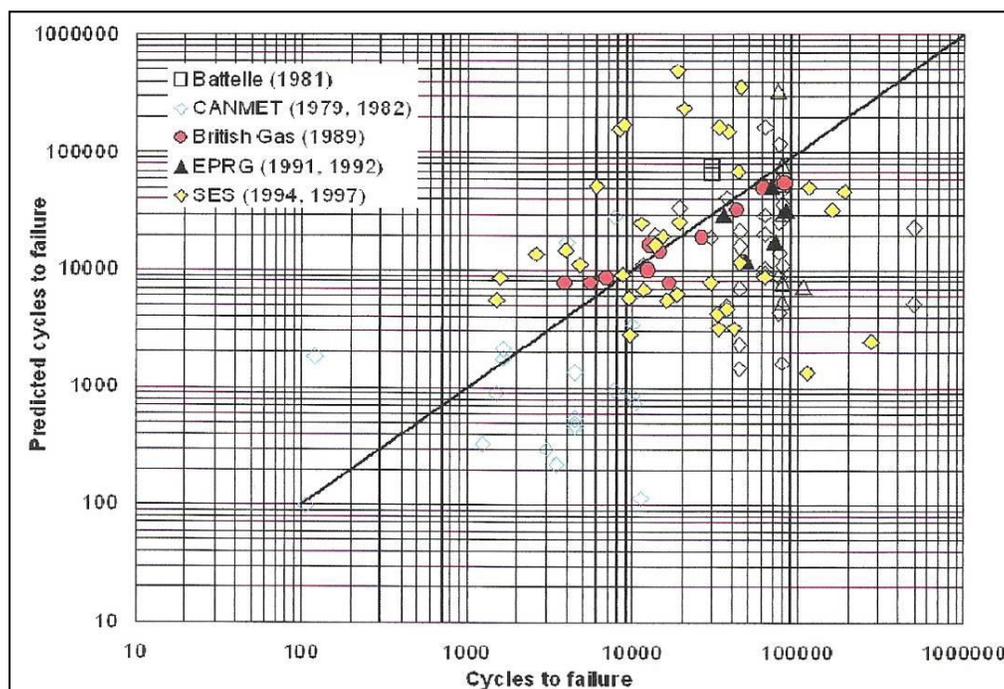
Figure 7.18 – Comparison of Full-Scale Fatigue Test Results on Combined Dents and Gouges, with the British Gas Model (Leis and Hopkins, 2003)

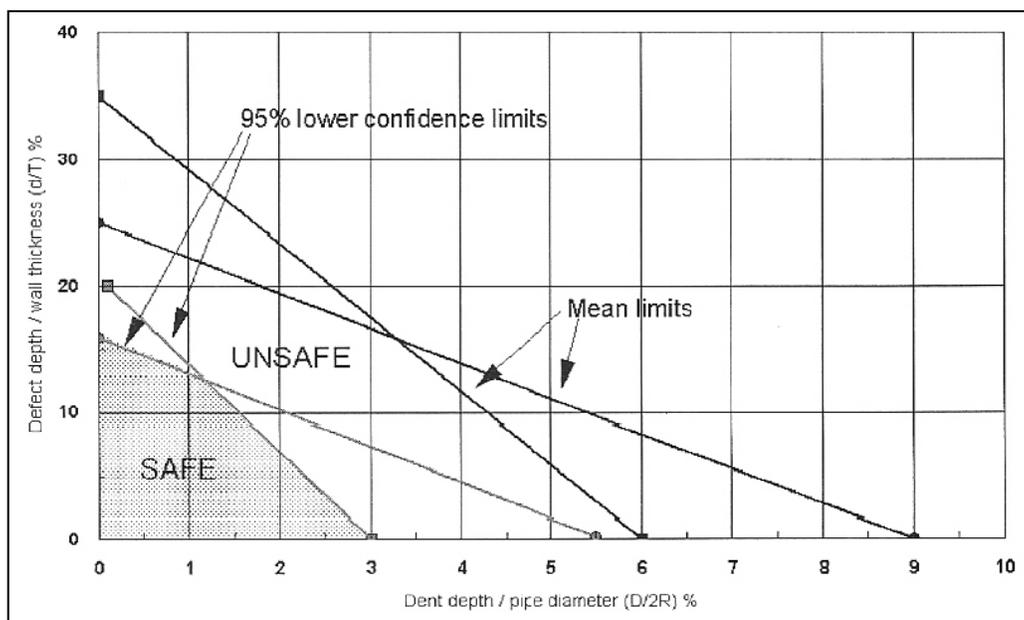
Figure 7.19 – Illustration of the Simplified Representation of Safe Limits for Combined Dents and Gouges (Bood et al., 1999)

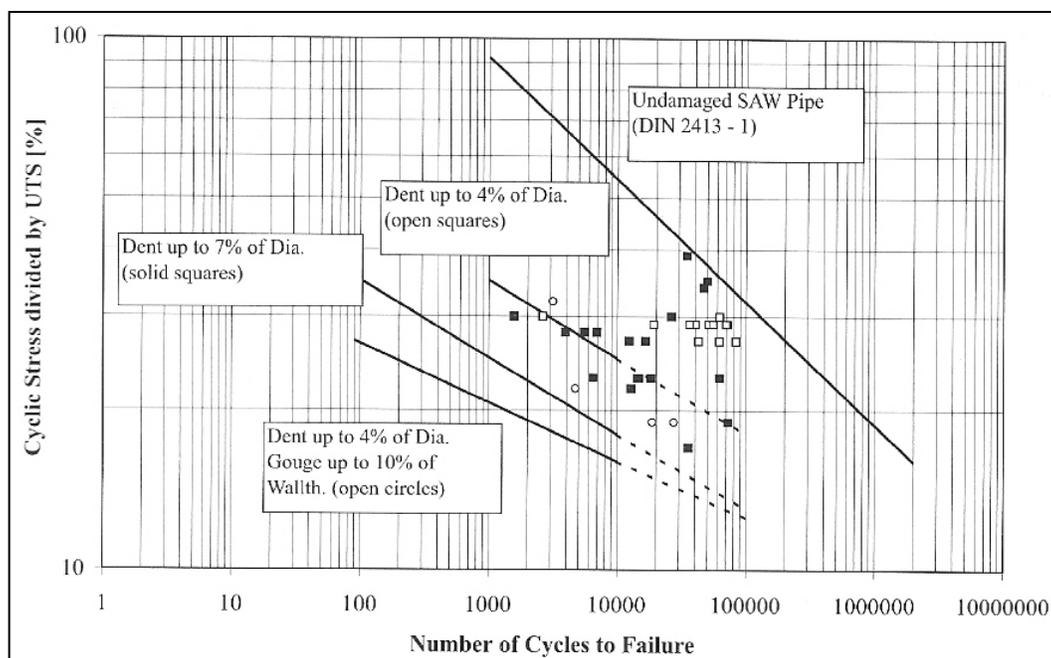
Figure 7.20 – Fatigue Limits for Dents and Combined Dents and Gouges, Related to DIN 2413-1, Including an Adjustment Factor of Ten on Life (Bood et al., 1999)

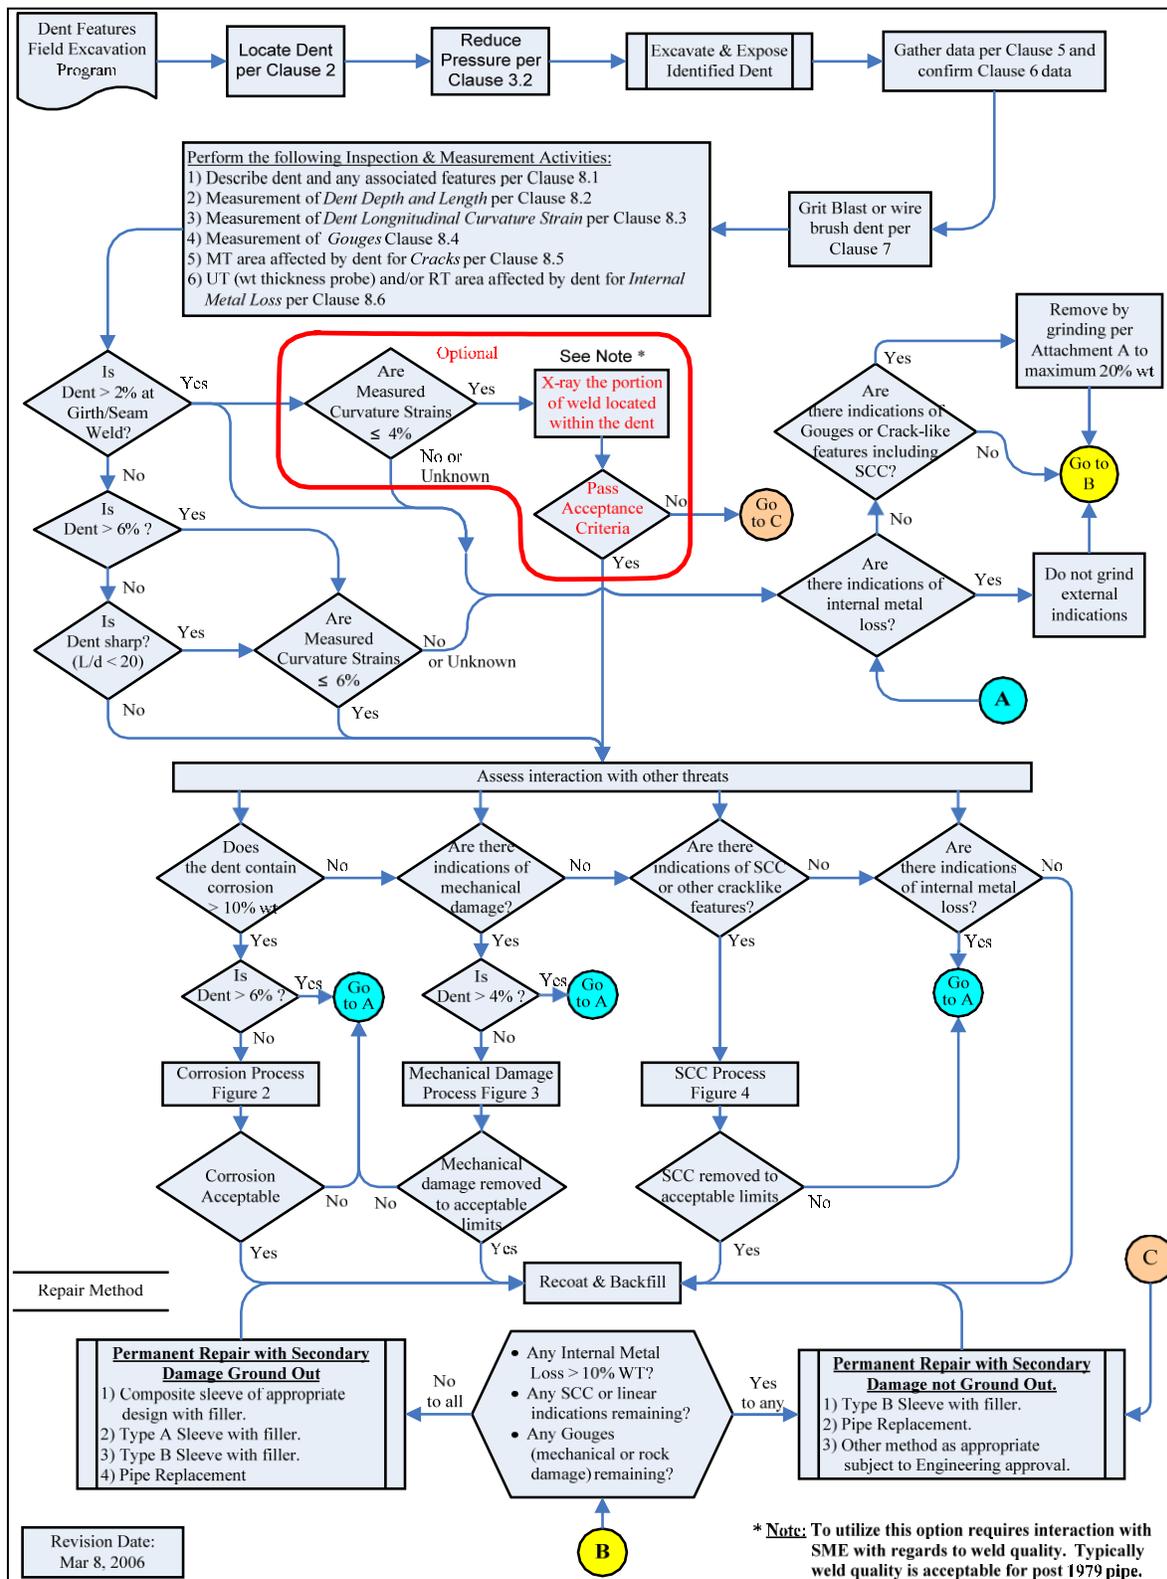
Figure 7.21 – Example of a Flow Chart for Assessing Damage Discovered Following Excavation (Warman et al., 2006)

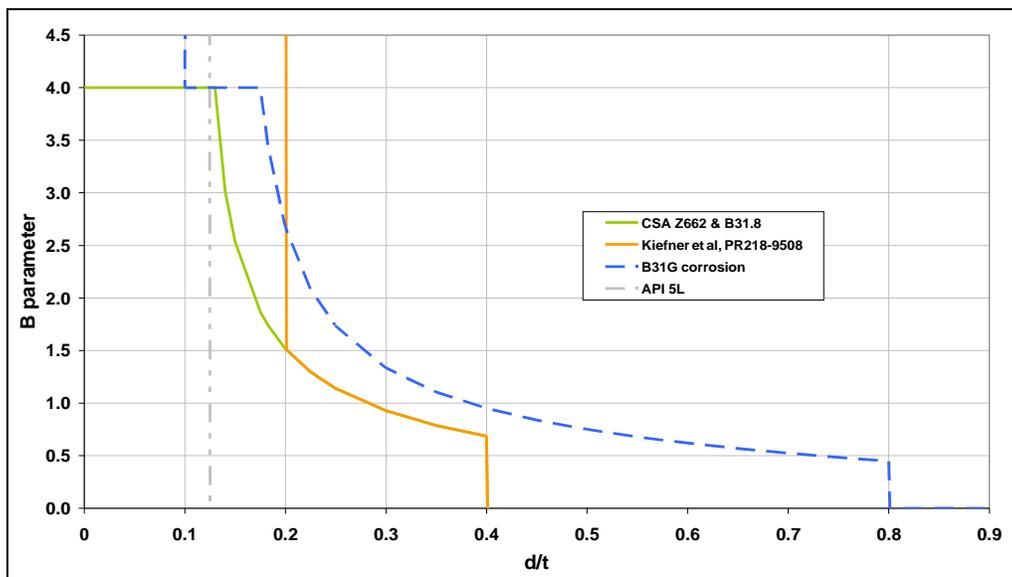
Figure 8.1 – Comparisons of Grind Criteria (Kiefner and Alexander, 1999)

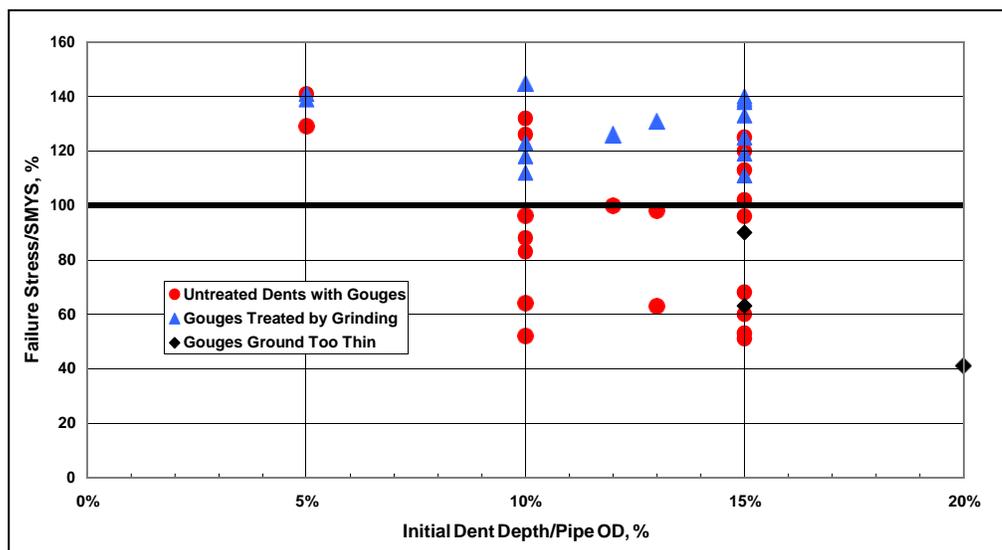
Figure 8.2 – Effectiveness of Grinding for Restoring Failure Stress (Kiefner and Alexander, 1999)

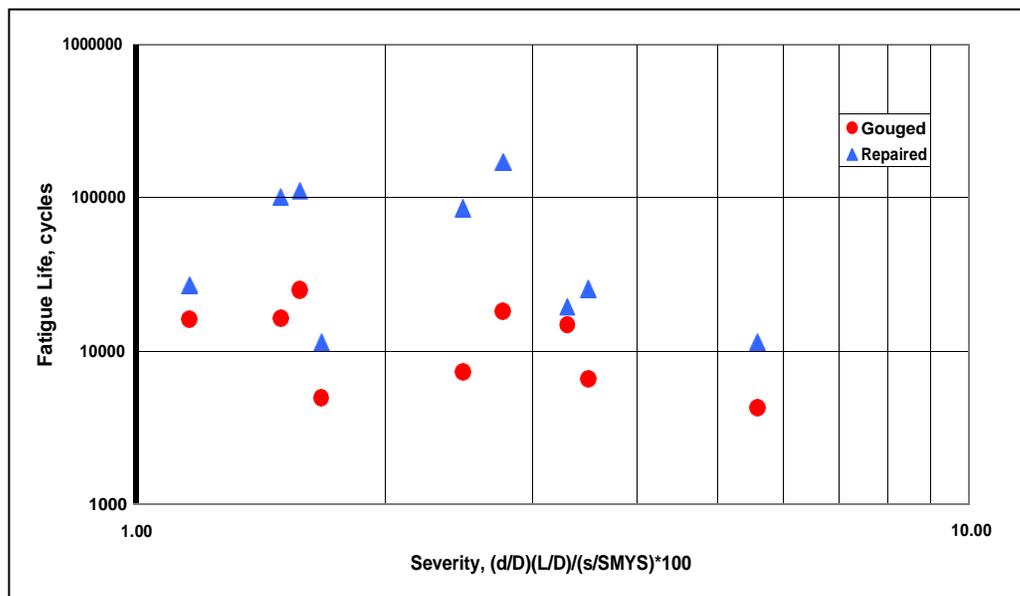
Figure 8.3 – Effectiveness of Grinding in Improving Fatigue Resistance (Kiefner, 1999)

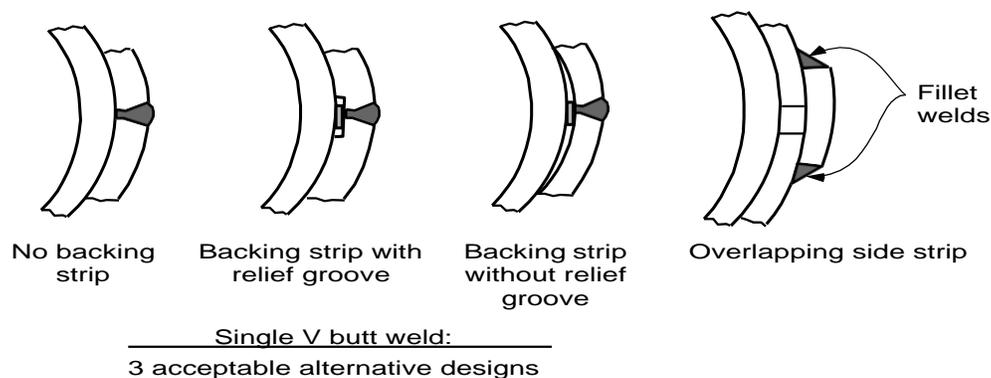
Figure 8.4 – Weld Details for Type A Sleeve (Jaske, 2006)

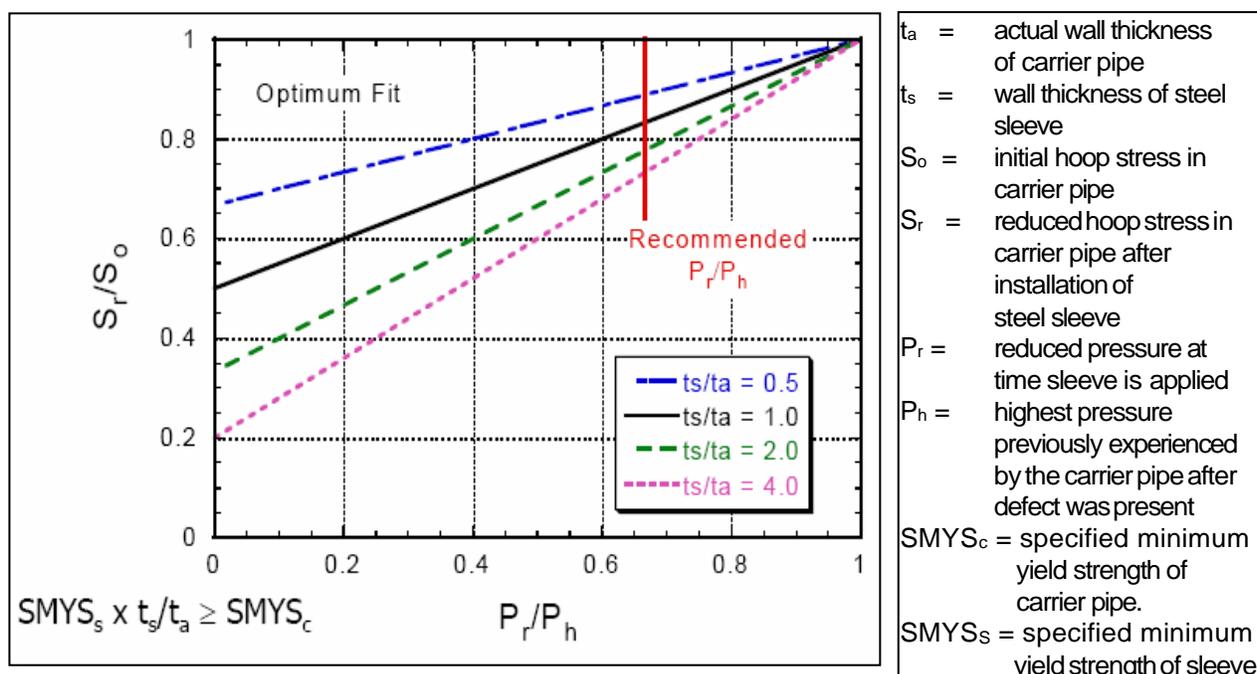
Figure 8.5 – Theoretical Relationships between Carrier Pipe Stress, Repair Pressure, and Wall Thickness. (Jaske, 2006)

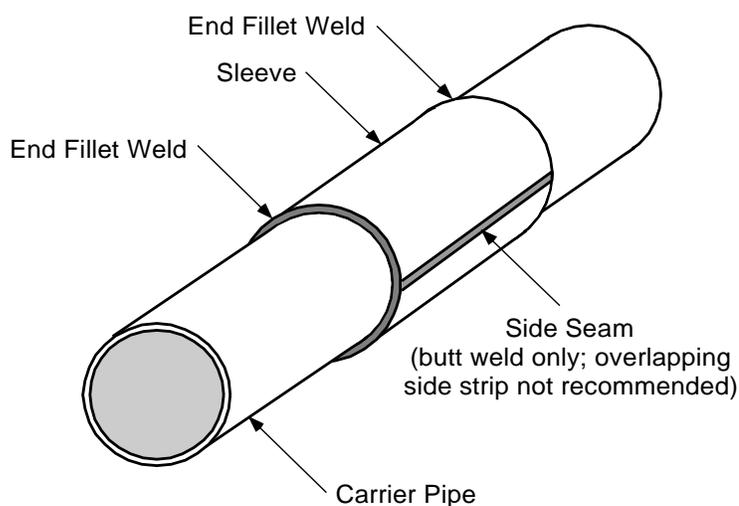
Figure 8.6 – Type B (Pressure Containing) Sleeve Illustration

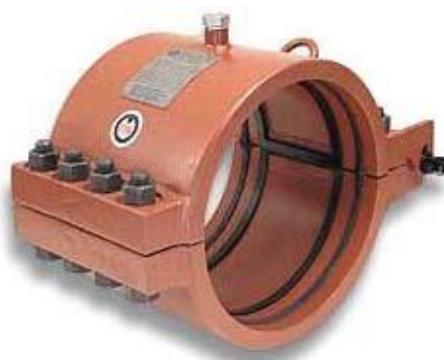
Figure 8.7 – Typical Mechanical Bolt-On Clamp (courtesy of T. D. Williamson, Inc.).

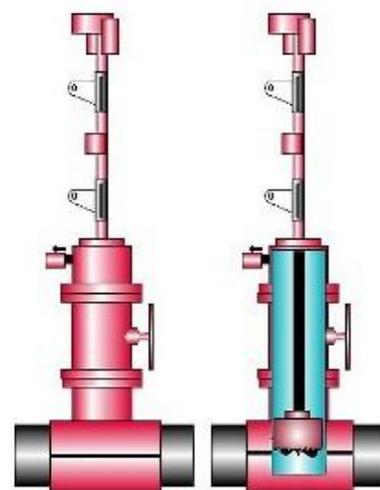
Figure 8.8 – Hot Tap Equipment Connected to Pipe (courtesy: <http://www.rafe1914.com>)
